BRICK NOGGING: INVESTIGATION AND REPAIR

D.T. Biggs¹

This paper will illustrate the historical use of brick nogging. A case study will be presented for an 1854 tavern building that developed exterior wall bowing from outward displacement of the brick nogging. Figure 2 shows the north elevation of the tavern where the backup to the exterior wythe is brick nogging. Two wood-framed additions are behind the tavern. The restoration scheme used to restore the masonry walls and to maintain the historical integrity of the building will be presented. The restoration of the wood-framed additions is not included. Upon full restoration, this historical site will become a Vermont state museum.

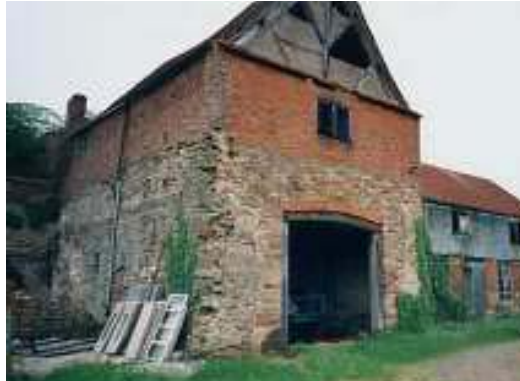
Figure 4 – Missing Nogging in Gable End

Lateral support of the nogging is typically provided by the bond between the mortar and the timber. Generally, lateral support anchors between the brick nogging and the timber are not provided. High lateral forces and deterioration of the mortar/timber connection may lead to a loss of the infill. Figure 4 shows a barn with several triangular-shaped infills missing.

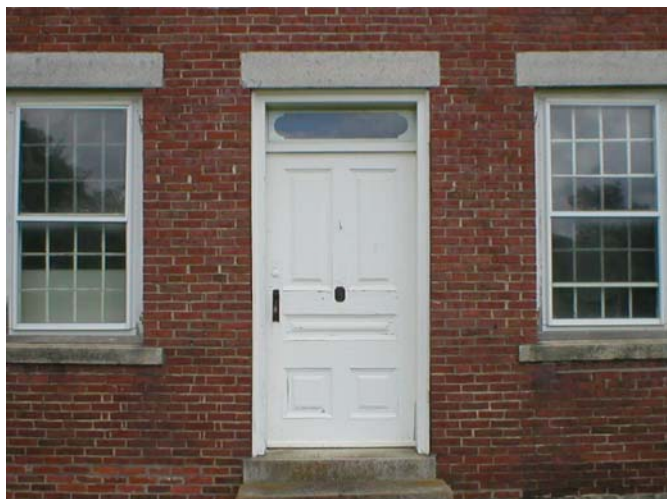
Figure 5 – West Wall

The exterior walls of the tavern are double wythe brick; they have an outer brick wythe bonded to an inner brick wythe with header courses at every tenth course. The inner brick wythe is nogging infilled between timber studs. The openings have stone lintels and sills (Figure 5).

defects included masonry cracking on all elevations, significant bowing on the west wall (as seen in Figure 6), and settlement of the west wall near the door (partially visible in Figure 5).

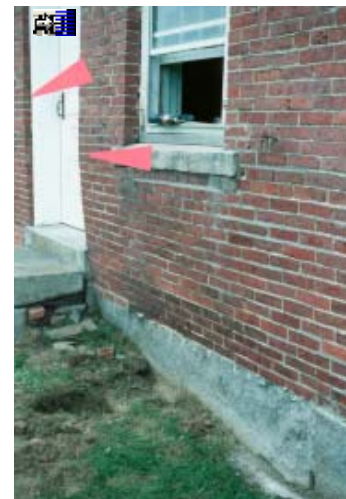
Figure 6 – West Wall

Figure 6 is looking from the south along the west wall. There is a granite base at ground level. The door in Figure 5 can be seen also. Figure 6 shows the wall bowing (arrows) evident at both sides of the door.

1. A survey of the gable end of the west wall was conducted to document the horizontal and vertical displacements. It indicated the wall was bowed approximately 46 mm (1.81 in.) between the first floor and the second floor; it was plumb above the second floor. The entire west wall of the tavern had settled approximately 29 mm (1.13 in.) from the northwest corner to the southwest corner. The cracks in the west wall are partially seen in Figures 7 and 8 (arrows). The pattern is indicative of settlement movement.

The integrity of the brick nogging was compromised by the movement. The exterior wythe was separating from the nogging, and the nogging was bowing outward as well. The bowing and the rotation were significant enough to be considered a safety concern.

To repair the wall bowing and settlement, the exterior wythe of the masonry had to be removed below the second floor; the masonry above could remain as long as restoration anchors were installed. By analyzing the wood framing, it was determined that the exterior wythe could be removed independently of the brick nogging.

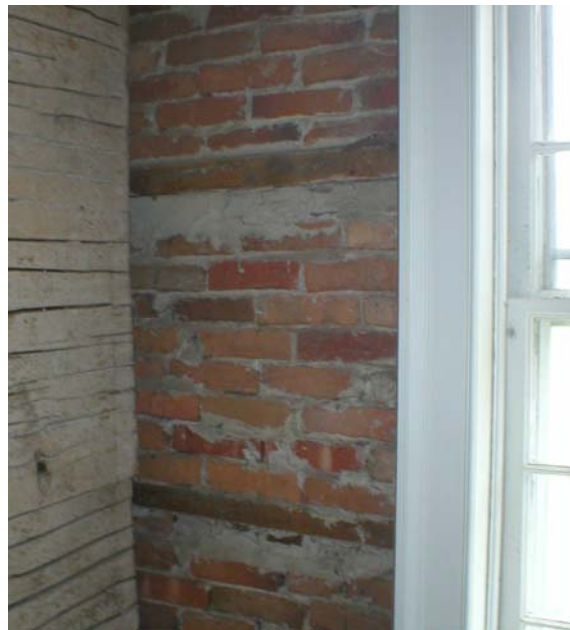
Figure 9 – Interior Probes

3. Interior removals were facilitated by the partial removal of the plaster finish. Figure 9 shows the interior at a corner; the lath is still on the left and removed on the right. Nine courses of brick nogging are in between horizontal timber blocking. There is mortar parging below the blocking that covers brick headers; the headers are visible on the exterior. The wall is two wythes (one course of nogging and a veneer) except at the timber studs and wood blocking where the wall is only a one-wythe veneer. No mechanical anchorage between the nogging and the timber was observed; no anchors attached the veneer to the timber framing. Surprisingly, no wood rot was observed in the several spots observed.

At wall studs, the mortar bond was typically broken by wood and mortar shrinkage. In the areas of bowing, the nogging was displaced outward and there was a gap of up to 19 mm (0.75 in.) between the timber framing and the exterior wythe. The collar joint had gaps from the displacement as well.

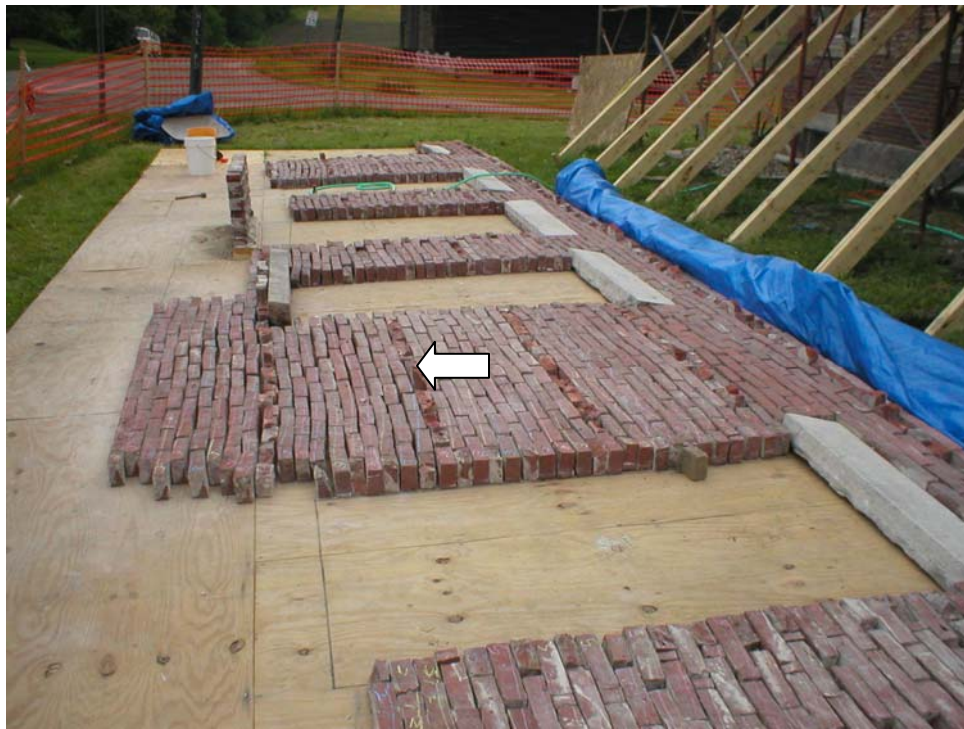
Figure 13 – West Wall Exterior Veneer

Figure 13 shows the exterior veneer laid out so it could be reconstructed exactly. The header bricks were broken (arrow) leaving the other half in the nogging.

During the rebuild of the veneer, the granite bases were reset and anchored to prevent further movement. The exposed wood was preservative treated (there was no rot after 148 years!). The exterior of the brick nogging was repointed. Masonry veneer ties were attached to both the timber studs and horizontal blocking, and the brick veneer was reinstalled level as an anchored veneer. The masonry ties were stainless steel and were lagged bolted into the timber framing. Figure 14 shows the mortar tooling to match the original.
