NON-DESTRUCTIVE TESTING & MONITORING OF MASONRY - NORTH AMERICAN CASE STUDIES

R.G. Grieve¹ and P.A. Jeffs²

ABSTRACT

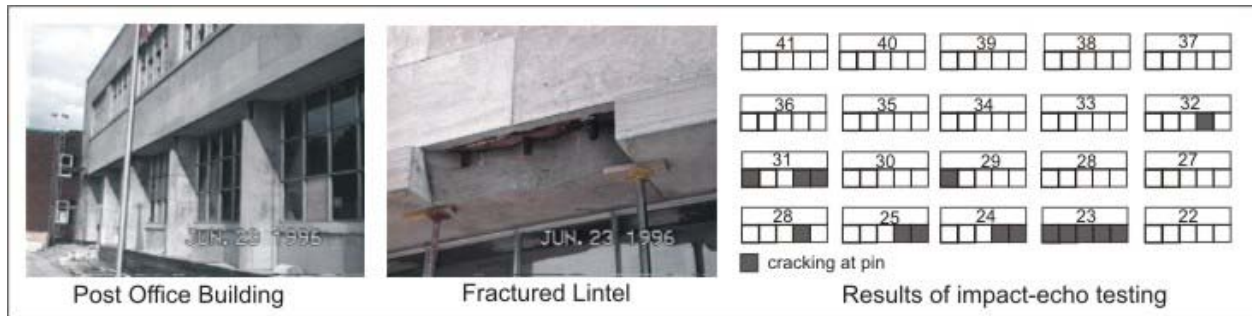
Figure 2 - Post Office Conversion - Impact-Echo Test Results

During conversion of an historic post office to a library, one of the limestone lintels split, crashing to the ground. Fortunately no one was hurt. Visual examination of the lintel determined that several pins installed into the top of each unit provided support. In this particular case, some of the pins had corroded, to cause the stone to split. After preliminary impact-echo tests on several whole and visually cracked lintels, it was determined that - although somewhat complicated - there were significant differences between signals induced within solid lintels compared to cracked lintels. Based on this preliminary work, every lintel was tested at each pin for the presence of cracking. This revealed that some of these remaining lintels were also cracked (see figure 2).

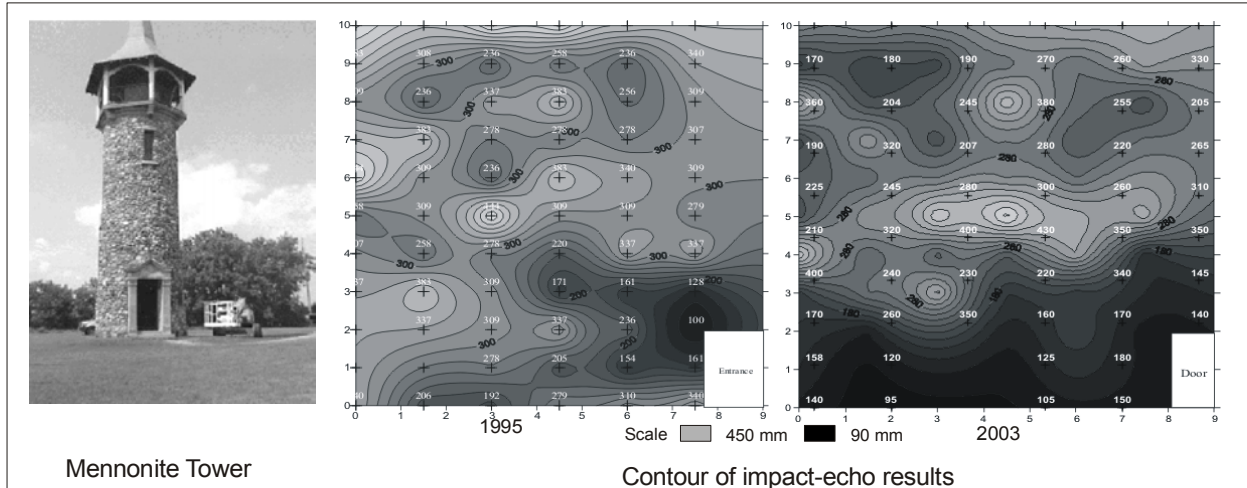
Figure 3 - Mennonite Tower Impact-Echo Tests

A Mennonite monument constructed in the early 1900's as a cylindrical tower was badly deteriorating. The construction consisted of a stone exterior wythe with an unreinforced concrete backup. Degradation of the concrete surface was visible on the interior and several cores confirmed deterioration of the interface between the facing stone and concrete.

In 1995, it was decided to evaluate the extent of this interface deterioration using impact-echo tests. The tests revealed that the deterioration was quite extensive, particularly around the bottom of the monument. Subsequent impact-echo testing in 2000 and 2005 revealed that the inner deterioration of the monument was accelerating and this information was sufficient to initiate a repair programme (see figure 3).

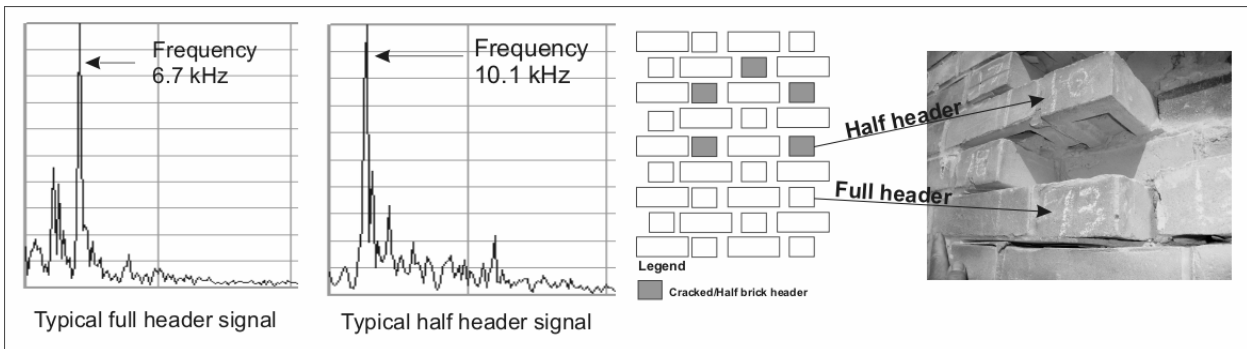
Figure 4 - Impact-Echo Tests on Brick Headers

Inspection of an historic brick structure in Toronto using light hammer-tapping techniques revealed significant sounding anomalies, thereby indicating that potential structural defects existed within the three wythe brick masonry assembly. It was considered possible that there might be serious failure of the 3-wythe thick masonry assembly. Test panels of approximately 600 x 600 mm (24 in x 24 in) were selected for impact-echo testing of the exposed header courses. Depending on the impact-echo signal received, each header unit was marked as potentially being either “full” or “partial”. The panels were then opened for inspection and the impact-echo results thus confirmed as being reliable (see figure 4). Impact-echo tests were subsequently completed on many more areas selected as being representative of the building masonry design. The precise detailing of false and full header bricks enabled the engineering company to more accurately assess the condition of the masonry.

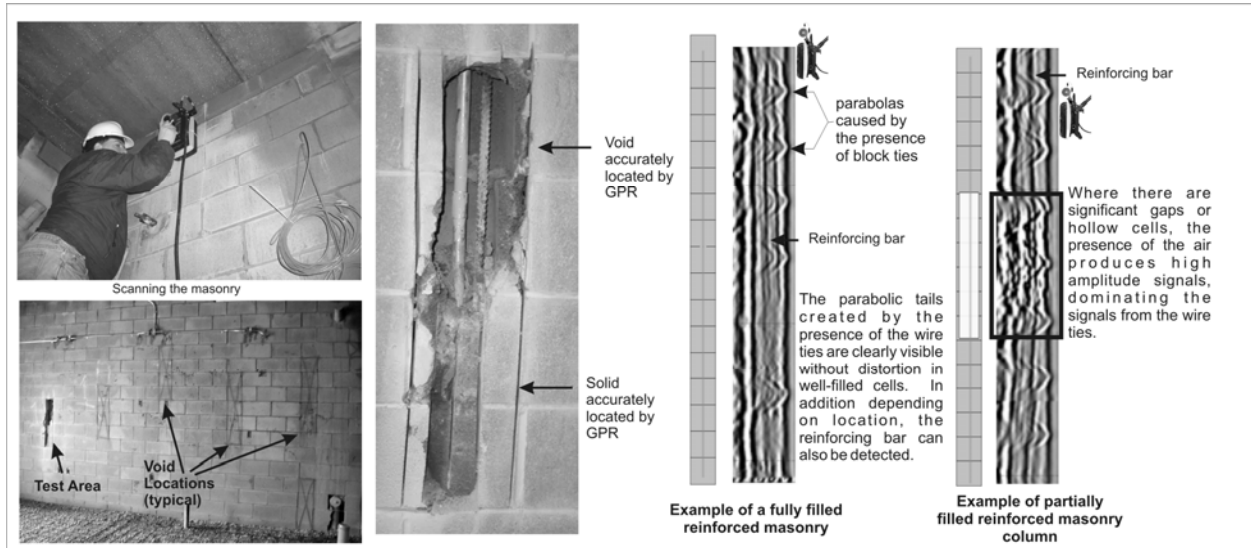
Figure 5 - GPR Scanning of Reinforced Masonry Walls Voided Locations.

During construction of a 3-story retirement home, one of the reinforced concrete masonry unit (CMU) walls was severely damaged by a severe gale. CMU is constructed by inserting reinforcing steel into selected vertical masonry cells and filling them with grout to form solid columns spaced between 1 and 2 metres apart. A preliminary investigation determined that the reinforced columns of the masonry units were improperly filled. It was subsequently deemed necessary to verify that all of the reinforced masonry columns in the building were properly

filled. Although it was known that impact-echo could detect voids in masonry units, GPR scanning was considered more definitive for this purpose. Scans were completed on 10 selected reinforced masonry columns. (see figure 5) Locations where the traces indicated the presence of voids in the columns were marked on the masonry wall in real time. The marked locations were subsequently opened for visual inspection. It was found that the GPR had detected the unfilled masonry cells with complete accuracy. This technique was adopted to inspect all the suspect masonry columns throughout the building. Repair consisted of injecting grout into the marked voided locations. As the alternative was to demolish and re-build all the suspect walls, this technique was considered to have saved considerable amounts of time and money.

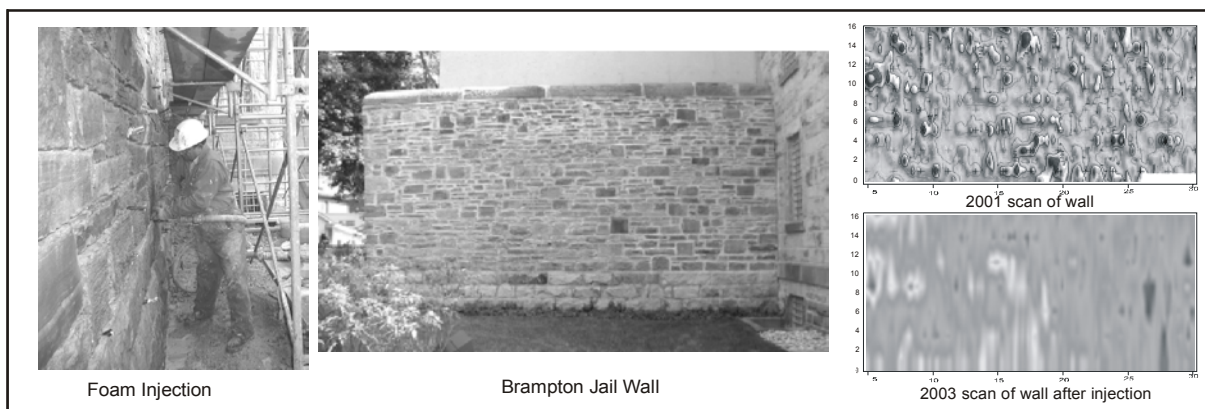
Figure 6 - GPR Tests on Reinforced Masonry

During initial cutting out operations of the old mortar, it was noted that the interior core rubble was in a poor condition and further investigation was determined necessary. A GPR survey

consisting of many horizontal scans along the wall was subsequently completed. The resultant data was processed to provide a 2D image of the core centre, which revealed the presence of many voids. The data also facilitated the installation of the injection ports and the concentration of grout at key locations. About 2 cubic metres (70 cubic feet) of grout was subsequently injected - approximately that calculated to be required from the data provided by the GPR survey. At another location, the GPR was able to confirm that only a nominal amount of voids existed within a portion of the jail foundation wall that was exposed by excavation, thereby eliminating the need for grouting. Some time after injection, the wall was re-scanned, revealing that the injection process had substantially filled the rubble core of the wall. (see figure 6) It is believed that this was the first time the technique had been used for this purpose in Canada.

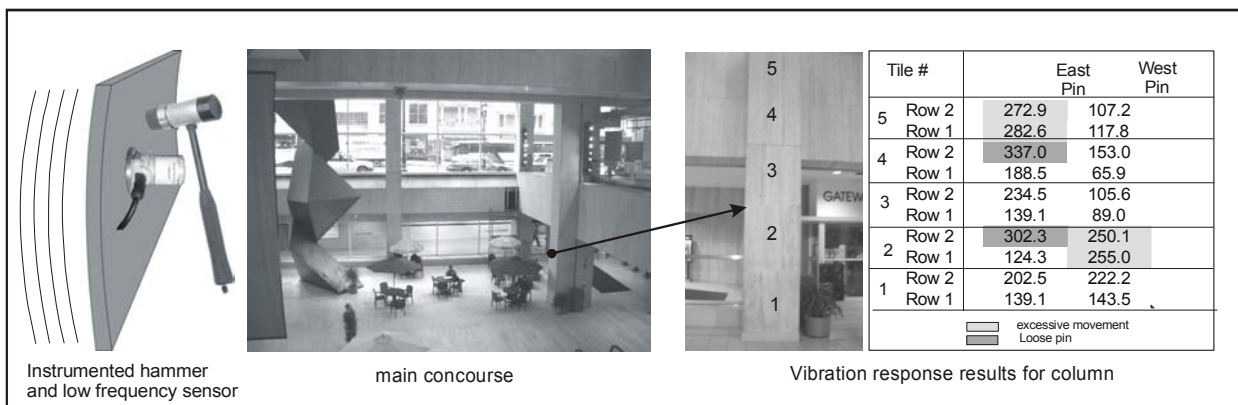
Figure 7 - Vibration response tests on pinned tiles

The interior of an office complex was built in the 1970’s using marble tiling. During one night, a tile came crashing to the ground - causing no injury, but initiating an evaluation of the stability of the tile installation. Each tile had been pinned to the structure using 4 ties consisting of a wire tie encased in plaster. A preliminary series of tests were undertaken using vibration response testing with an instrumented hammer and low frequency transducer. (see figure 7) A series of tests was completed on several selected tiles. One of the pins of each tile was then cut, and a second series of tests carried out. This was followed by cutting a third pin on each tile and repeating the tests. It was found that the vibration response test produced high “mobility” value at each of the cut pins. Tests were then completed on selected areas of concern throughout the tile clad areas. The survey indicated areas of tiling where re-pinning was necessary.

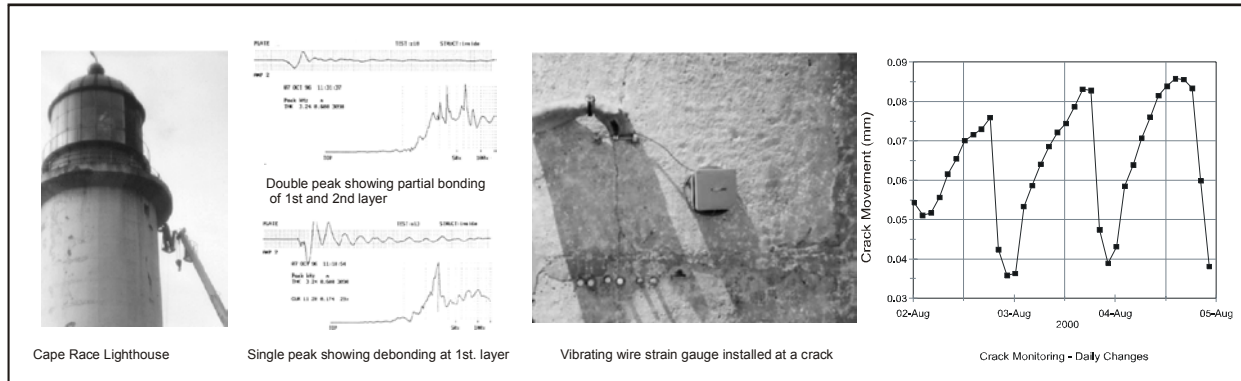
Figure 8 - Impact-echo and crack movement test results

Situated on a remote headland in southeastern Newfoundland, Canada, and constructed in 1905, Cape Race Lighthouse is believed to be the second oldest reinforced concrete lighthouse structure in the world - the oldest probably being in Russia. Several repairs were completed in 1937 and 1969, which resulted in two additional layers of concrete being installed over the original structure. Impact-echo tests on the inside of the structure and another series of tests on the outside of the structure indicated that the outer layer was poorly bonded, while the bond between the middle layer and the tower core was in a better condition. (see figure 8) Cores taken at selected locations through the full thickness of the tower confirmed these conditions and also revealed deterioration of the outer/centre interface. To ensure that the original concrete had sufficient capacity to permit the implementation of the restoration strategy, the tensile strength of

Restoration included cutting three expansion joints and repairing cracked and spalled areas. But it was noted that after these repairs, several hairline cracks remained. It was considered likely that these cracks could open up during seasonal temperature changes. The question was, should they be routed out and sealed or could an elastomeric coating satisfactorily bridge the cracks. To verify this and obtain an idea of the magnitude of the movement, vibrating wire strain gauges were installed over selected cracks, logging the strain and temperature every hour for a period of about a month. This data enabled calculations to be made regarding the likely seasonal movement based on climate charts for that area. This estimated seasonal crack movement was then provided to the coating manufacturer who subsequently provided an elastomeric coating which could accommodate that degree of movement.

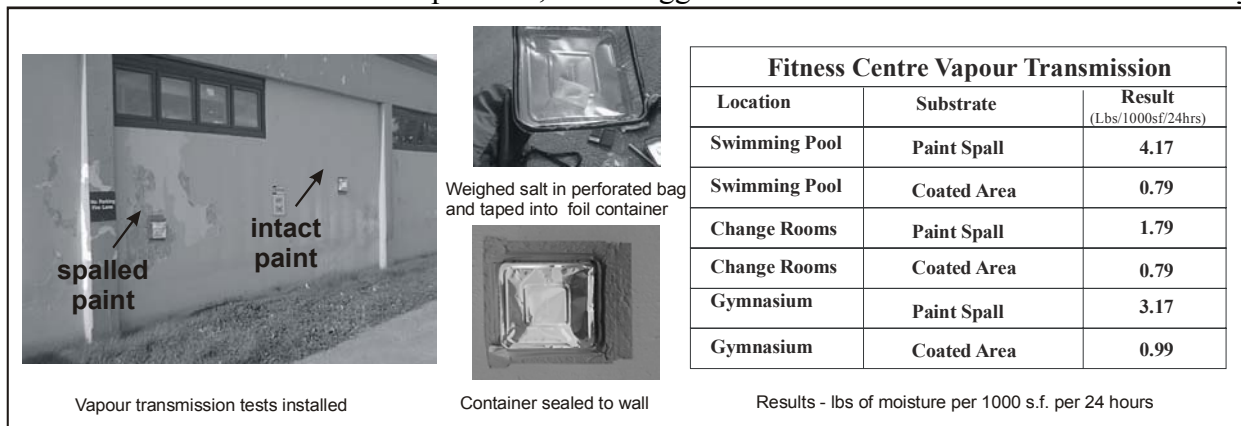
Figure 9 - Vapour transmission tests on exterior wall

During the spring of each successive year, the painted surfaces of a swimming pool and gymnasium structure continued to flake and spall in random patches. Inspection revealed that the south side of the swimming pool walls had the greatest amount of surface spalling. To acquire information on the source of the problem, small loggers were installed in the exterior and cavity

walls of the building and set to record the temperature and humidity every 4 hours. Local personnel were then trained to download the data to a “data shuttle” and send the files by e-mail on a monthly basis. In addition, a method of measuring the vapour transmission based on the ASTM F 1869 [ref 3] test method was developed using accurately weighed calcium chloride in perforated bags. Several test areas for this vapour transmission test were selected at locations where there had been no recent damage, as well as at locations adjacent to recent paint spalls. (see figure 9). The calcium chloride tests revealed that there was significantly greater rate of moisture vapour emission at the spalled locations compared to the adjacent areas where the paint was still adhered to the wall. This demonstrated that the primary force in the deterioration process was vapour pressure. This was subsequently confirmed by the humidity and temperature data obtained over a 1 year period, which showed high humidity in the wall cavity of the swimming pool wall continued at a very high level throughout the winter period - despite low outside temperatures and humidity. During thaw condition of April and May this resulted in high vapour pressures in the cavity wall (see figure 10 for an example of the type of data obtained)
