## A FINITE ELEMENT APPROACH TO CALCULATE TWO ANCIENT MASONRY VAULTS

**Gero A. Marzahn<sup>1</sup>, Rüdiger Jahnel<sup>2</sup>, Michael Köhler<sup>3</sup>, and Nguyen V. Tue<sup>4</sup>**

### ABSTRACT

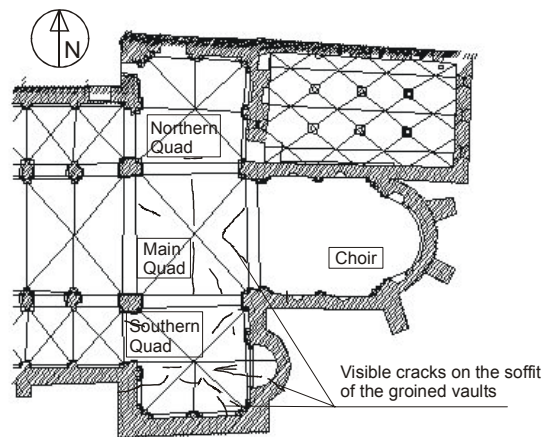
**Figure 2 – Transept of the church displaying cracks on the inner surface of the vaults**

The failure of the choir's dome also caused the loss of the horizontal support for the adjacent central vault on its east side. Even though the masonry arch on the east side bears the vault vertically, it offers almost no horizontal stiffness so that the vault's thrust is pushing it towards the side, giving it an oblique position. Furthermore, the central vault is forced to bridge a larger span since the opposite abutments remain fixed. The stiff vault is barely able to follow the arch without sagging at its apex. This situation, which is accompanied by severe bending, has caused typical cracks stemming from the ridge of the caps into the piers forming a triangular crack pattern as can be seen in Figure 2. By means of these cracks, the vaults have developed joints in

First, all open joints and cracks have to be carefully filled with mortar. The second major step should be the strengthening and stiffening of the abutments. Specifically, they have to be retrofitted with grouted stainless steel tendons that are slightly posttensioned. Stiffening the abutments with precompression serves as an important restraining element to fix the vaults' base to prevent further degradation. Because the analysis implied that the vaults may not endure any additional sideward shifts, the stiffening structures themselves as well as the process of transferring the bracing forces into the ground must restrict all deformation to a minimum.

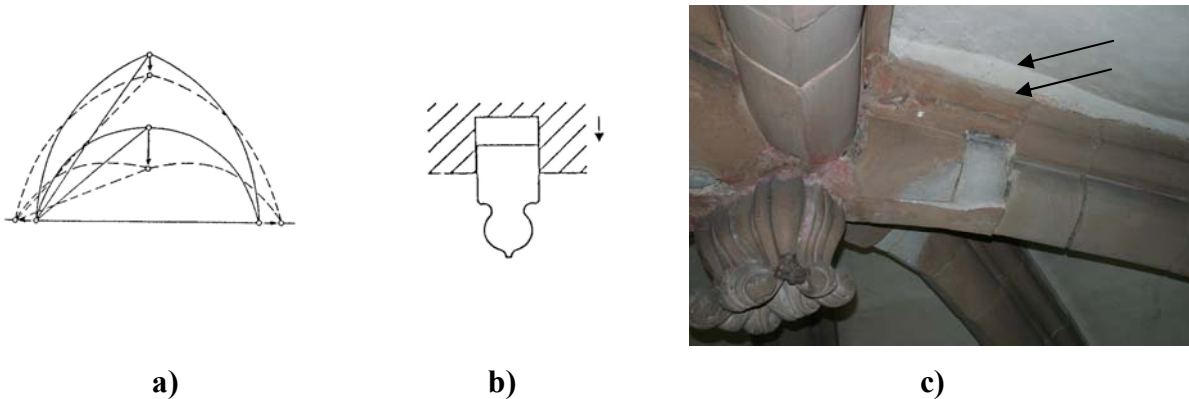
Because of different rises between caps and ribs, the ribs with a lower rise tend to sag more than the caps as the apex is lowered. Indeed, measurements determined that the ribs have been pulled out of the masonry caps by more than 10 cm (4 in.) (Figure 4) despite the same horizontal shift. They are no longer fully mortared into the masonry and are in danger of falling down. The same potential destiny applies to the keystone at the southern apex.

**a)** **b)** **c)**  
**Figure 4 – Comparing the sagging mechanisms of ribs and caps**  
**a) mechanism [3], b) pulling out the ribs [5], c) vault over the south side**

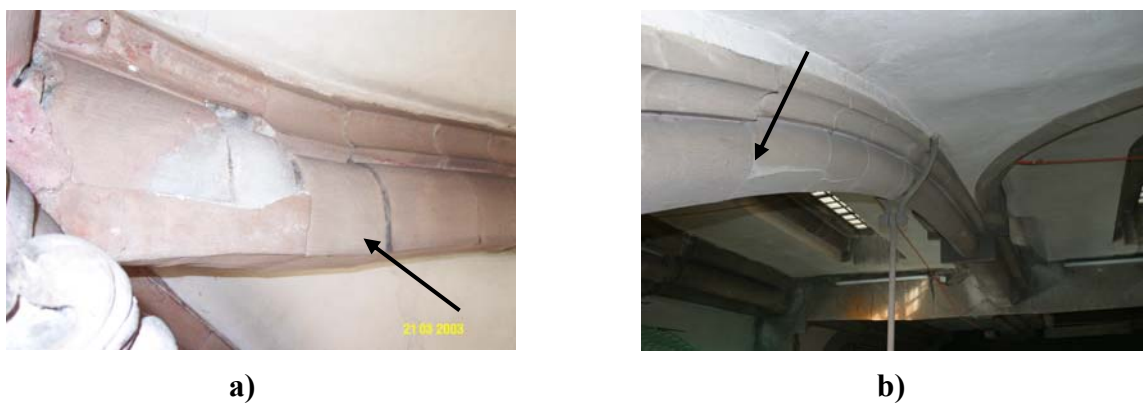
The lowered apex also caused bending tensile stresses on the soffits, which opened once-mortared joints especially in the cantilevered ribs (Figure 5). Mortar crumbled out of the open joints. Toward the domes' base, the bending moments have changed their sign, giving rise to considerable compressive stresses on the inner surface. As a result, spallings have occurred at some cantilevered rib elements due to heavily concentrated compression forces.

**a)** **b)**  
**Figure 5 – Ribs in damaged condition**  
**a) open cracks at the vertex, b) spalling of ribs due to concentrated compression**

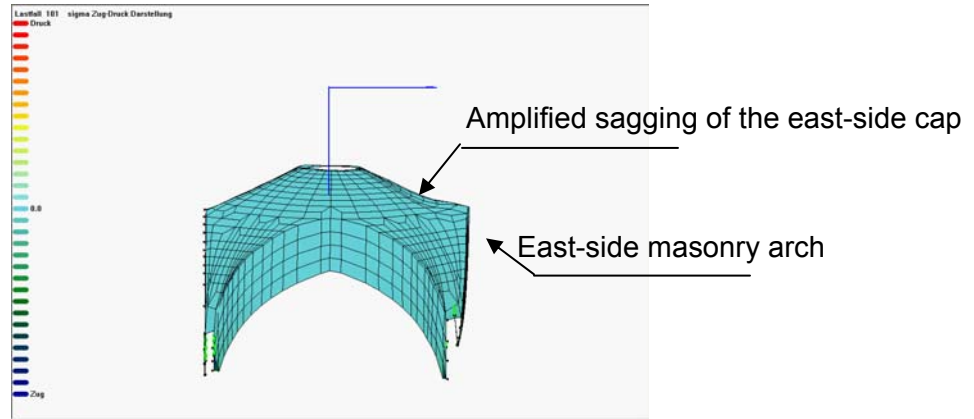
The stress distribution for gravity loads was nearly in the compression range and varied between 0.05 and 0.25 N/mm<sup>2</sup> (7.25 and 36.25 psi). Although the ribs had become apparent in the stress plots, no significant differences between the bearing behaviour of caps and ribs were apparent, yet the deformation found along the east-side edge of the vault indicated that there were increasing strength and stiffness degradations. That is, areas near the horizontally unsupported east-side masonry arch had started to hang on the stiffer ribs (Figure 9), relieving the cap's load because an unfavourable superposition of membrane and bending stresses inside the cap initiated cracks, at first, and then weakened the cap's ability to carry loads, forcing the loads to bypass the arch. Indeed, tests demonstrated that stresses on the soffit along the east-side arch had partly changed their sign into tensile stresses.

The stress flow diagram reveals a ring of compressive stresses surrounding the vertex, but stretching more to the south and north as the cap started to sag. The east-west direction is relieved of stresses to an extent not really equal to that at which the north-south direction takes higher loads. Thus, the load-carrying concept, where the thrust originating from the vaults is normally distributed in all directions, no longer applies.

**Figure 9 – Deformed vault structure under dead load**

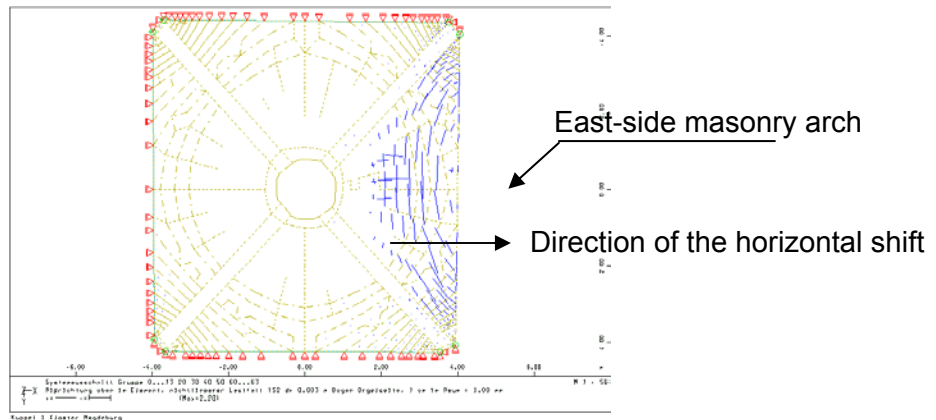
**Figure 10 – Crack propagation under a combined loading of gravity and horizontal shift**

As can be seen in Figure 10 (scale 1:56), the crack propagation on the inner and outer side expanded into the structure as the horizontal shift grew. At a displacement of 2 mm, the typical triangular crack in the eastern cap had already developed almost entirely [7]. Superimposing the crack patterns of the inner and outer surfaces, it becomes evident that many cracks have spread through the whole shell thickness. The sagging of the vaults not only led to higher stresses (appr. 70 percent of allowable stresses at a shift of 2 mm) but also caused a nominal enhancement of

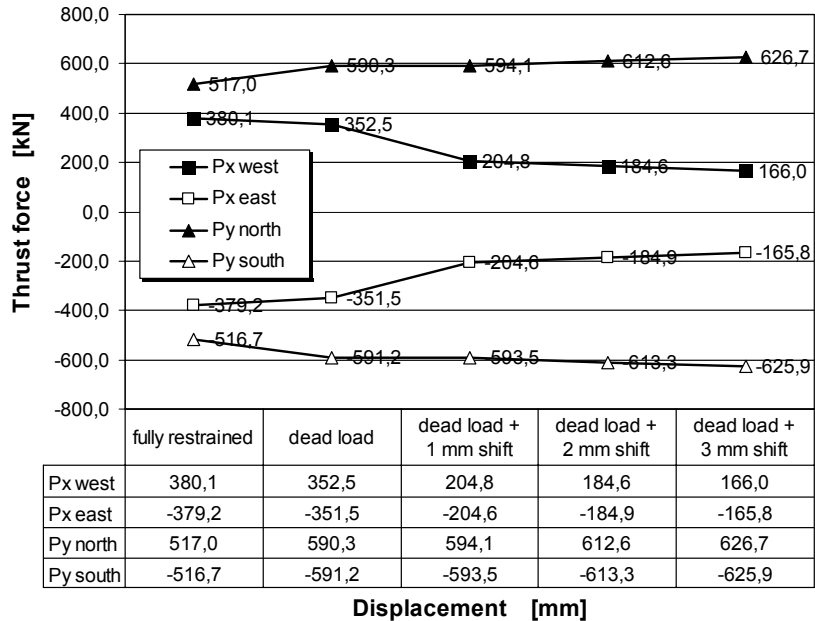
thrusts. As the eastern arch leaned back and took less loads, the vault's thrust had to be redirected mostly in a north-south direction, causing a stress increase of almost 20 percent at a shift of 3 mm. Meanwhile, the east-west direction of the vault's thrust was relieved by a 43 percent stress reduction compared to its state with firmly fixed abutments (Figure 11).

**Figure 11 – Development of the vault’s thrust depending on horizontal support displacement in eastward direction**

The diagram in Figure 11 displays the development of the central vault’s thrusts under gravity loads with increasing shifts of the east-side masonry arch. Starting from a state in which all abutments were in fixed positions, the horizontal forces changed slightly when the east-side restrainers were removed. Whereas the initial state suggests an ideal case with undistorted loading conditions, the second state denotes the situation created by the horizontally unsupported east-side arch. With enhanced horizontal shift, the east-west reaction force dropped rapidly, especially within the first millimeter when the drop was approximately 54 percent compared to the thrust under fully restrained conditions. The current situation is estimated at somewhere between a 2 and 3 mm horizontal shift, which serves as a warning that delaying retrofitting measures could lead to further damage to the structure.
