## RESTORATION & STABILIZATION OF A DAMAGED & DETERIORATED CHURCH TOWER

P.A. Jeffs<sup>1</sup>

### ABSTRACT

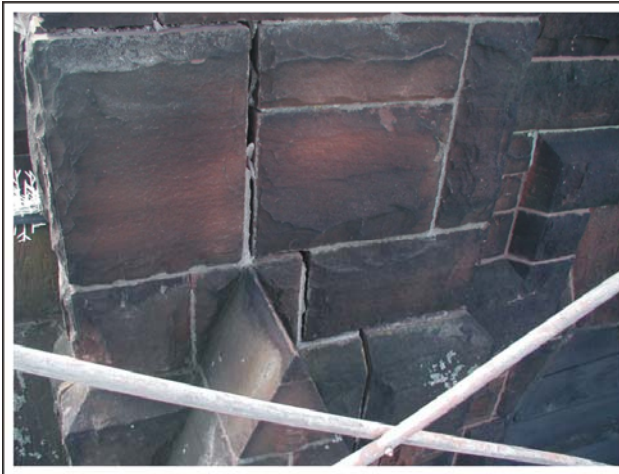
It was considered likely that the excessive lateral movement was caused by the infiltration of rain-water into cracks - the cracks having first been caused by shrinkage, differential settlement and/or movement from temperature change, wind-loading, etc. Formation of ice and the

subsequent development of stresses during expansion may have then contributed to the excessive movement that had taken place – up to almost 25-mm (1.0 in) at the upper-most levels within the corner buttresses (Figure 1). A major concern was the evidence that two of the four keystone units within the upper louvered window lintels had become dislodged (Figure 2). Although it was impossible to determine whether this was the cause or the result of the movement process, it was considered likely that lateral movement of masonry units would have been increased as a result of any lateral thrust imposed on the buttresses by the dislodgement of the keystones.

**Figure 1 - Evidence of considerable lateral movement within buttresses.**

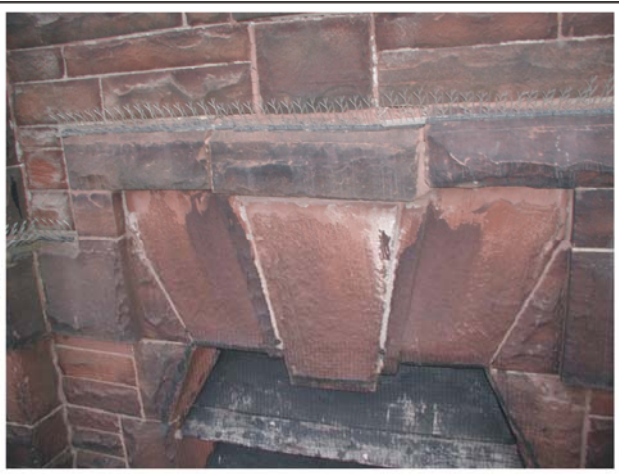
**Figure 2 - One of the dislodged keystones.**

To relieve the lateral thrust loads on the buttresses, the dislodged keystones were jacked back into their original position and the joints repointed (Figure 24) The jacking operation avoided considerable masonry re-building work that would otherwise have been required to re-position the keystones. The deteriorated floor was removed and a new floor constructed with steel angle beams that were bolted to the interior masonry to provide more durable support and better load distribution (Figure 25).

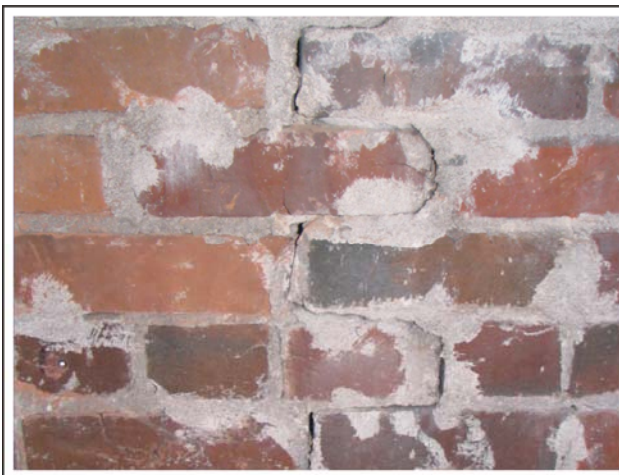
An inspection of the interior revealed a vertically oriented step-crack (Figure 3). The crack aligned with the exterior northeast buttress at the church roof eave level and it was believed that its occurrence was due to reactions to the exterior movement described above. An inspection of the round windows on each elevation, as well as the surrounding masonry, revealed that moisture was penetrating open masonry joints, often bypassing poorly installed flashing details. It was also evident that water was entering through gaps around the window frames (Figures 3 and 4).

**Figure 3 - A step crack within the interior aligned with the exterior buttress joint.**

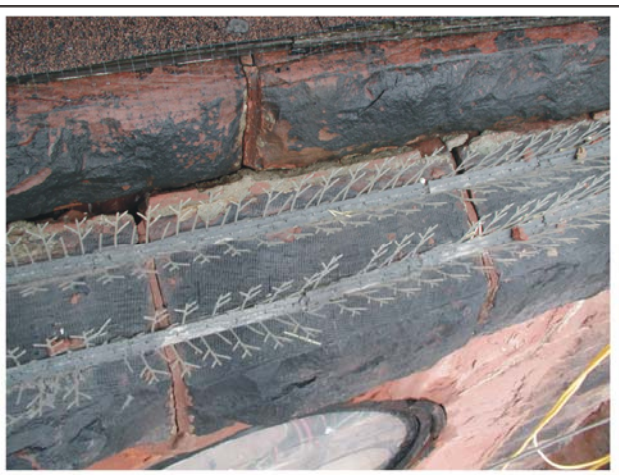
**Figure 4 - Evidence of water penetration at several locations.**

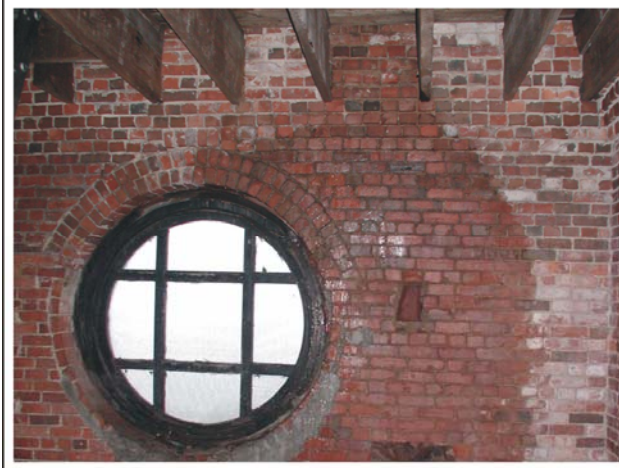
Rainwater had obviously been gravitating between the outer and exterior wythes, thoroughly saturating the upper levels of the tower masonry assembly and ultimately freezing during the winter months. This resulted in deterioration of the interior brick and, in particular, contour scaling of the exterior rock-faced finished window surround (voussoir) sandstone units - many of which had been improperly fabricated for their bedding plane (Figure 5 and 6).

**Figure 5 - Evidence of moisture saturation on the interior.**

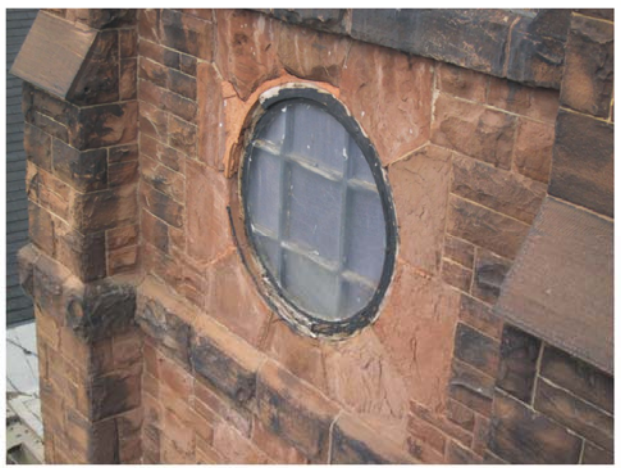
**Figure 6 - Evidence of contour scaling and damage to voussoir stones.**

The sandstone voussoir units around the round windows and the masonry units within the sections of wall between the buttresses were removed and rebuilt (Figures 17 and 18).

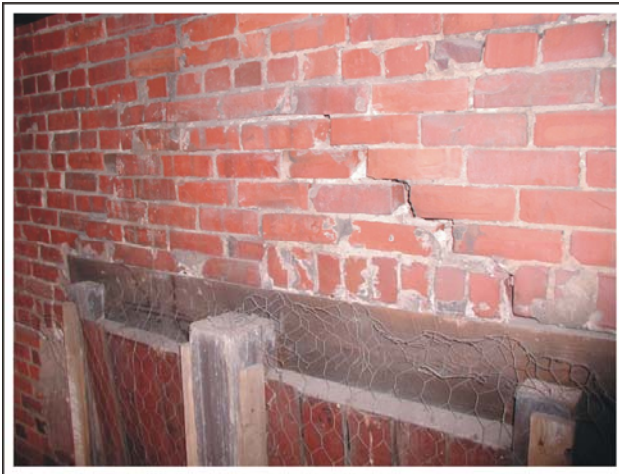
An unusual form of damage to the masonry above the louvered windows was also evident within the interior, the nature of which indicated that a lateral inward thrust had occurred at some time (Figure 7). This event could have occurred as a result of lateral movement of the buttresses, the dislodgment of the keystones, or the impact of the copper roof as it pounded against the exterior masonry. In addition, the wooden joists that supported the middle level floor were badly deteriorated due to repeated wetting/drying actions, with at least one of the joists having become detached. The suspended floor deck was also in a poor and potentially dangerous condition (Figure 8).

**Figure 7 - Evidence of an inward lateral thrust of the masonry.**

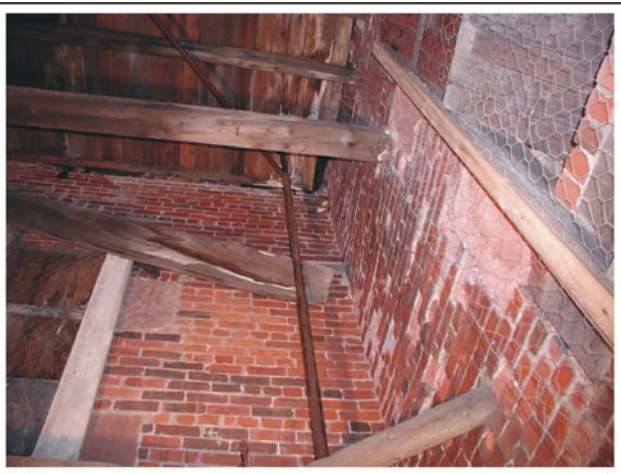
**Figure 8 - Evidence of deterioration to one of the wooden floor assemblies.**

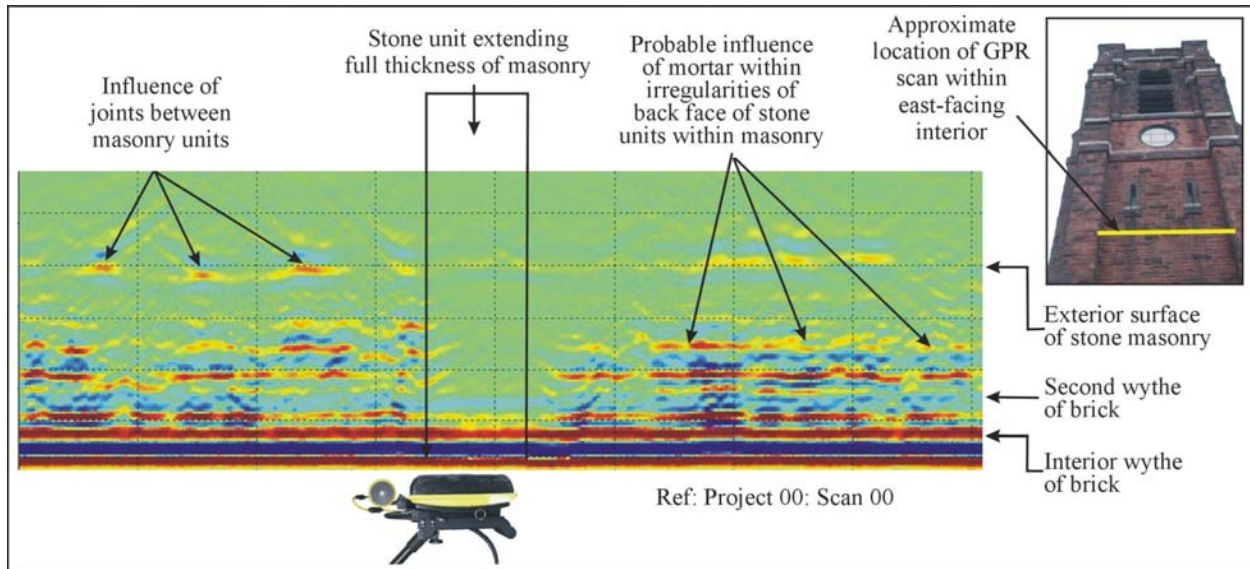
The results of the GPR evaluations indicated that there were very few concerns regarding the current stability of the masonry assembly (Figure 9). However, the tests did indicate the presence of moisture within the masonry assembly - particularly below window units - and the location of cracks could also be determined. The only hidden damage that could be detected was within the area where impact from the copper roof could have been expected to cause damage.

**Figure 9 - Example of information provided by the GPR investigation.**

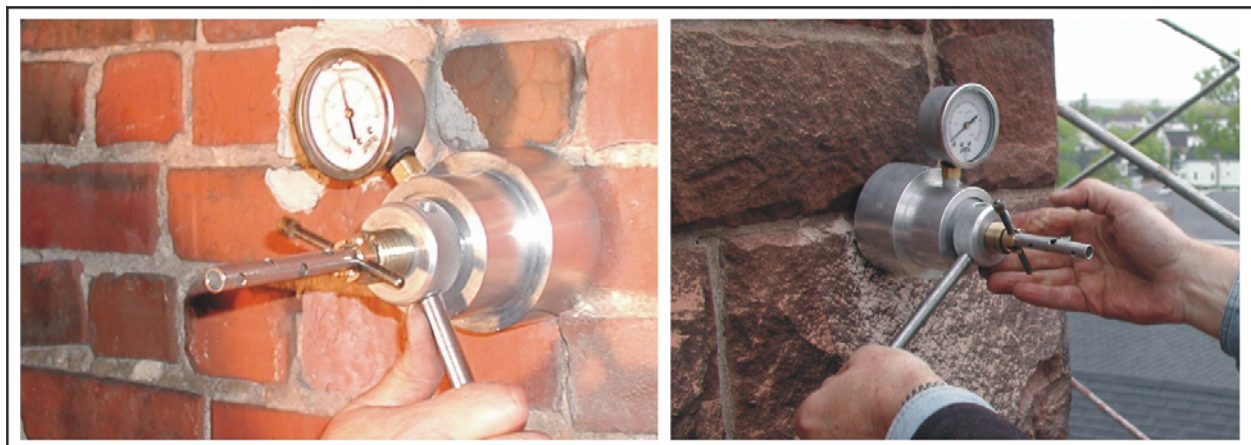
The tensile strength testing indicated that satisfactory pullout strengths could be developed (Figures 10 and 11). However, it was determined that lower results could be avoided by installing the ties at 45-degree angles to prevent terminating the ties within the critical embedment length in the mortar joints. Typical results were in the order 4.0 to 6.0 MPa (600 to 1000 psi) when installed through brick and 7.0 to 10.0 MPa (1000 to 1500 psi) when installed through stone.

**Figure 10 - Tensile strength testing of the masonry ties**

**Figure 11 - determining pull-out strength of masonry ties.**

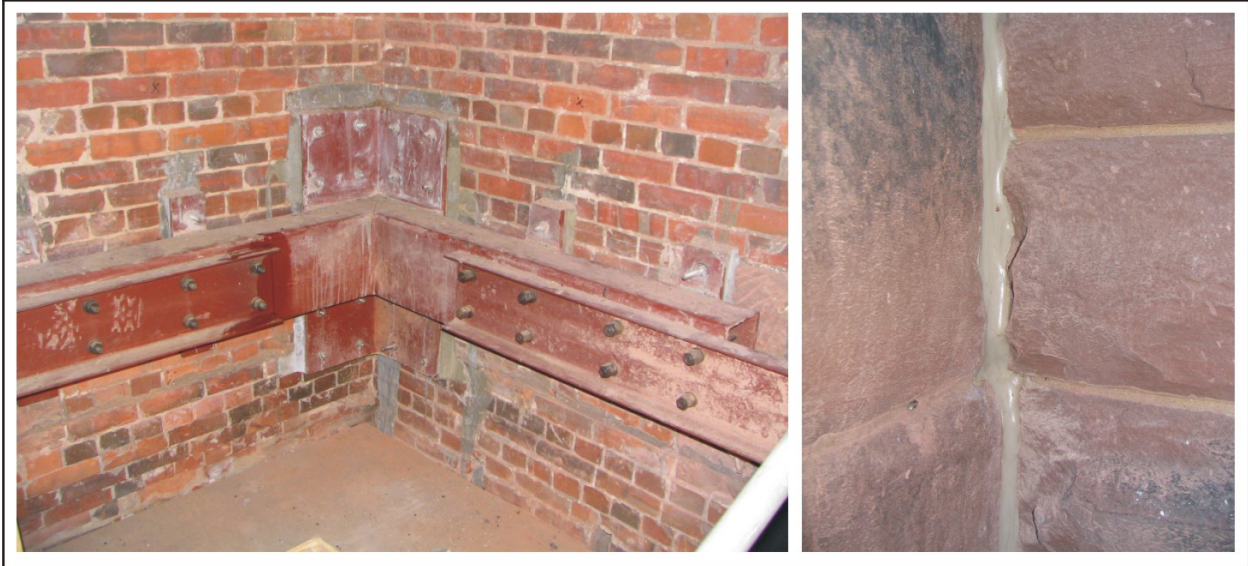
**Figure 12 - Sliding beam and anchorage arrangement.**

**Figure.13 - Vertical joint sealed with an elastomeric joint sealant.**

The first stage of the restoration strategy addressed the problem of how to permit a limited amount of movement to continue to take place – while preventing further damage being caused to the masonry. The devised strategy included the design and fabrication of an arrangement of steel ring beams attached to each wall section at four locations within the tower. The beams were secured to the interior masonry assembly using masonry bolts with their anchorages embedded within the exterior stone wythe. The bolts were sleeved at their centre portions to facilitate the development of the desired tension upon tightening. Fabricated steel brackets were then attached to the corners of the interior walls to align with the interface between the buttresses and the walls on the exterior and the beams were secured to the corner brackets. The beams and brackets were designed and fabricated with a “sliding bolt” arrangement that permits some controlled lateral movement of the buttresses to take place (Figure 12). A cement-based mortar had originally been used within the full-height of vertical joints at the interface between the buttresses and the tower masonry walls. To better accommodate movement, the mortar was removed and the joints subsequently sealed with a mortar-colour matching elastomeric joint sealant (Figure 13).

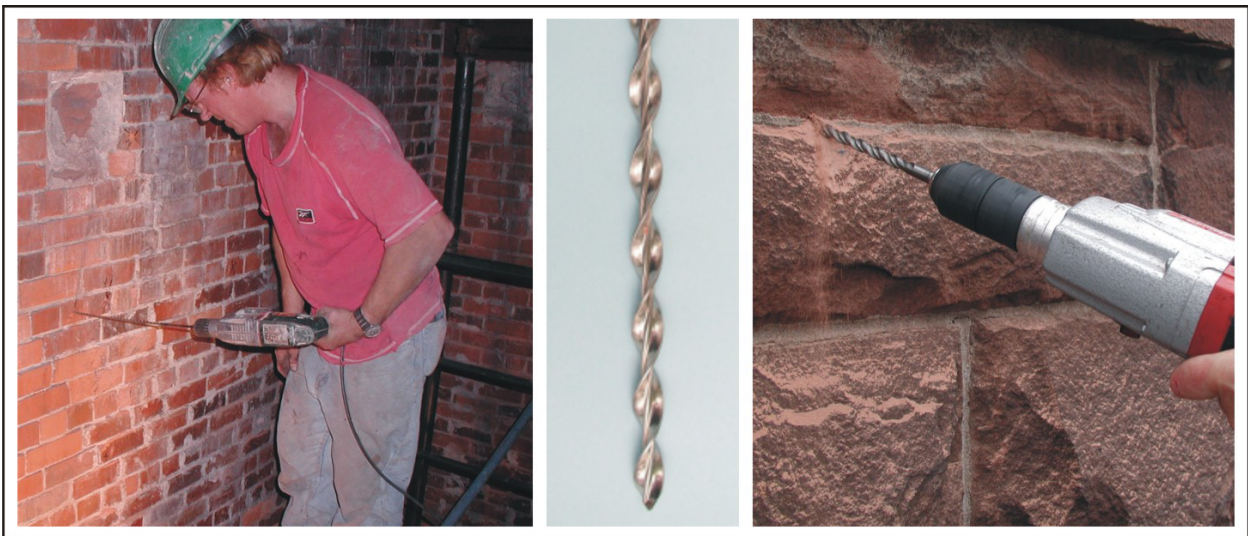
**Figure 14 - Installing ties from interior.**

**Figure15 - Helical tie.**

**Figure 16 - Installing ties from exterior through buttress stones.**

Helical stainless steel masonry ties were then installed at 600 mm x 400 mm (24 in x 16 in) spacings within the interior of the three levels to embed within the exterior wythe of sandstone masonry units (Figure 14). The profile and limited flexibility of the ties permits a more composite action to take place across the multi-wythe masonry assembly without excessively increasing rigidity (Figure 15). The ties were also installed within buttress stones to stabilize them against further excessive movement, again without excessively increasing rigidity Figure 16). The ties were installed at 45-degree angles within each buttress stone above the church main roof level and thus, each unit was “stitched” to the adjacent or underlying masonry unit.

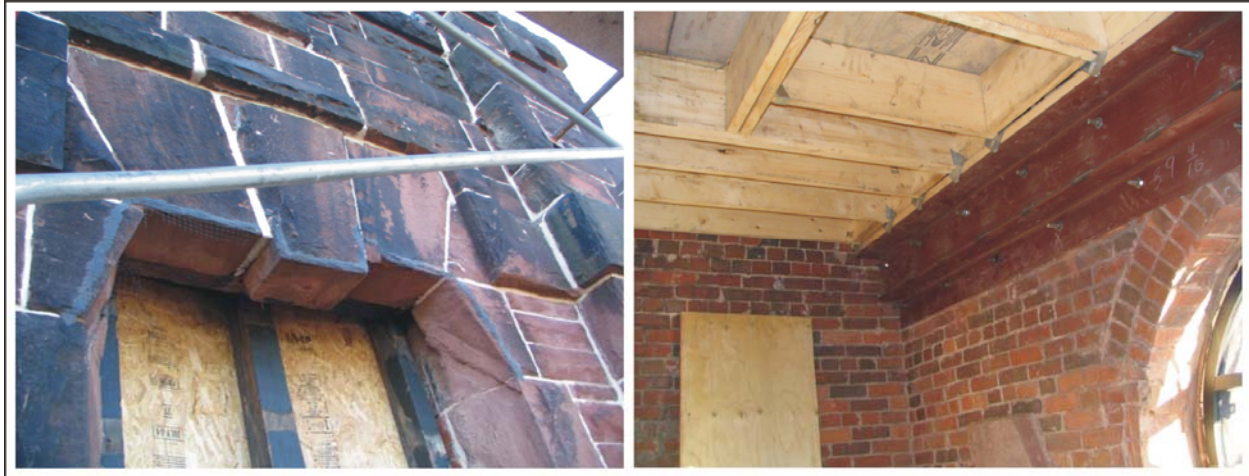
**Figure 24 - The dislodged keystones were repositioned.**

**Figure 25 - The newly installed floor with its steel angle beam support.**
