**13<sup>TH</sup> CANADIAN MASONRY SYMPOSIUM**  
**HALIFAX, CANADA**  
**JUNE 4<sup>TH</sup> – JUNE 7<sup>TH</sup> 2017**

**PRACTICAL CONCERNS FOR JACKING AND SHORING MASONRY STRUCTURES**

**Biggs, David<sup>1</sup>**

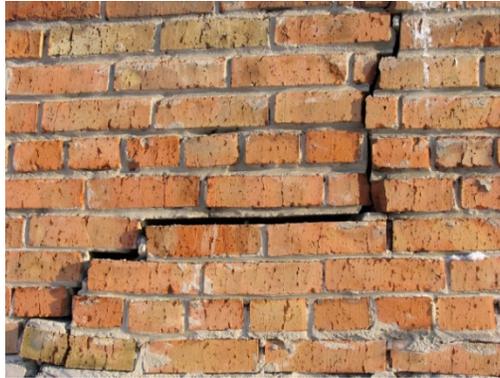
Jacking includes vertically lifting and stabilizing a specific part of the building thereby leaving the remaining structure intact. The reasons for the jacking are often settlement or shifting of some part of the foundation or localized distress of the structural system that supports the masonry. The need for jacking is often determined based upon large cracks in the mortar joints and/or units where gaps have formed (Figure 3).

**Figure 3: Masonry Cracks**

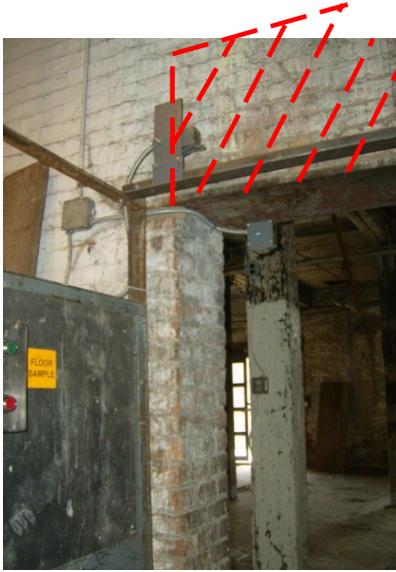
Figure 4 partially shows an interior opening for an industrial elevator in a six-story masonry building (c.1902). The wall is four brick leaves thick (41cm); the opening is 2m wide. A large T-section with a thick bottom flange supports 2m of brick wall above. The owner desired an enlarged opening that would match the size of the openings on the upper floors (see red line outline of proposed opening on Figure 4). 33 cm of the masonry above the opening needed to be shored so that a new support could be installed.

**Figure 4: Existing Opening to be Enlarged Vertically**

This shoring solution was selected because it had two advantages; the angles did not require temporary posts and they served as the permanent support. There was one disadvantage; dependent upon the opening width, the local building code may require that the steel framing be fireproof protected.

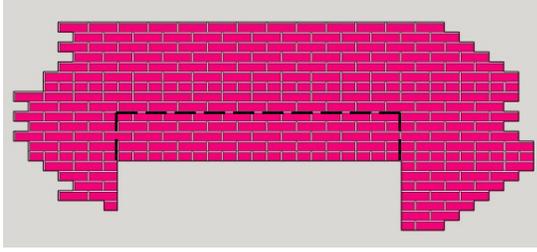
**Figure 5a: Existing opening**

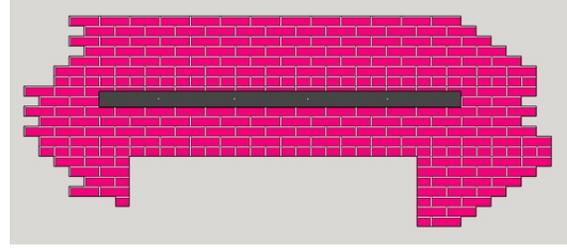
**Figure 5b: Steel angles both sides of wall**

Another considered solution was to install steel angles on both sides of the wall with the horizontal legs routed into the mortar joint. These angles would span full length and support the wall area above temporarily. Figure 5a graphically shows the existing opening and a portion of the wall above. A dashed line shows the wall area intended to be removed. In Figure 5b, steel angles were designed to satisfy load capacity and deflection criteria and added to both sides of the wall by routing the mortar joints just above the desired opening. The angles have 178mm vertical legs, 102mm horizontal legs and are 10mm thick. 13mm bolts were added to keep the angles tight to the wall. The angles were extended beyond the jambs to provide adequate bearing. Figure 5c is the view after the masonry was removed and the jambs rebuilt at the cut brick. Finally, a 7mm plate was welded to act as a closer to the underside after a mortar parging was added (Figure 5d).

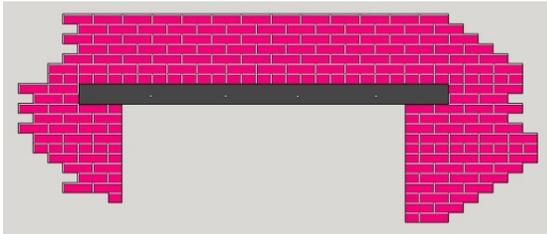
**Figure 5c: Wall area removed**

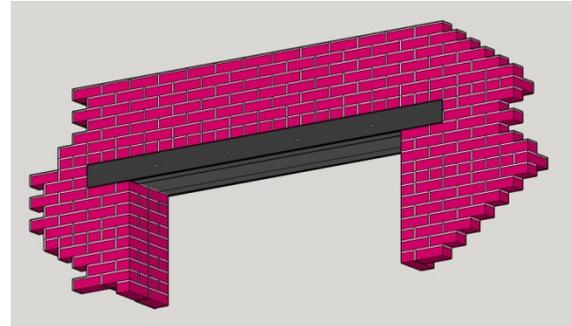
**Figure 5d: Bottom cover plate added**

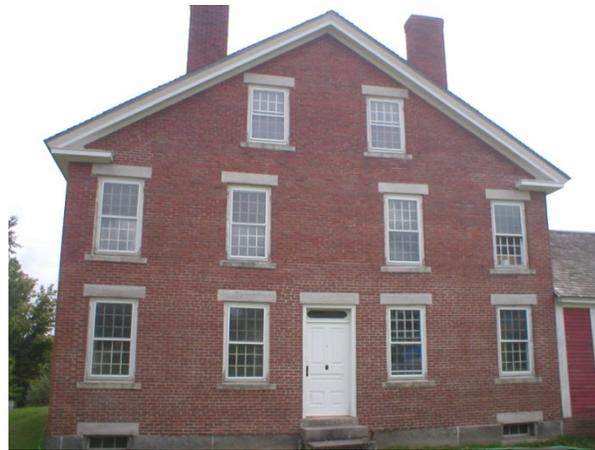
Figure 6 shows an 1848 tavern building where the brick exterior was noticeably cracked, deflected and bowed around the entry door [1]. The building has a wood frame and brick was used as both the exterior leaf and nogging between the wood framing. The exterior leaf and nogging were connected by brick headers.

The evaluation of the building structure indicated the vertical deflection problems were created by the foundation support of the exterior leaf. The deflection created bowing of the exterior leaf that affected the brick nogging also. The determination was that the exterior leaf of the lower floor needed to be removed, rebuilt and re-anchored.

**Figure 6: 1848 Tavern with Deflection, Bowing and Cracking around Door**

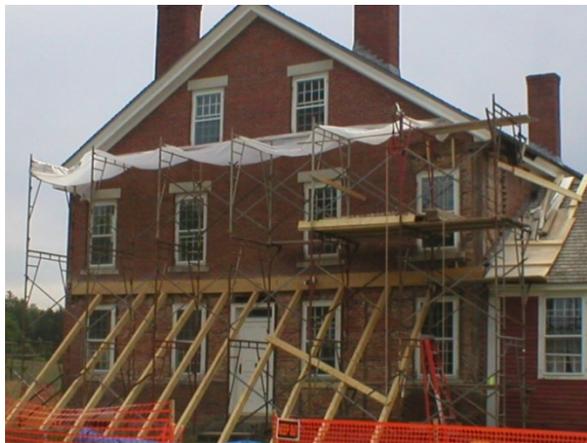
Figure 7 shows timber shoring installed and the exterior leaf being removed. The brick nogging and wood frame are exposed. Figure 8 shows the brick laid out on the ground; the broken and cut headers are visible. The exterior leaf was reinstalled in its original position as an anchored veneer.

**Figure 7: Shoring Installed**

Timber framing was used for the shoring; steel could have been used but the loads did not require it. A ledger was bolted into the wood framing to support the exterior leaf above with the assistance of the shoring. The solution was simple to implement; the loads were calculated by the weight of the exterior leaf.

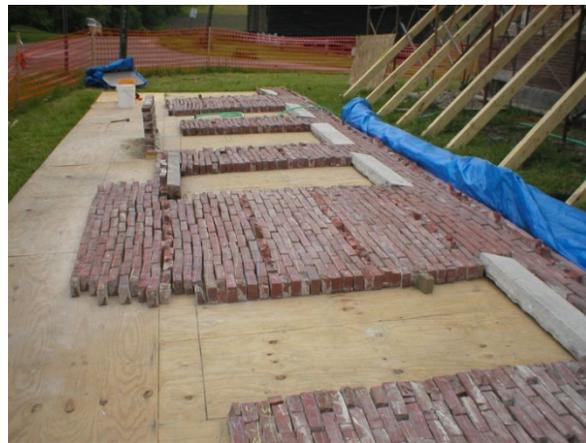
**Figure 8: Exterior Leaf and Headers**

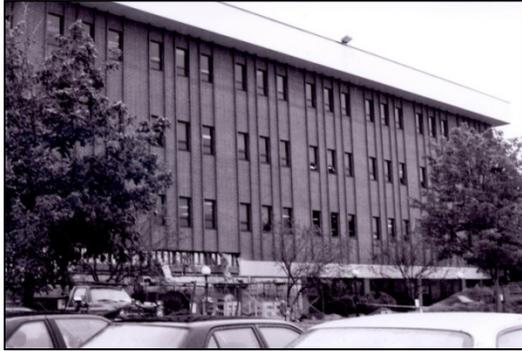
Figure 9 shows a building with a steel frame (c.1972). The exterior cavity wall has cold-formed metal stud backup and anchored brick veneer for the upper floors and glass window wall below.

**Figure 9: Four-story Steel-framed Office Building**

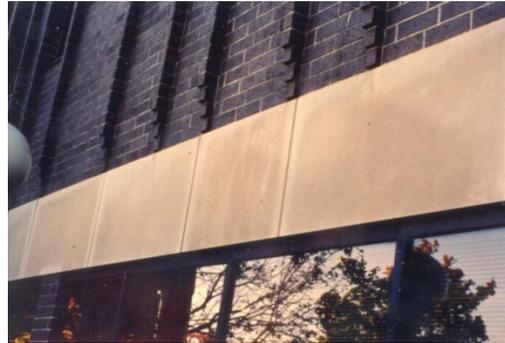
Just above the glass window wall, the exterior veneer has stone trim (Figure 10). After nearly 30 years, bulges were found in the brick veneer and there was noticeable window movement [2].

Project records indicated a design error was discovered during construction and the solution implemented was to make the veneer full height bearing despite there being shelf angles. The

brick veneer was mortared tight at the shelf angles at each floor and the window mullions were strengthened to support the full veneer.

**Figure 10: Stone Trim at Bottom of Brick Veneer**

Investigations and analyses performed to evaluate the veneer bulges determined that horizontal eccentricities from the brick veneer placed an outward load on the stone panels that were not accommodated in the initial stone panel anchorage design. This required removal of the stone panels and several courses of brick up to the first shelf angle to correct the anchorage problems. Temporary shoring was installed and then the panels and brick were reconstructed.

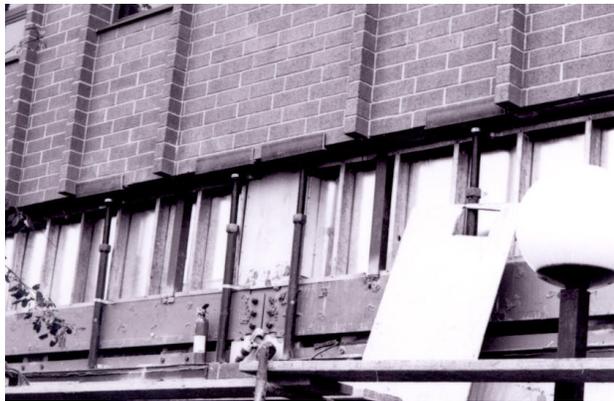
**Figure 11: Shoring after Panel Removal**

Figure 11 shows pipe shoring installed where the panels were removed between the shelf angle above and the lower framing. Notice the added steel angles at the top of the pipes. The shoring spacing allowed the panels to be removed incrementally. Figure 12 shows the original condition on the right and the rebuild on the left.

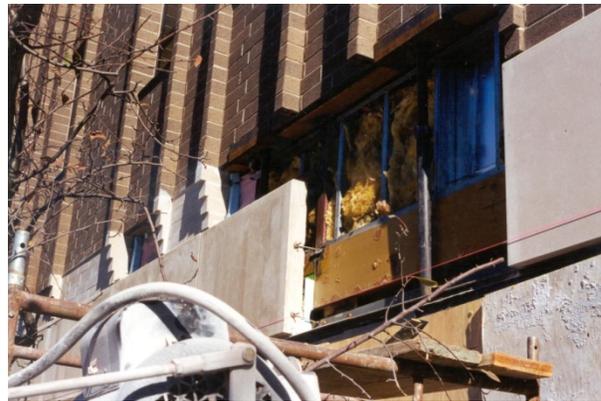
**Figure 12: Shoring during Rebuild**

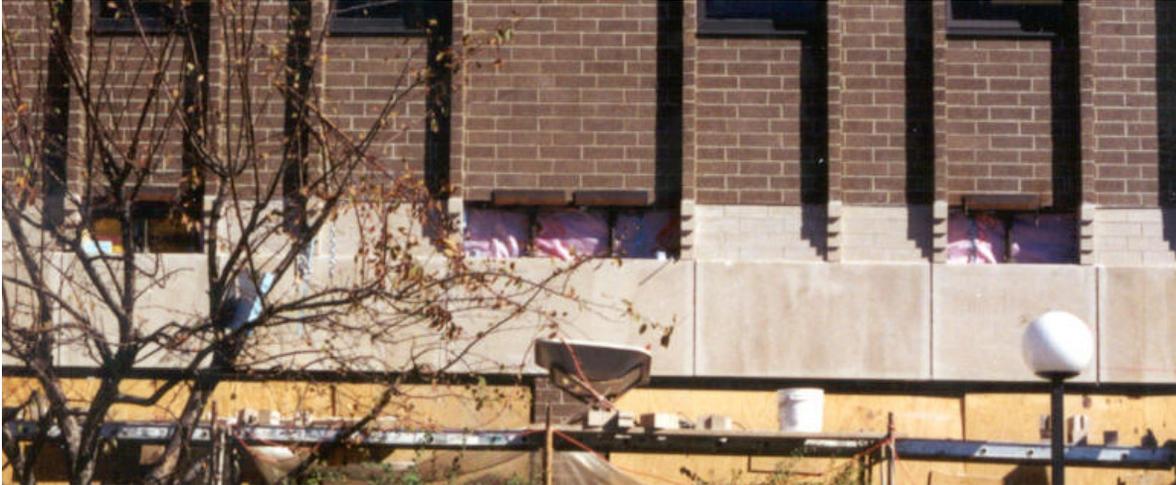
**Figure 13: Nearly Complete**

Figure 13 shows one area nearly completed. New lighter-colored brick that matched the stone trim was selected because the original brick was not available. Vertical steel angles were added as the backup support to strengthen the stone anchoring. The temporary shoring was removed as the stone panels were reinstalled with new, more substantial anchors.

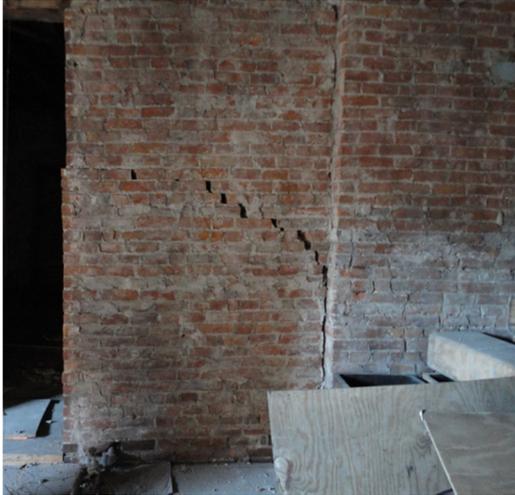
Figure 14 shows an interior bearing wall of a four-story historic building (c. 1876) where the support structure for the two-leaf brick bearing wall is timber. Previous building modifications were inadequate to support the upper three floors and each floor had settlement and cracking similar to what is shown.

**Figure 14: Cracked Wall**

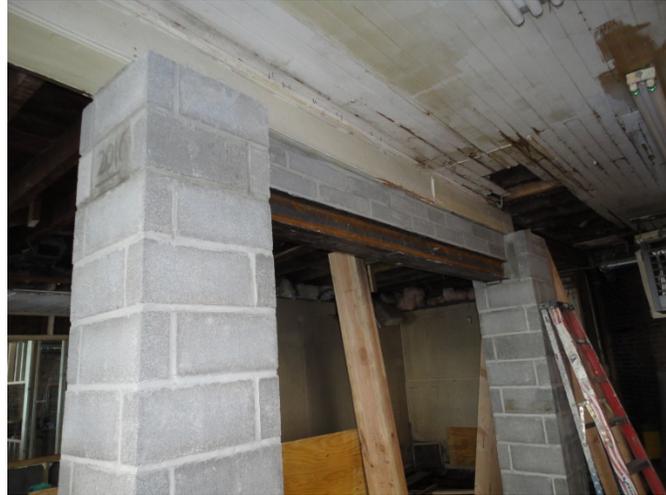
**Figure 15: Jacking Beam/Permanent Support**

New piers and structure were added to the first level (Figure 15). The foundations were strengthened beneath the piers which were oversized for architectural purposes. The steel beam shown was used for jacking the walls above approximately 50mm and kept as permanent support.

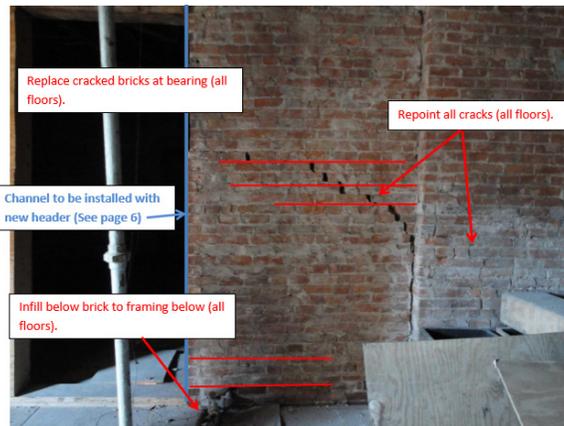
**Figure 16: Follow-up Strengthening**

Once the jacking was completed, the upper wall repairs were implemented (Figure 16). A steel channel was added at the jambs to help support the header above and retain the cracked wall laterally.

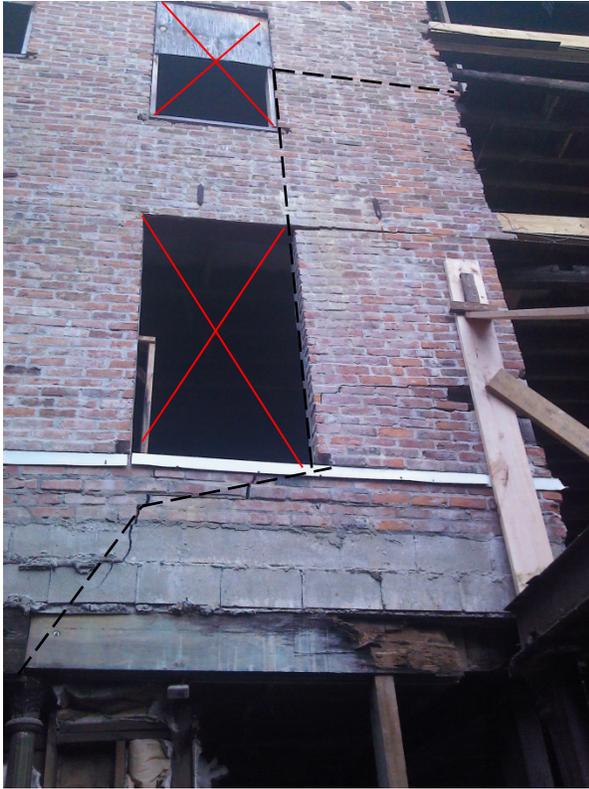
Figure 17 is part of the same historic building. It is an exterior non-bearing wall. The dashed lines indicate where a portion of the wall settled as much as 75mm due to deterioration of the lower supports. Previous attempts to add concrete masonry infill and framing were unsuccessful in stopping the cracking and settlement. Prior to jacking, temporary X-bracing was also added to the windows so they remained square during jacking.

**Figure 17: Cracked Wall**

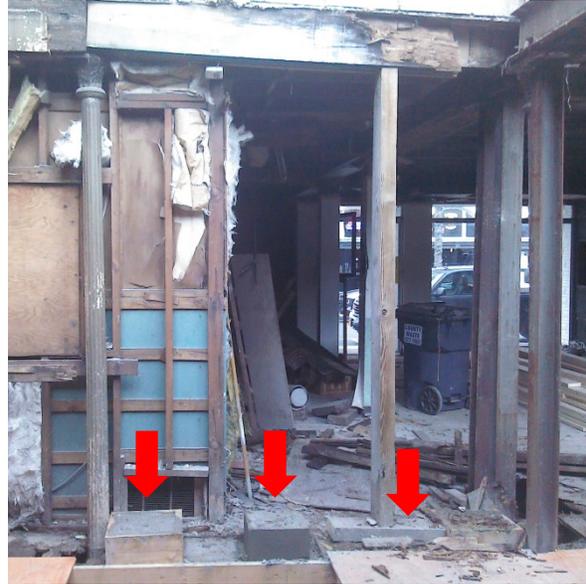
Figure 18 shows the lower part of the wall. There are no photographs of the jacking in progress but the arrows show pads created for the jacking posts (the right one was also used for some temporary shoring).

**Figure 18: Jacking Locations**

All the cracks were cleaned out before jacking which took about an hour. Once the jacking was completed, the follow-up included pointing cracks, adding crack stitches, and vertically strengthening the masonry pier with reinforcement cut into the wall from the interior and then grouted.
