13TH CANADIAN MASONRY SYMPOSIUM
HALIFAX, CANADA
JUNE 4TH – JUNE 7TH 2017

**EVALUATION OF ATYPICAL SULFATE ATTACK OR A NEW FORM OF MORTAR
DETERIORATION**

Smith, Andrew¹

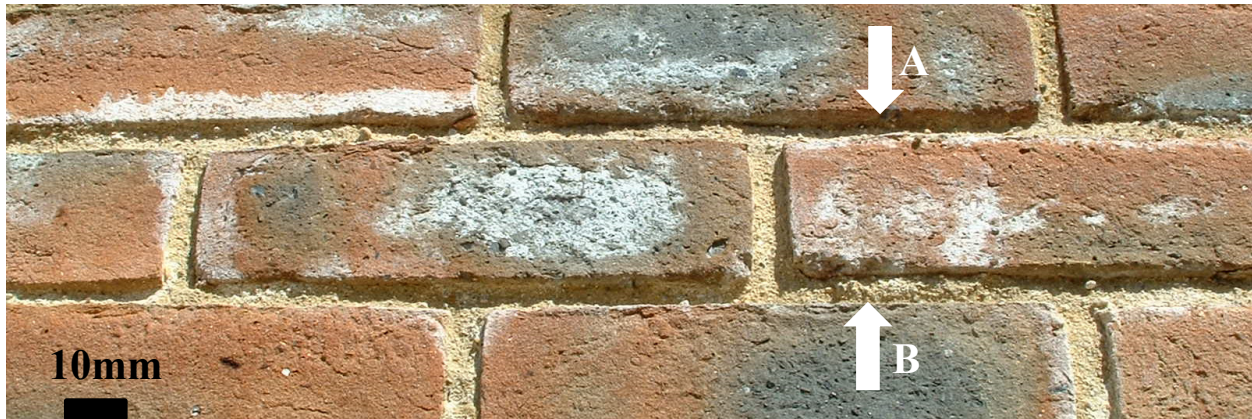
Although the inspection was undertaken 7 years post build, the degree of damage to the mortar was limited to only a small number of localised areas of brickwork, in areas of the property that showed surface white efflorescence on the brickwork. The mortar joints were ‘rubbed or brushed’ rather than ‘tooled’, so the surface of the mortar joint remains porous.

Figure 1: One of the Localised Areas of Brickwork where the Mortar Joint has Eroded Back Approximately 10mm from the Brick Face (A). Blistered and Friable Mortar can be seen in Association with Mortar Joint Surface Efflorescence (B).

The primary form of damage to the mortar joints on this property were identified as being: ‘localised erosion to a maximum depth of 10mm, associated with areas showing significant evidence of efflorescence on both bricks and mortar joints’. A typical such localised section of brickwork is shown in Figure 1. In Figure 1, Arrow B shows an area of mortar joint that is both eroded, but shows significant surface blistering and efflorescence of the mortar joint itself.

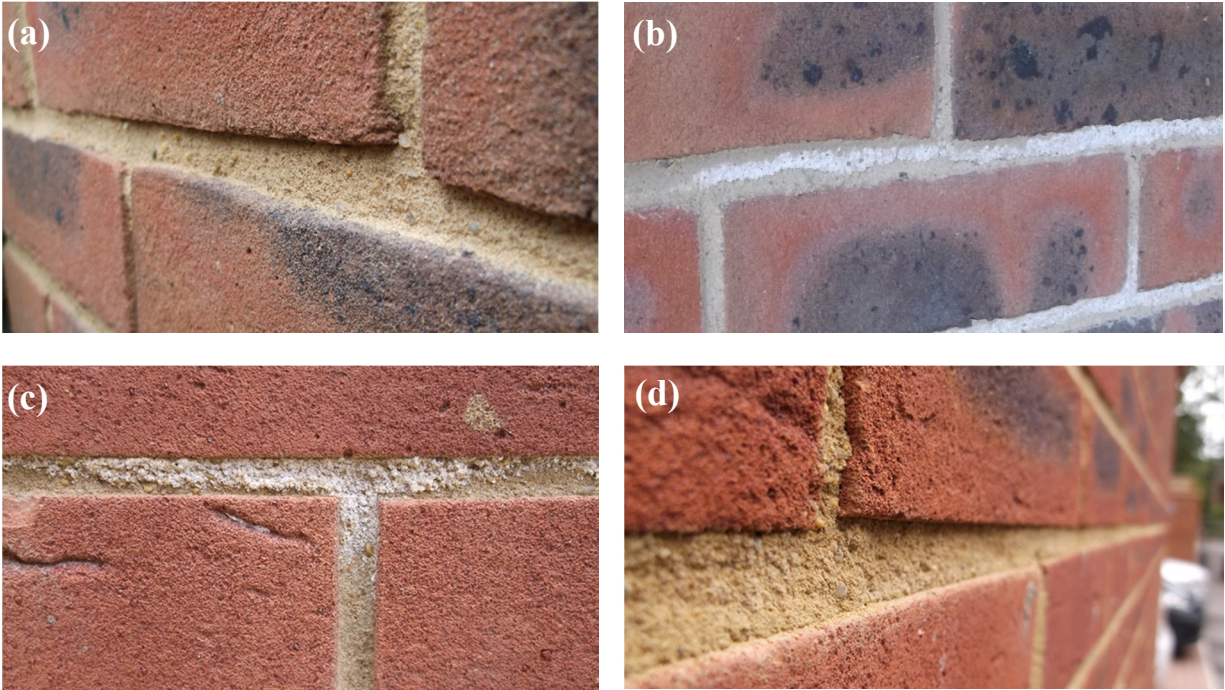
Figure 2: Mortar erosion and mortar joint efflorescence as seen during the inspection of the brickwork at Site B. (a)-(b) ‘Red Multi Stock’ Brick Type 1, (c)-(d) ‘Red Extruded’ Brick Type 2. (a) typical erosion of the mortar joint surface, (b) (c) typical mortar joint efflorescence, (d) mortar joint erosion associated with the Red Extruded, Brick Type 2.

Whilst the investigation could not rule out that a form of sulfate attack may be the root cause of the erosion of the surface of the mortar joints, this is by no means a ‘classic’ case of sulfate attack. There were some aspects of the mortar and type of damage that do not fit with this diagnosis:

- No mid line mortar bed cracking.
- No deterioration of the middle part of the mortar joint.
- No expansion or disruption to the brickwork, only the mortars outer surface.
- No substantial deposits of the by-products of the sulfate attack reaction, ettringite and gypsum in the affected areas of mortar.

Figure 2 shows a selection of photographs taken at the time of inspection and sampling of the mortar at Site B. Of note was the fact that both the brick types, despite having been manufactured at different brickworks, from different clay types, and by different manufacturing processes, brickwork built from both exhibit mortar joint surface erosion (Figure 2a and 2d) and surface efflorescence (Figure 2b-2c) of a very similar nature.
