**DAMAGE TO MASONRY BUILDINGS FROM THE 1995
HANSHIN-AWAJI (KOBÉ, JAPAN) EARTHQUAKE
- Preliminary Report -**

Michel Bruneau¹

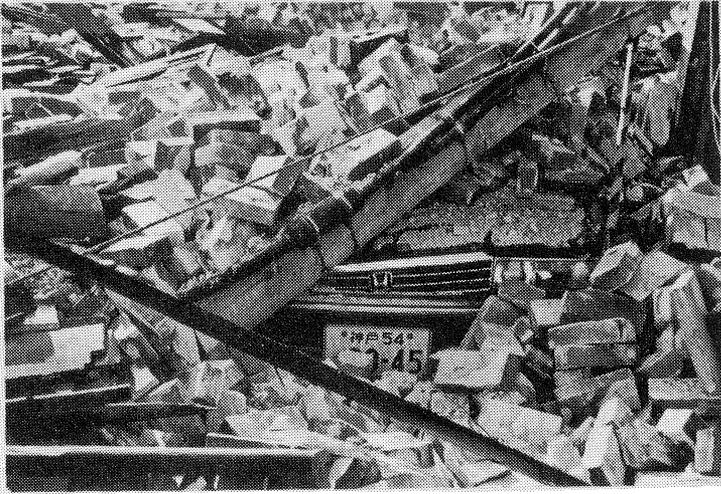
Interestingly, wherever unreinforced masonry buildings could be found by the author, they suffered extensive damage, whether or not they were surrounded by damaged buildings constructed of other materials. For example, a sake-distillery near the shoreline, east of Kobe, suffered from the collapse of a large number of its buildings (Figure 1), while none of the adjacent reinforced concrete and steel buildings showed signs of apparent damage. These failures appear to be dominantly of the out-of-plane type, although some severe in-plane shear cracks could also be observed in the remaining uncollapsed buildings.

Figure 1a: Rubble masonry from collapsed buildings of a sake-distillery blocking an alley (close-up)

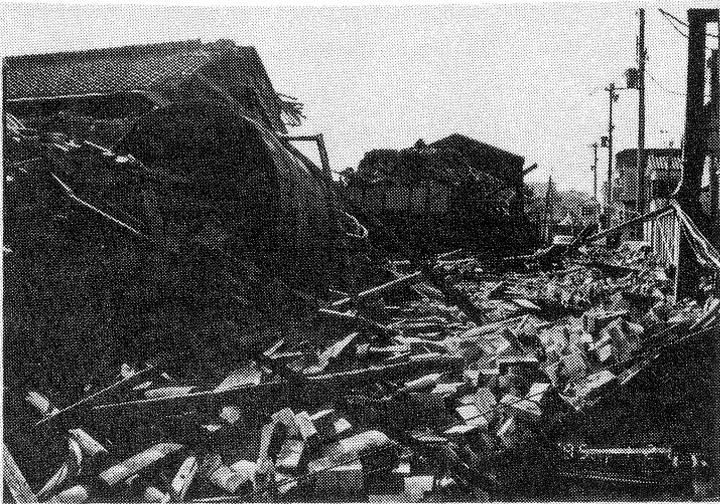
Figure 1b: Rubble masonry from collapsed buildings of a sake-distillery blocking an alley (global view)

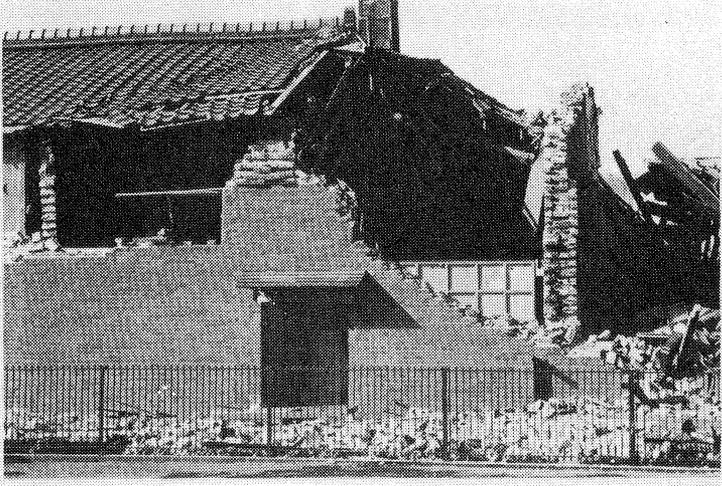
Figure 1c: Walls partly collapsed in out-of-plane manner from a building of a sake-distillery complex

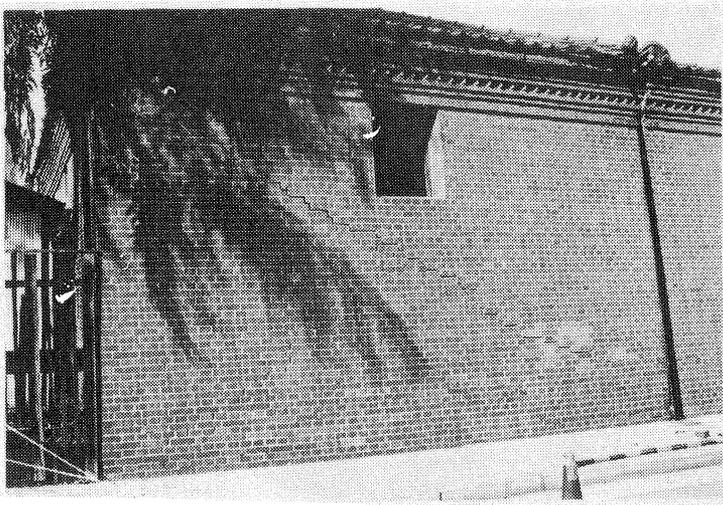
Figure 1d: Wall with visible in-plane cracking from an uncollapsed building of a sake-distillery complex

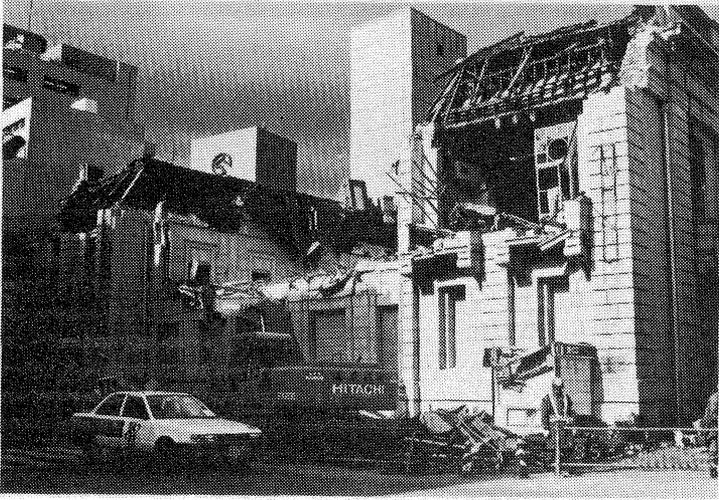
By contrast, another building which suffered significant out-of-plane failure of its walls at the higher stories and the "caving-in" of its central portion (Figure 2), was located in downtown Kobe, and surrounded by numerous heavily damaged buildings of other construction types.

Figure 2a: Severely damage unreinforced masonry building in Downtown Kobe (global view)

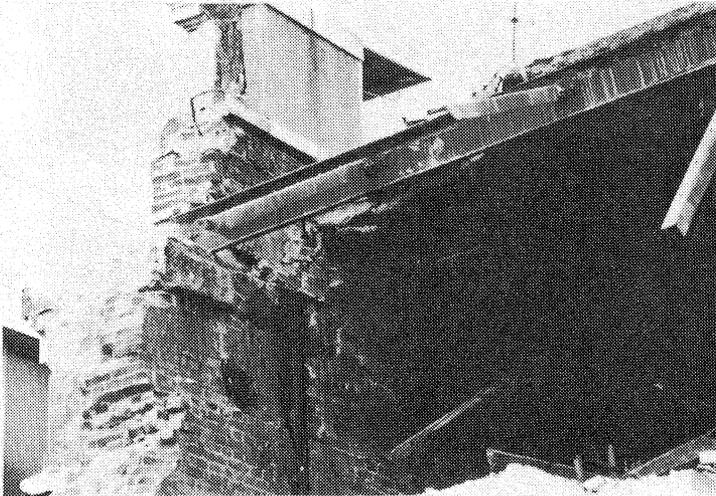
Figure 2b: Close-up view of simply supported gravity structure for damaged unreinforced building in downtown Kobe

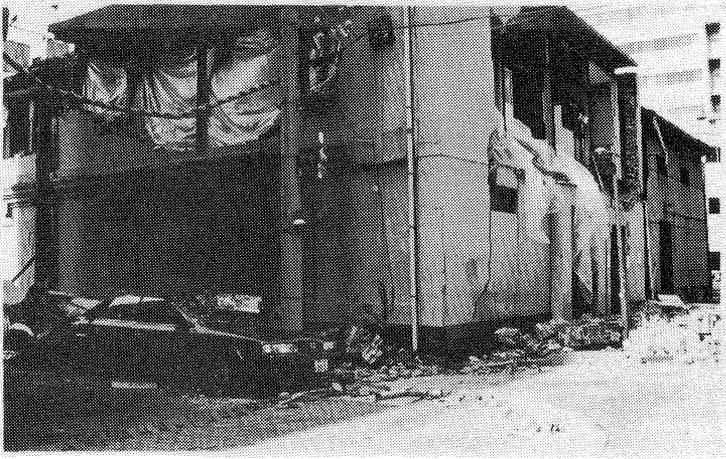
Interestingly, some buildings which appeared to have suffered no damage when seen from their main entrance side, were actually found to have lost significant portions of their higher-story walls in an out-of-plane manner when inspected on the other sides. For example, this happened to the building shown in Figure 3, located in downtown Kobe near one of the expressways that collapsed. Given the otherwise excellent in-plane behaviour of these buildings, this out-of-plane failure could have easily been prevented by adding vertical reinforcement braces or other simple and inexpensive retrofitting techniques developed in California (Bruneau 1994b).

Figure 3a: Global view of out-of-plane damage to an unreinforced masonry building in downtown Kobe

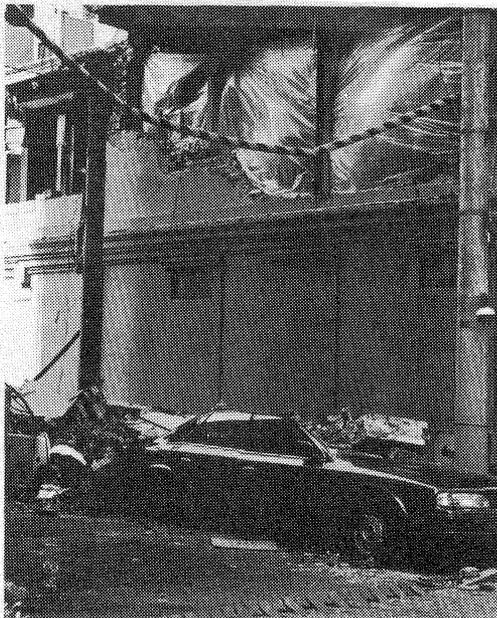
Figure 3b: Additional global view of out-of-plane damage to an unreinforced masonry building in downtown Kobe

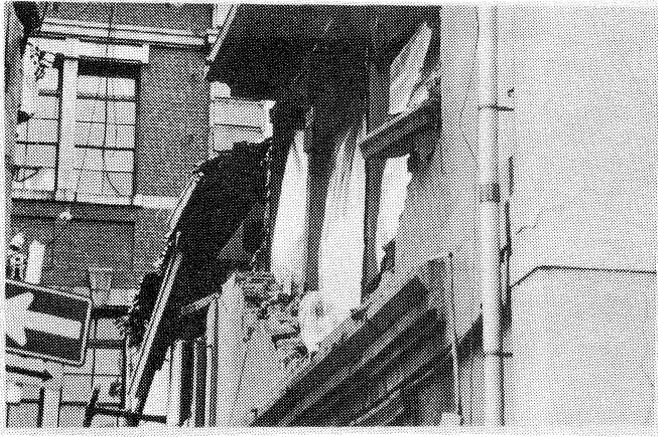
Figure 3c: Close-up view of out-of-plane damage to an unreinforced masonry building in downtown Kobe

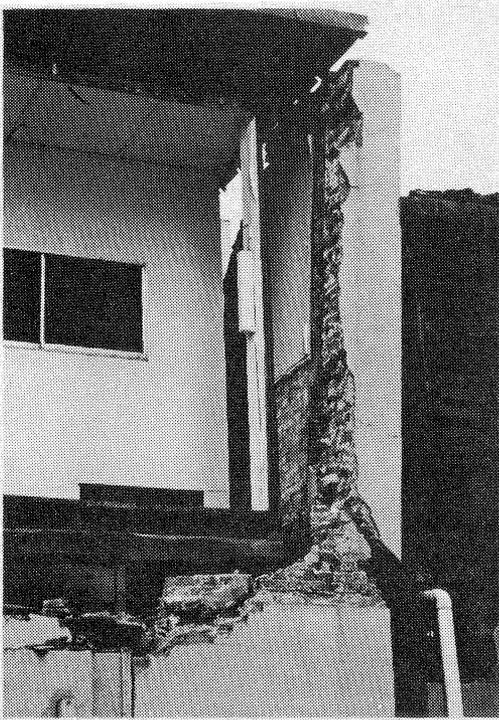
Figure 3d: Additional close-up view of out-of-plane damage to an unreinforced masonry building in downtown Kobe

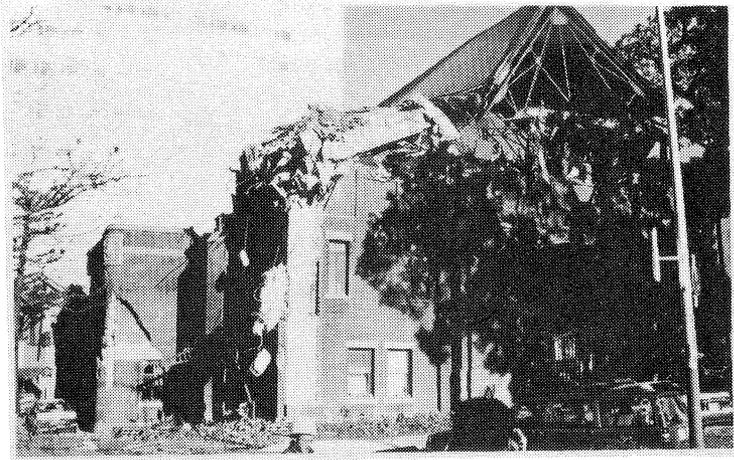
In a few instances, damage was observed to reinforced concrete frames for which unreinforced masonry has been used as infills. For example, one church suffered a tremendous amount of damage to its lightly reinforced concrete frame and infills at the level where numerous window openings were present (Figure 3). Damage to the lower part of the church was actually slight, as the infills and smaller amount of openings provided a considerable amount of overstrength to the reinforced concrete frames. However, the gable of that church was a "pure" unreinforced masonry gable as opposed to an infilled gable. Being inadequately tied to the steel roof-frame, it partly collapsed in an out-of-plane manner. Some of the wall anchors, consisting of bent bars originally embedded in the masonry, were seen hanging from the steel frame (this can also be seen in Figure 3, but with some difficulty).

Figure 4a: Damaged church having reinforced concrete frame infilled with unreinforced masonry

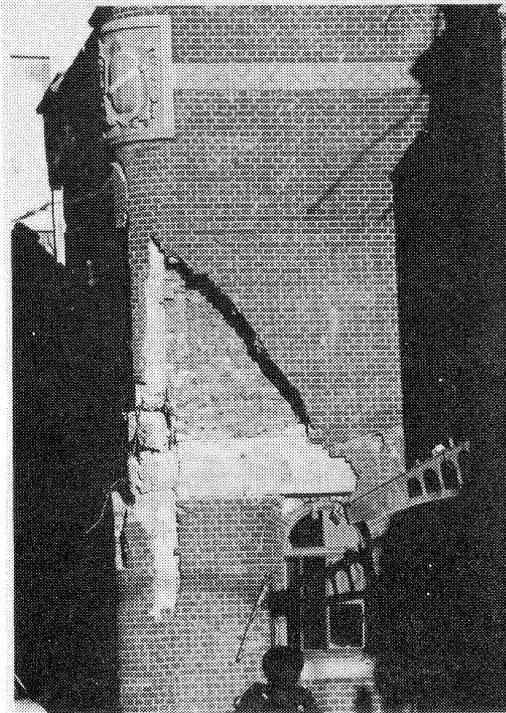
Figure 4b: Minor damage to covering masonry wythe covering the infilled frames at church's lower level

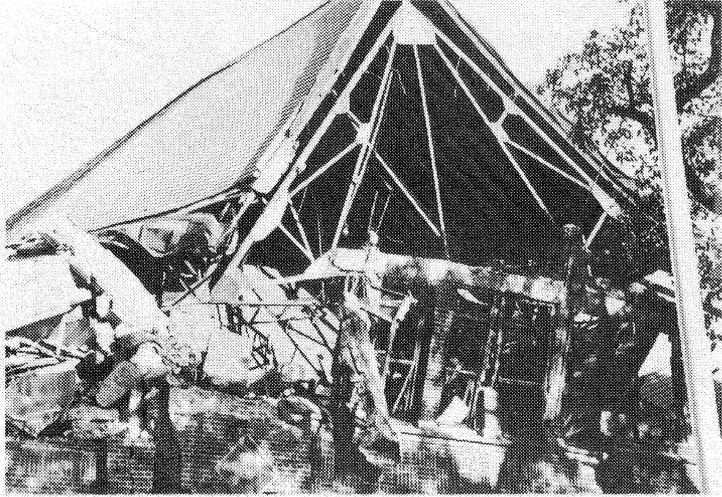
Figure 4c: Close-up view of damaged level of church where more openings existed in the infilled reinforced concrete frame

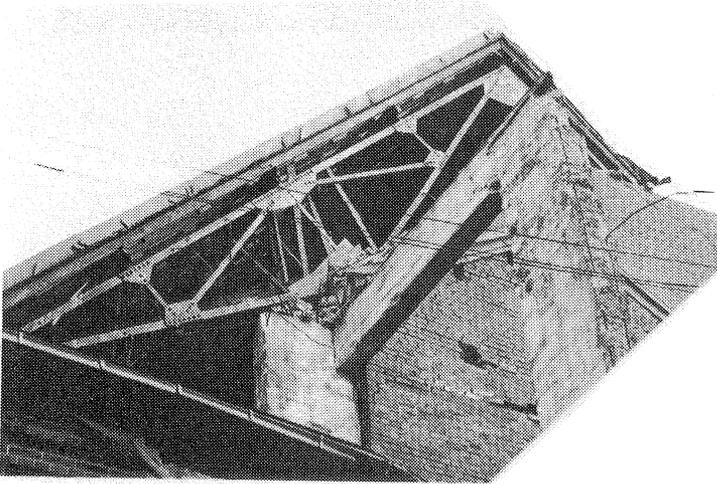
Figure 4d: Out-of-plane failure of poorly anchored unreinforced masonry church gable

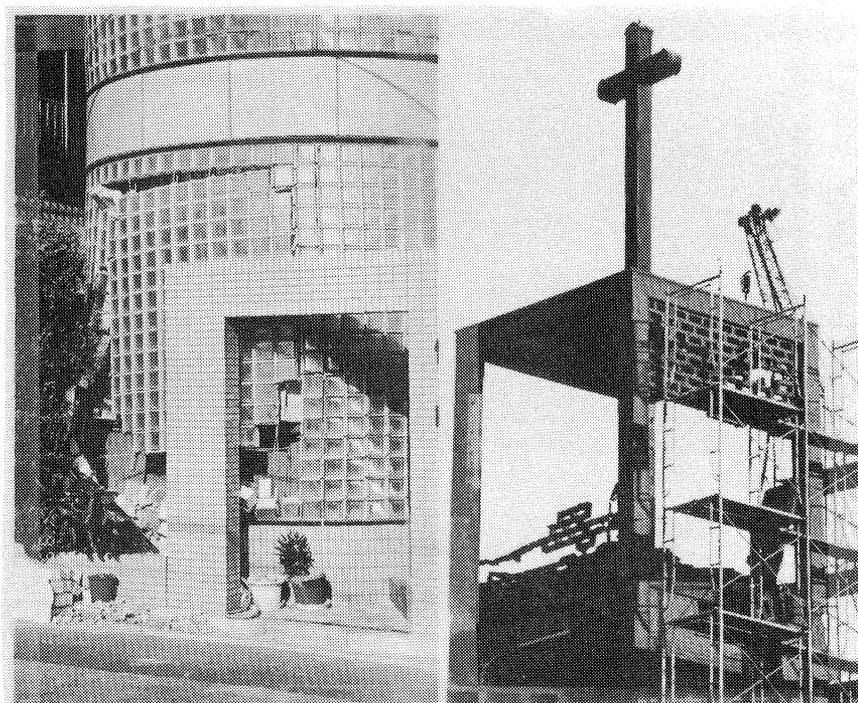
The seismic performance of non-structural masonry was not reviewed extensively by the author. However, damage was sometimes observed to non-structural masonry used in decorative architectural elements. For example, a circular reinforced glass-block wall which has been damaged is shown in Figure 5. Also shown on that figure is an example of the excellent behaviour of thin adhesive masonry coverings, frequently used in Japan as architectural finishes.

Figure 5: Damage to non-structural masonry elements
(a) Glass-block reinforced masonry; (b) decorative infill masonry

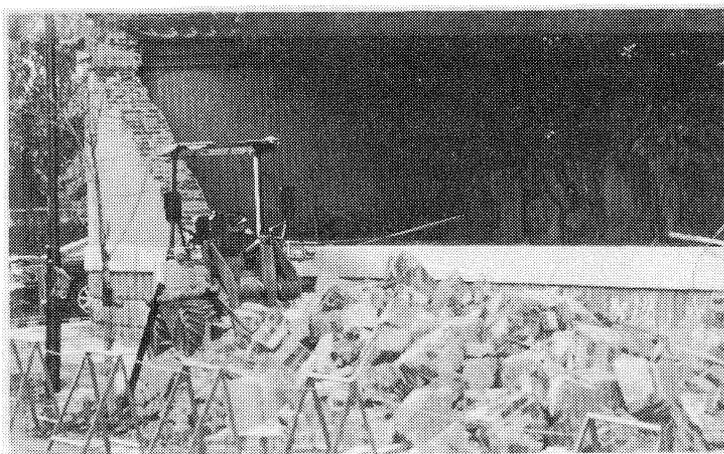
Many small masonry dividing walls also collapsed during this earthquake. Most were unreinforced masonry walls, although the presence of light reinforcement was sometimes observed, generally poorly anchored or even erroneously placed in ungrouted cells. Thicker dividing masonry walls were generally unreinforced. Some of these thicker walls which collapsed are shown in Figure 6. Incidentally, these particular walls were located in a part of town where adjacent buildings did not suffer visible damage.

Figure 6a: Collapsed thick unreinforced masonry property wall

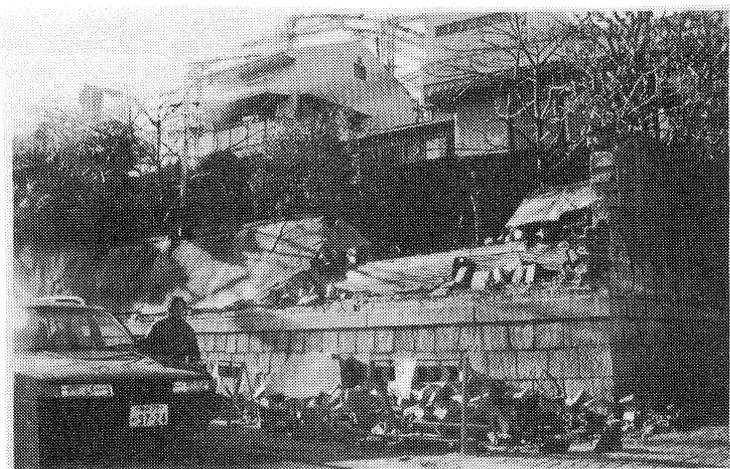
Figure 6b: Collapsed thick unreinforced masonry property wall

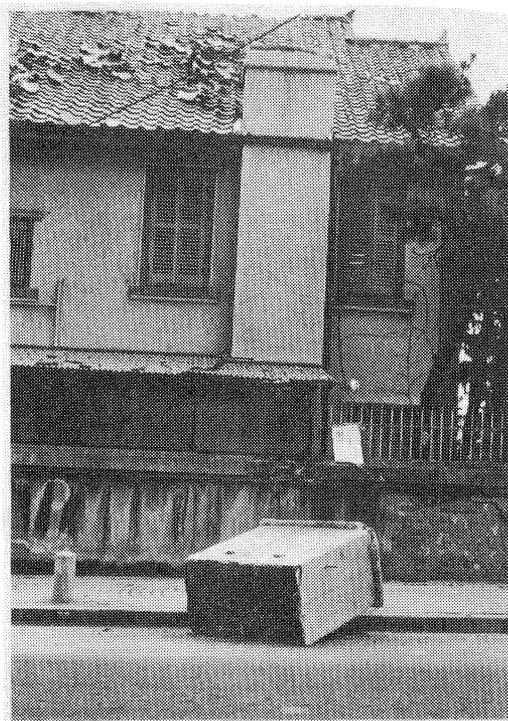
North American style chimneys are rare in Japan. Nonetheless, one impressive failure was observed by the author in the "foreign" district were some old Western-style houses exist. A rather heavy chimney which collapsed is shown in Figure 7.

Figure 7: Large fallen unreinforced masonry chimney
