## DIAGNOSTIC INVESTIGATION OF THE STONE PILLARS OF S. NICOLO' L'ARENA, CATANIA

A. Saisi <sup>1</sup>, L. Binda <sup>1</sup>, L. Zanzi <sup>2</sup>

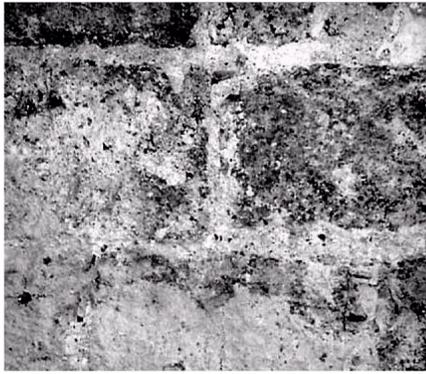
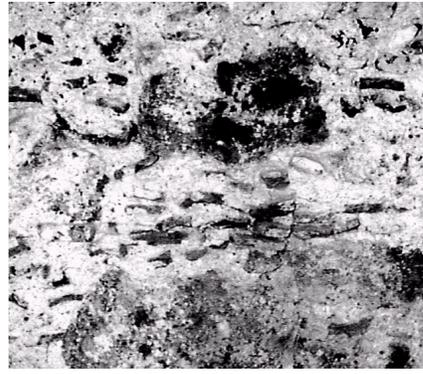
The masonry texture appears characterised by two different typologies: (i) a solid stonework built by large and regular blocks and filled with rubble masonry made with rather strong mortar; (ii) a highly inhomogeneous stone masonry surrounded by a cover more than 300 mm thick, made with tile fragments, stones and rather weak mortar, locally called "incoccio" (Figs. 3a and 3b). Often the two typologies are present in the same structural element (Fig. 4). Apparently the second one was used as repair technique (Fig. 5).

Figure 3. Main masonry typologies of the Church. Regular block masonry (a) and "incoccio" (b).

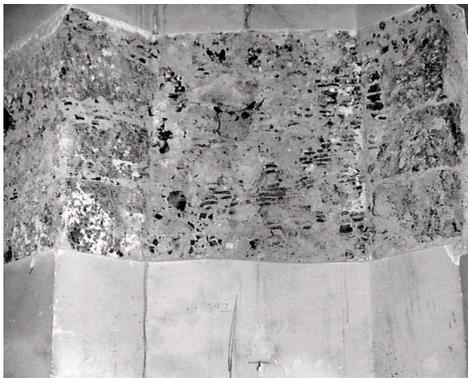
Figure 4. Regular stones and "incoccio".

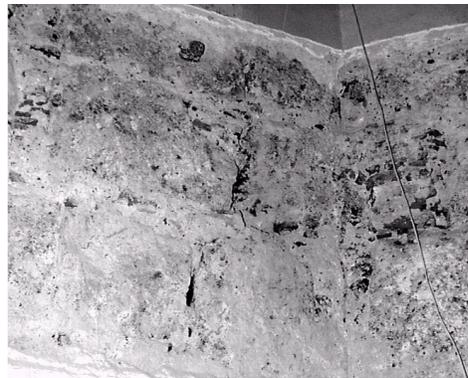
Figure 5. "Incoccio" probably used to widen the section of the pillars.

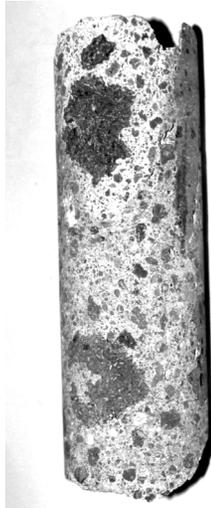
Fig. 6 shows a segment of core drilled from pillar 2. As it is possible to observe, the mortar inside the pillar 2, at the height of 6.40 m, is very compact. As known, the coring inside the masonry usually does not allow the extraction of consisting samples, especially of mortar, being the operation very invasive due to the fact that the sample is drilled wet.

In this case, the optimal mechanic characteristic of the mortar enabled the extraction of a coherent core of the masonry.

Figure 6. Core drilled inside pillar 2 at 6.40 m of height

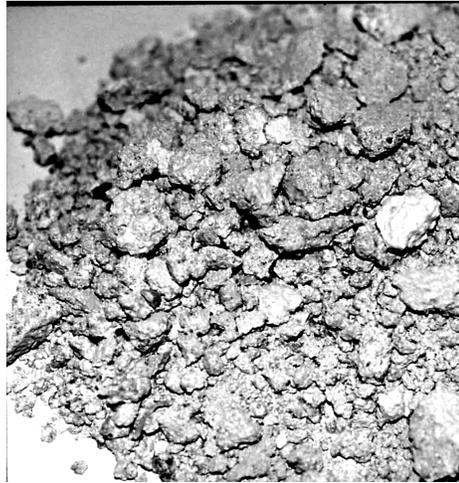
The mortar sampled from the "incoccio" of the pillar 1 is exemplified in Fig.7. The material, completely different on respect to the ones sampled inside the pillars, appears very weak and incoherent.

Chemical and petrographic analyses carried out on the two mortars show that the "incoccio" mortar is an air lime mortar, while the other can be defined hydraulic. The hydraulicity of the mortars sampled by coring inside the pillars 3, 4 and 6, is revealed, in fact, examining the high levels of soluble silica find in the chemical analysis. They can be caused by the presence of pozzolanic aggregates chemically reacting with the hydrated lime.

Figure 7. Consistence of the mortar sampled from "incoccio" in pillar 1.

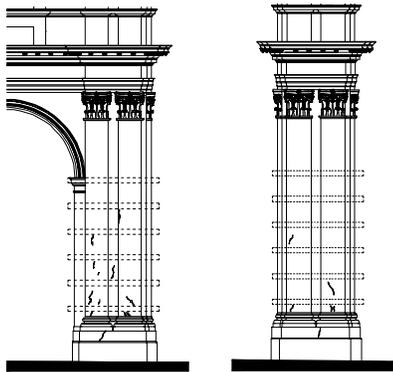
After the 1990 earthquake, apart from the previously mentioned damage to arches and vaults, the most dangerous situation seemed to interest pillars 1 and 2, which were showing vertical cracks.

Figure 8. Crack pattern of pillar 1.

The very low velocities that have been found in the pillars 1 and 2 and the fact that these pillars show a dangerous crack pattern (Fig. 8 and 9), confirm the need of urgent preservation actions. From an external observation, the masonry texture seems, in fact,

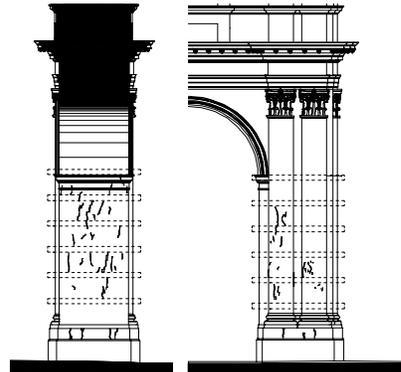
Figure 9. Crack pattern of pillar 2.

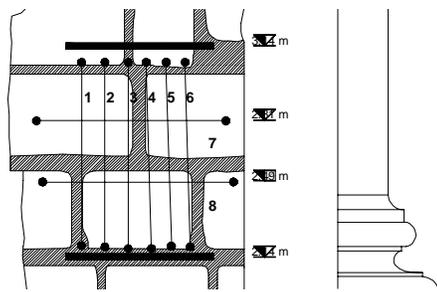
Fig. 10 and 11 show the masonry texture, the flat jacks position, the measurements tools and the stress-strain plots from double flat-jack test. The stress strain diagrams (Fig. 12 and 13) demonstrate the good characteristics of the pillars in terms of compressive strength and elastic properties.

Figure 10. Masonry texture and localisation of the test MPD5 on pillar (Fig. 2).

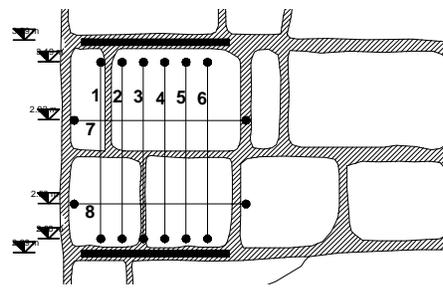
Figure 11. Masonry texture and localisation of the test MPD3 on pillar (Fig. 2).

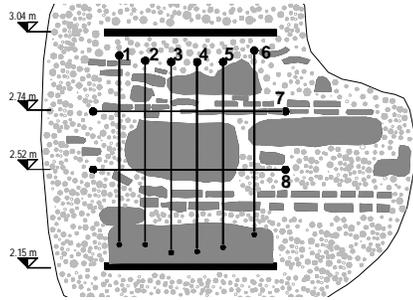
The texture of the pillar 1 is shown in Fig. 14, where the incoccio presence is clearly recognisable. Such masonry, built by tiles, small stone and weak mortar, is present in the tested portion of the perimeter pillar, as well as probably in larger surface (Fig. 15).

Figure 14. Masonry texture and localisation of the test MPD1 on pillar 1 (Fig. 2).

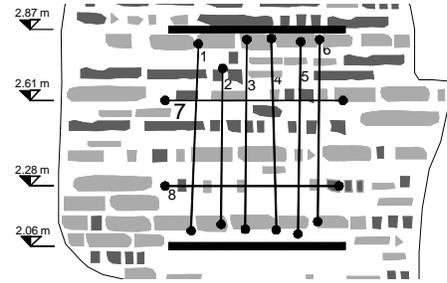
Figure 15. Masonry texture and localisation of the test MPD2 (Fig. 2).

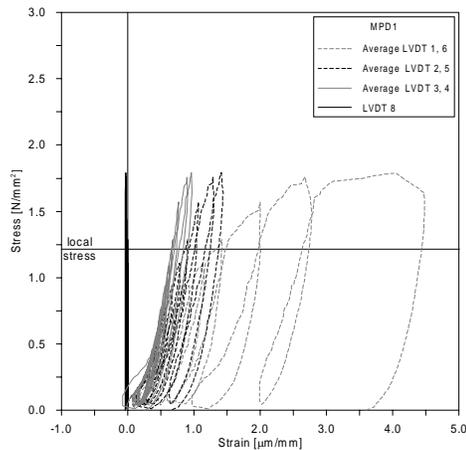
Figure 16. Stress strain curve of test MPD1

The double flat jack results seem very different from the ones obtained previously (Fig. 16 and 17). First of all, the deformation is about 10 times the one of the other tested pillar for much lower stress values. Furthermore Fig. 14 shows clearly why the measured values are so much different. This is due to the high inhomogeneity of the masonry.

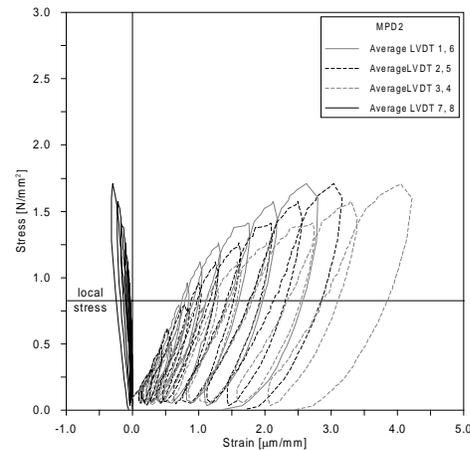
Figure 17. Stress strain curve of test MPD2

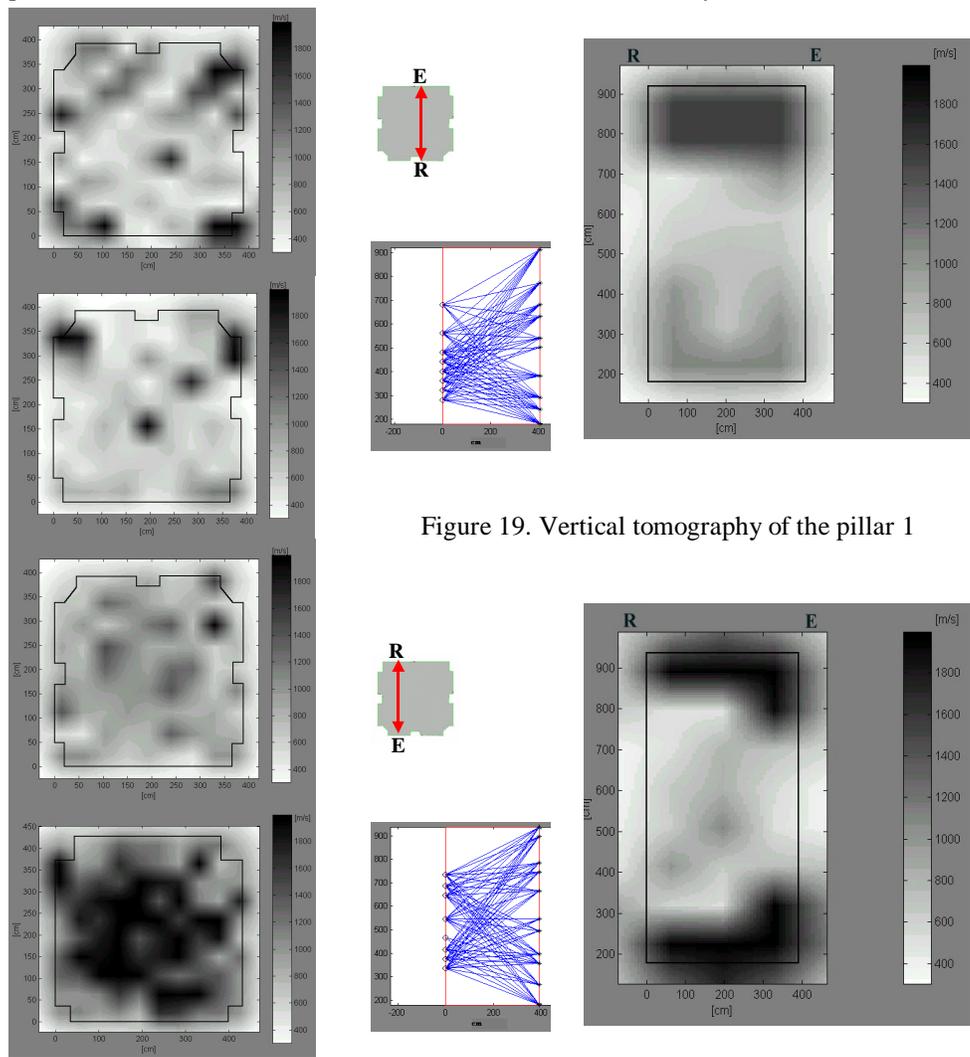
In Fig. 18 the sequence of the horizontal tomographies of pillar 2 are represented. A typical distribution of the velocity on the pillars 1 and 2 shows average velocities relatively high at the base and at the top of the pillars and very low velocities in the middle. This situation is very clear in the vertical tomography of both pillars even if the vertical sections have a lower density of ray as shown in Fig. 19 and Fig. 20.

Figure 19. Vertical tomography of the pillar 1

Figure 18. Horizontal tomographies of the pillar 2, at 8.9, 7.6, 4.9, 3.8, 1.8 m.

Figure 20. Vertical tomography of the pillar 2

very poor, characterised by the presence of the so called "incoccio".

From coring of the pillars it was also clear that the internal mortar is very weak.

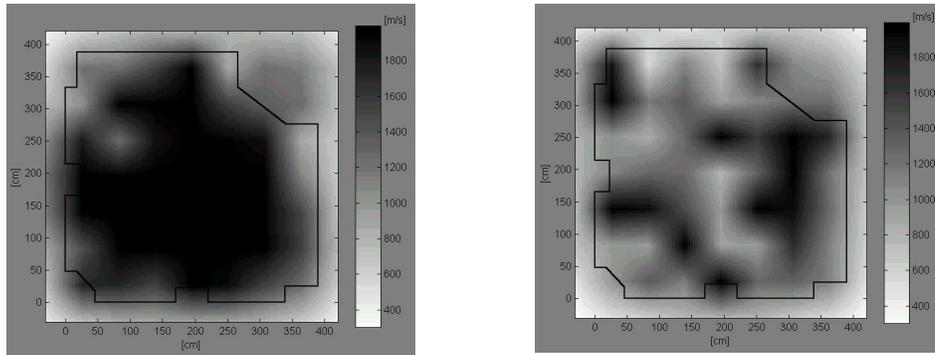
Figure 21. Horizontal sections of pillar 6 and pillar 10 at 5.8 m.

The other pillars that have been investigated generally present much higher velocities indicating a less alarming state of conservation (Fig. 21).

In particular the pillar 6 seems characterised by a better quality material. The observation of the masonry texture reveals a large block stonework, rather regular, as external leaf.
