RESTORATION AND RECONSTRUCTION OF THE ST. CHARLES MUNICIPAL CENTER RIVER WALL AND PLAZA

Edward A. Gerns¹

¹ Principal, Wiss, Janney Elstner Assoc. Inc.,
10 South LaSalle, Suite 2600, Chicago, Illinois, USA, egerns@wje.com

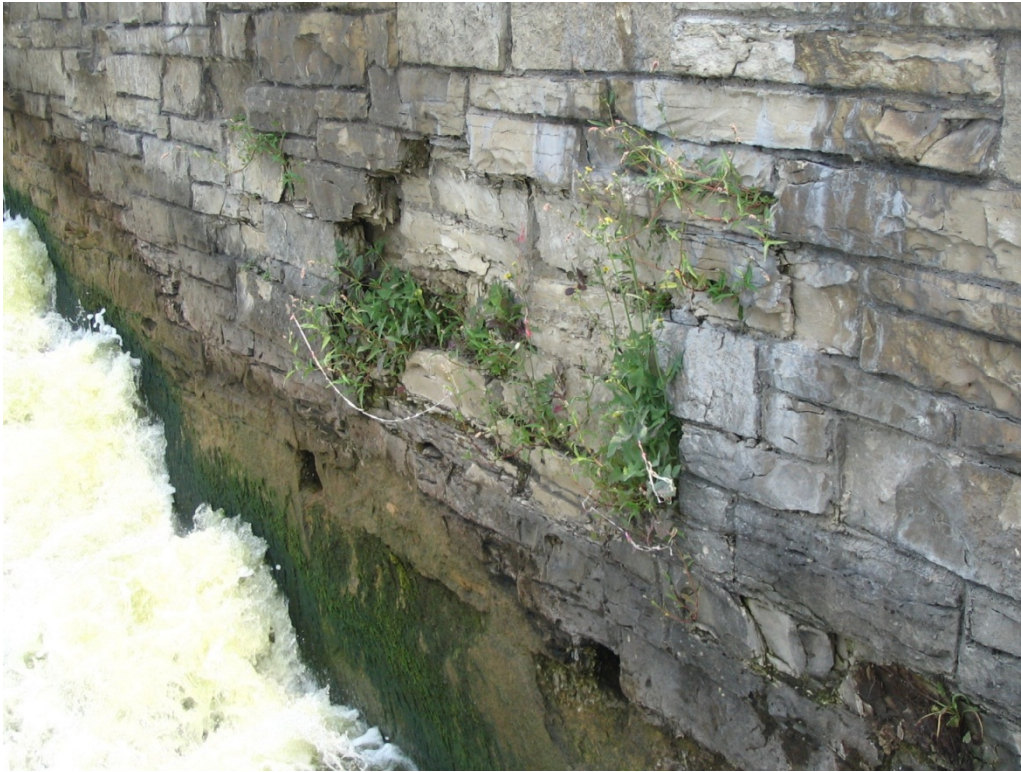
Extensive distress was observed throughout the various components of the river wall. Typical distress observed in the limestone cladding of the river wall included spalls, incipient spalls, cracks, deteriorated mortar joints, exfoliated/scaled limestone surfaces, and displaced limestone cladding. The majority of distress in the limestone cladding was the result of weathering (i.e., exposure to water and cyclic thermal changes) over time. As expected, the areas with the

greatest exposure to water (e.g., the fountains and wall adjacent to the fish ladder) exhibited the greatest levels of distress.

Figure 3: Deteriorated Limestone Adjacent to the Fish Ladder

Beyond the environmental conditions to which the stone was exposed, the sedimentary limestone used had many soft and weak planes as well as fissures. These characteristics are associated with its original formation by the sedimentation process of deposition in multiple layers or beds. By contrast, the Indiana limestone used at the top of the walls is known for its uniform density and color and lack of weak planes. The rough cut limestone cladding units, which were typically installed with the bedding planes positioned in the vertical direction (parallel to the exposed face) such as at the river wall, are more susceptible to deterioration from long term weathering, see Figure 3. Water is absorbed into the softer and more porous bedding planes and with time the bedding planes separate from the adjacent stone, see Figures 4 and 5. When the bedding plane is oriented parallel to the face of the wall, spalling, exfoliation and face shearing result. Typically, limestone units are laid up such that the bedding plane is positioned in a horizontal direction so that deterioration of individual units will be restrained by the surrounding units.

1. Remove and replace the limestone cladding and handrail at the river wall from the Main Street Bridge north to the west stairway. Rebuild the existing fountain at this portion of the wall, as well as repair the concrete backup wall.
2. Remove and replace the fishing platform surface from the Main Street Bridge north to the stairway.
3. Remove and replace the limestone cladding and handrail at the remaining portion of the river wall. Rebuild the existing fountain at this portion of the wall, as well as repair the concrete backup wall.
4. Remove and replace the remaining portion of the fishing platform surface.
5. Remove and replace the existing stairway including the stone or precast concrete cladding.
6. Rebuild the viewing platform at the far north edge of the river wall and plaza
7. Remove and replace the plaza, replicating the original as-built condition.

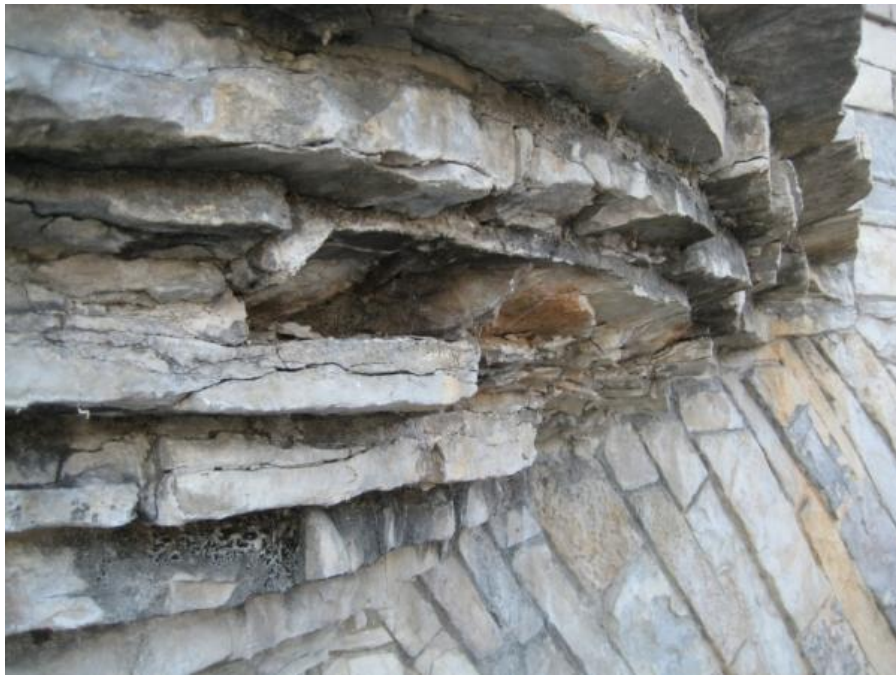
Figure 5: View of Deterioration of Stone at Fountain

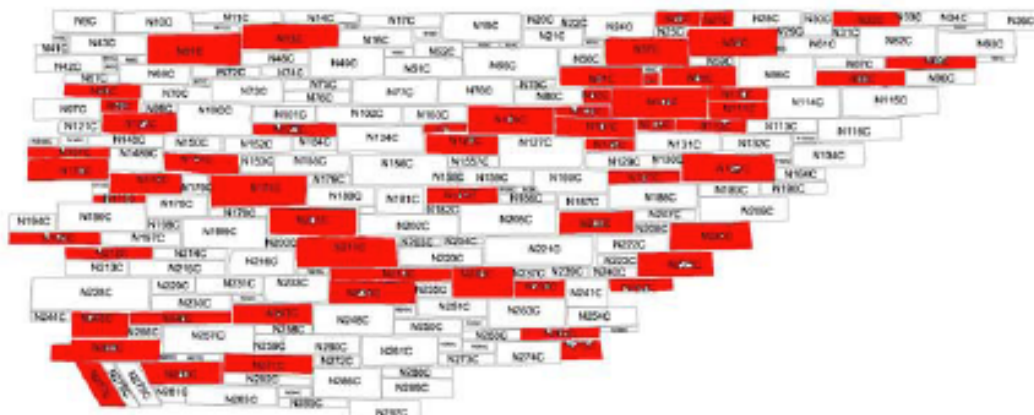
Figure 7: Representative Digital Scan of Stone. Replacement Units are Designated in Red.

In order to replicate the original configuration of rough cut limestone, the contractor made a digital scan of the wall prior to demolition, see Figure 7. Using the scan, each unit was numbered. Units exhibiting significant damage or face bedding were identified and replaced with new units. Having a sense of the size and quantity of the damaged or deteriorated units, the contractor was able to reduce waste and pre-size many of the units.
