REPAIR AND SEISMIC RETROFIT OF A XV CENTURY BUILDING COMPLEX HEAVILY DAMAGED IN THE L'AQUILA EARTHQUAKE

A.Benedetti¹ and S.Verlinghieri²

ABSTRACT

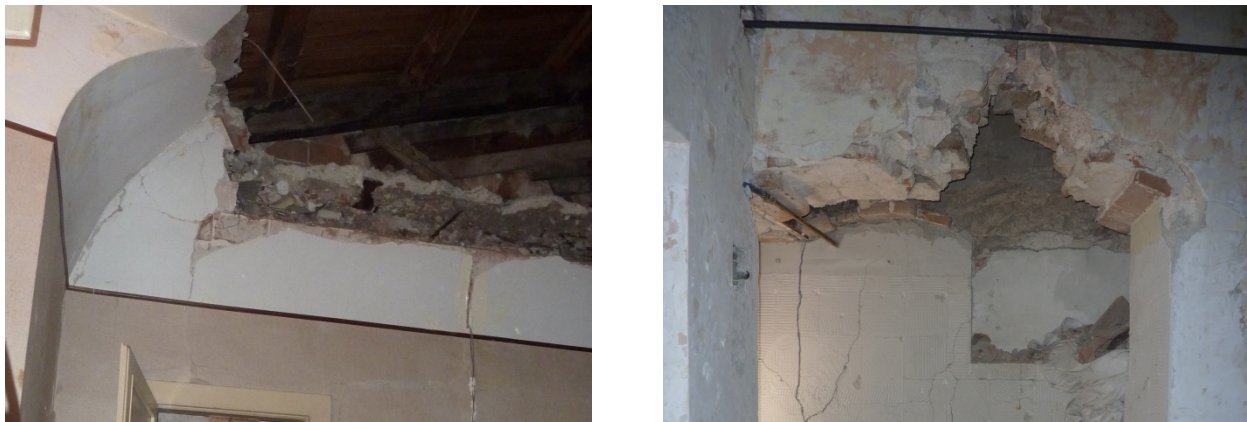
exterior walls due to overturning forces, loss of vault - wall connection and local fall down, timber floor disaggregation, and collapse of architraves (figures 4 to 6).

Figure 4: View of damaged vaults and architraves after the earthquake

A specialized retrofit technique was used for vaults (figure 14); first of all, all the cracks were filled with fluid mortar and sewed with fibre strips. Afterwards, the masonry shells were strengthened with a grid of fibre strips and by formation of masonry reinforced ribs (figure 15). Finally, the vault volume was filled with expanded clay aggregates, a nonwoven film, and a thin finishing concrete slab. Where necessary, inside the vault volumes were placed the tie bars connecting the facing walls supporting the vault.

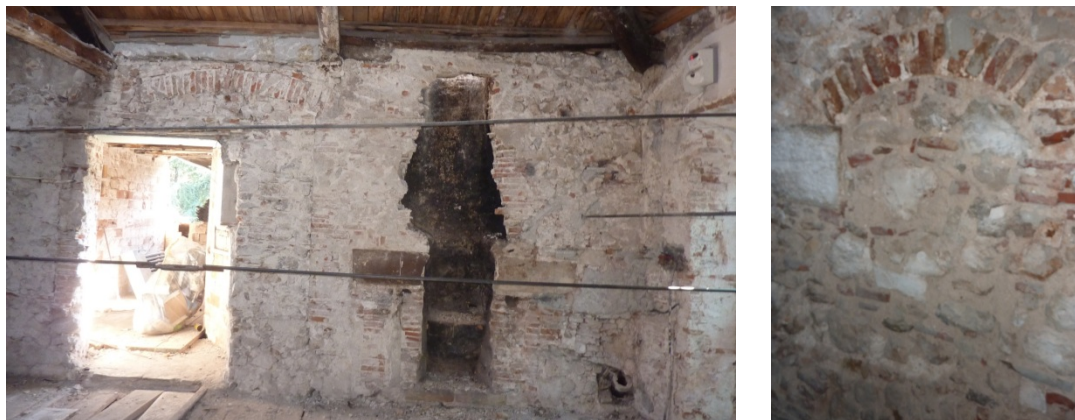
The main drawbacks of the building are connected to the typical geometry of the medieval buildings with a "stillicidio" wall pair cutting the building plan, and the presence of a great number of fireplace flues. Even the very bad mechanical properties of the typical L'Aquila mortar containing rounded sandy particles create an overall mechanical deficiency of the building.

Figure 5: View of chaotic wall organization with flues and heterogeneity of texture

The diffused strengthening works encompass masonry injection with lime mortar, formation of steel connectors between masonry leaves by using the injection holes, replacement of bad or cracked bricks with reconstruction of the masonry texture, and filling of flues or cavities (figure 13). Perimeter stiffening of window and door openings was achieved by means of steel frames.

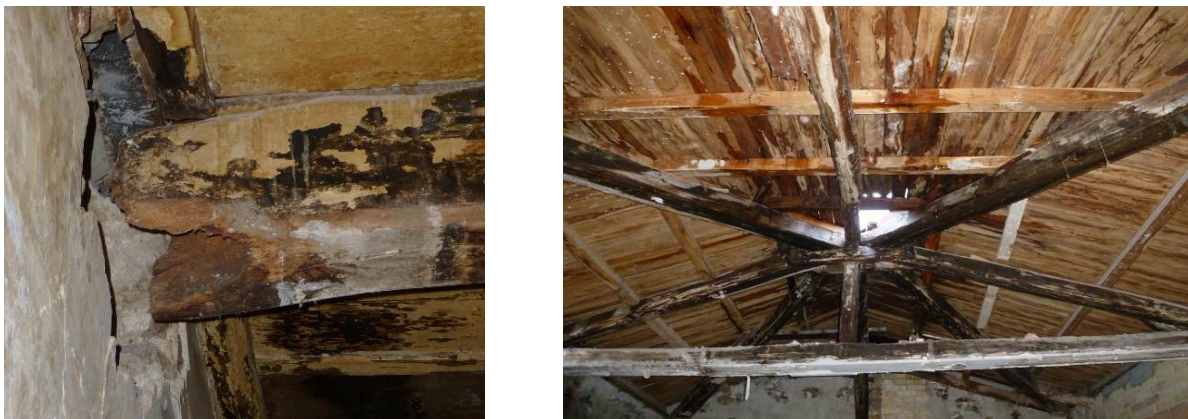
Figure 6: View of timber beams and frames with damaged sections

The second floor ancient timber beams with lacunar plank presented a number of local defects including an anomalous deflection subsequent to creep; moreover, the diaphragm action was insufficient due to the rough organization of the upper deck planks (figure 16).

The retrofit was based on the addition of a new solid timber beam above the original one; this additional section was inserted in between the joists and tightened with wedges and fastenings. Even the rafters were connected with angles and screws for obtaining a stiff grid. The in-plane

shear stiffness was enhanced with screws fixing the planks and connecting a new lightweight concrete slab to the timber structure.

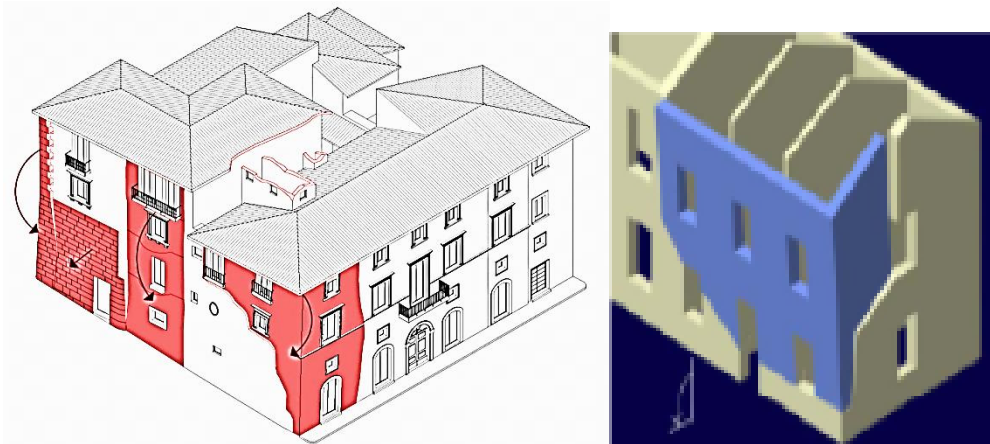
Figure 7: Indication of the external wall leaning due to incipient overturning

Unfortunately, the largest part of the external walls (figure 7) is composed of stone masonry, so that coring suitable for laboratory tests is not viable. In this case laboratory tests were restricted to tests on stone specimens and punching tests on mortar layers. By this way very different strengths were obtained for sandstone and mortar. Typically compressive strength of stones was around 90 MPa while mortars rarely exceeded 3 MPa. The situation was different for the first floor vaults constructed with thin clay fired bricks (figure 8).

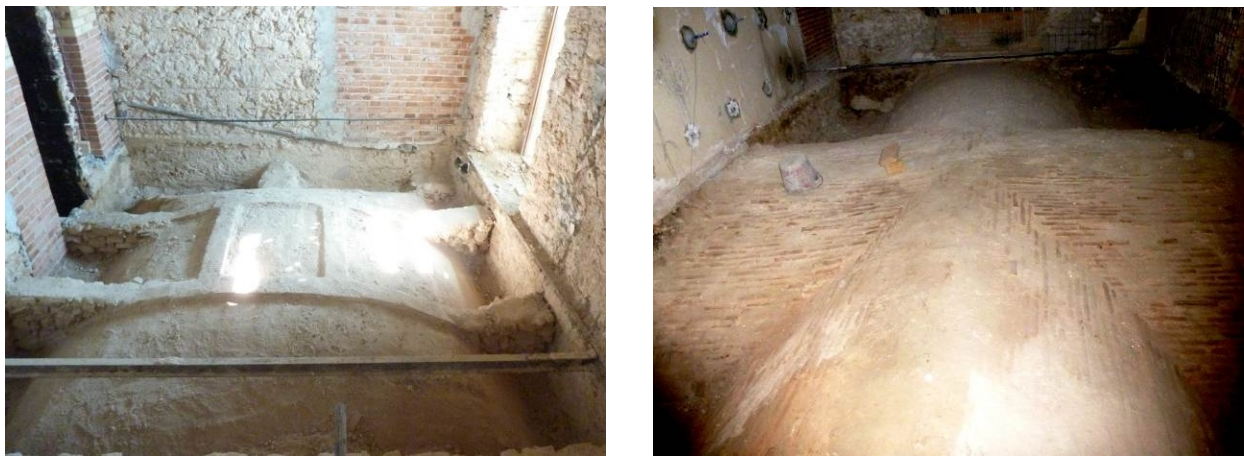
Figure 8: Barrel vault with stone stiffeners and cross vault made with one head bricks

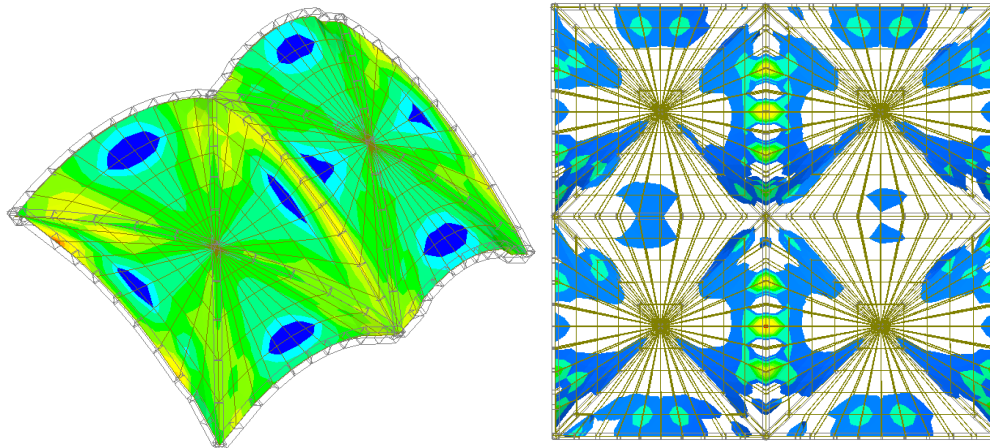
Even for the masonry vaults the procedure is based on the comparison of the stress resultants (figure 11). In this case the zones with tensile stresses are identified and the tensile resultants are computed in both X and Y directions. Owing to the need to fulfil the internal shell equilibrium with a no-tension material, these forces shall be carried on by a reinforcement network connected to the vault surfaces.

Figure 11: Tensile stresses in X-X direction for the 1st and 2nd floor cross vaults

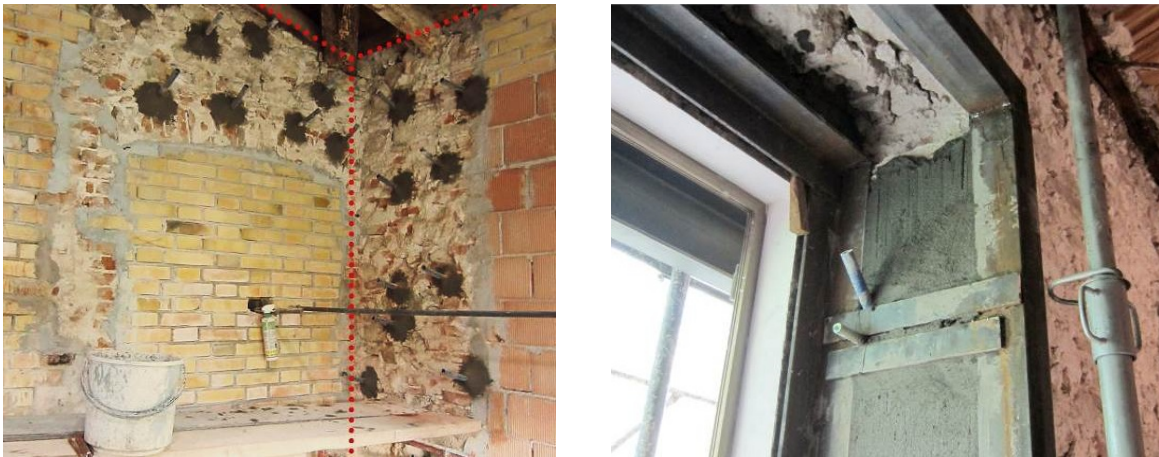
Figure 13: Injections, brick texturing and frame stiffening around windows

One of the most interesting stiffening networks is based on the connection of the adjacent window steel frames with screw bars (figure 13). By this way the shear performance of the wall is enhanced and the stiffness and the compressive strength are increased by the confinement effect of the linked frame borders. It should also be mentioned that, because the window parapet was initially thinner than the neighbouring panels, the thickness was preliminarily reset by texturing and sewing a new leaf.

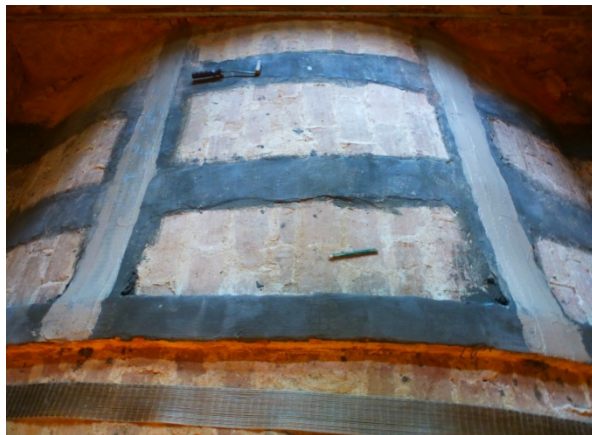
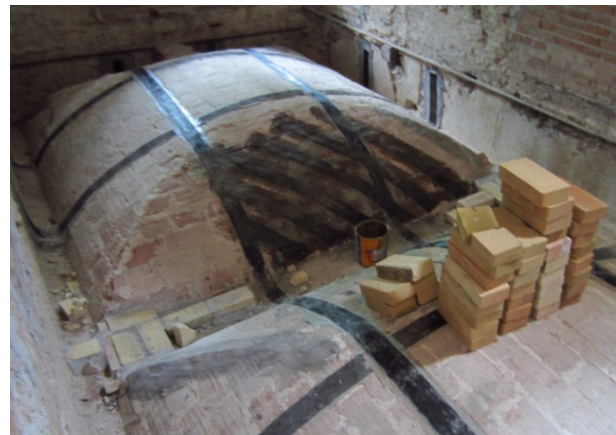
Figure 15: Hardwire and C-FRP repair and strengthening of vaults

As said before, in order to maintain the transpiration of the masonry shells, steel wire bundles were bonded with high strength lime mortar. This made easier the fastening of the strips into the neighbouring walls simply by inserting the twisted ends in drilled holes and filling with mortar.

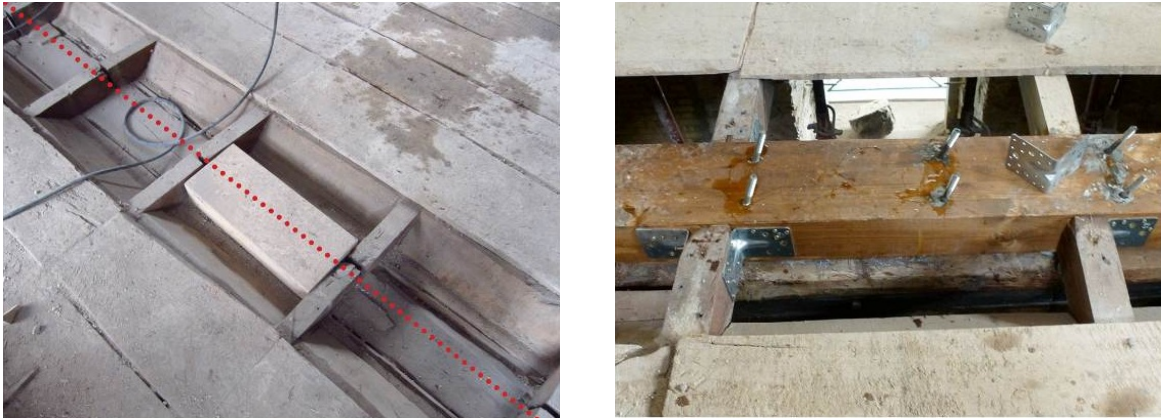
Figure 16: Increasing depth of timber beams with timber blocks and fastening of lintels

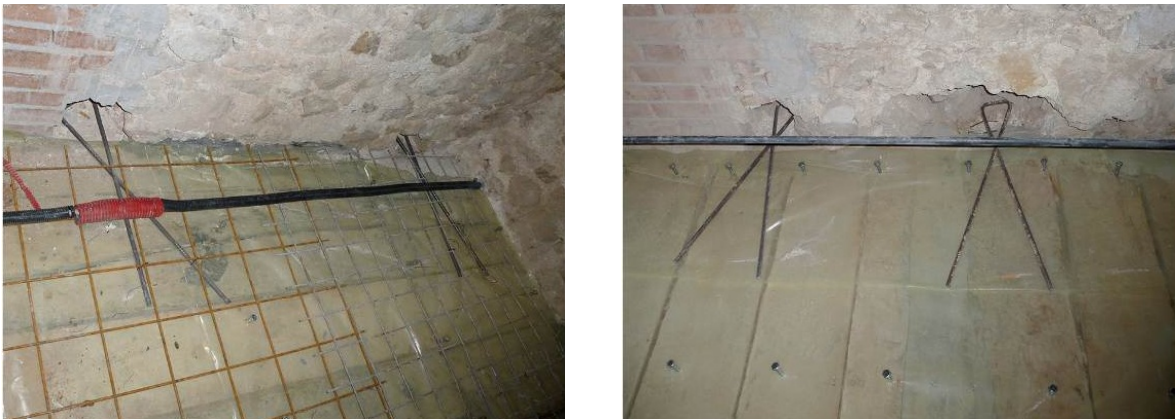
Figure 17: Steel ties placed around rooms and edge connectors to be grouted into the slab

The new floor slab is reinforced with a single wire mesh but all the sides are organized with chevron bars able to transfer shear from the slab to the wall (figure 17). Furthermore, the slab contains tie bars running inside the diaphragm and restraining the facing walls around the slab.
