DESIGN AND EXECUTION OF THE POST-EARTHQUAKE REPAIR AND STRENGTHENING OF HERITAGE STONE MASONRY HOUSES

M. Lutman¹

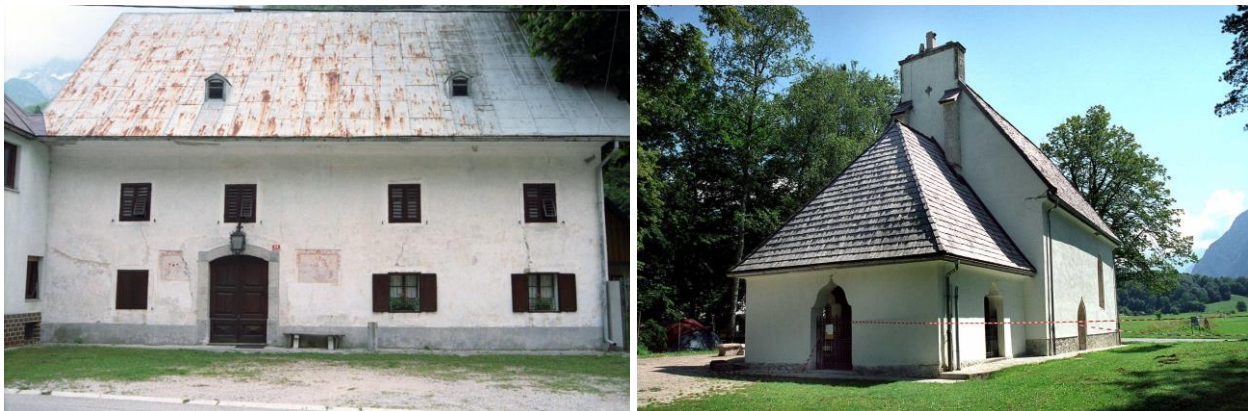
Figure 1: a) Original stone-masonry building; b) Stone-masonry church in Bovec – the upper part of the bell wall overturned due to out-of-plane vibrations

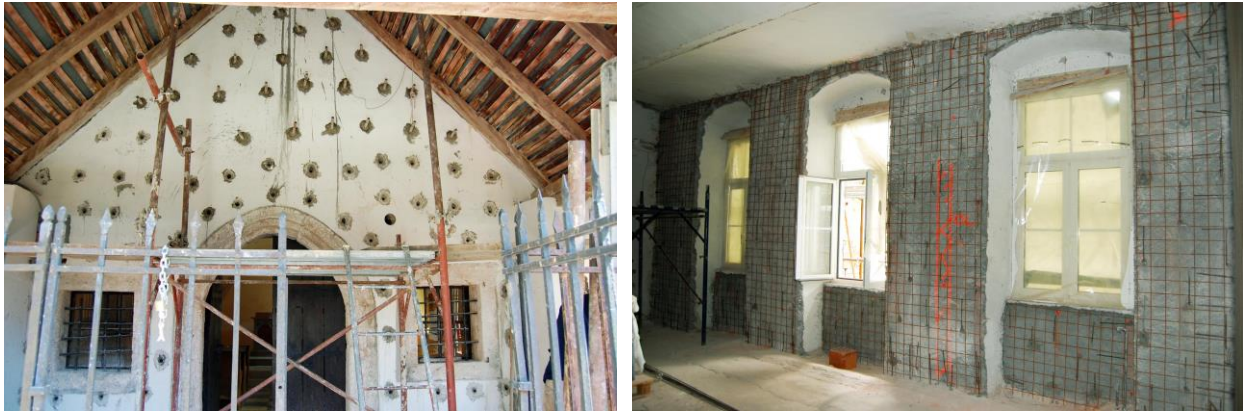
Figure 3: a) Systematic cement-grouting of masonry b) Reinforced cement coating: steel mesh is placed after steel anchors are fixed through the floor structures and adjacent walls.

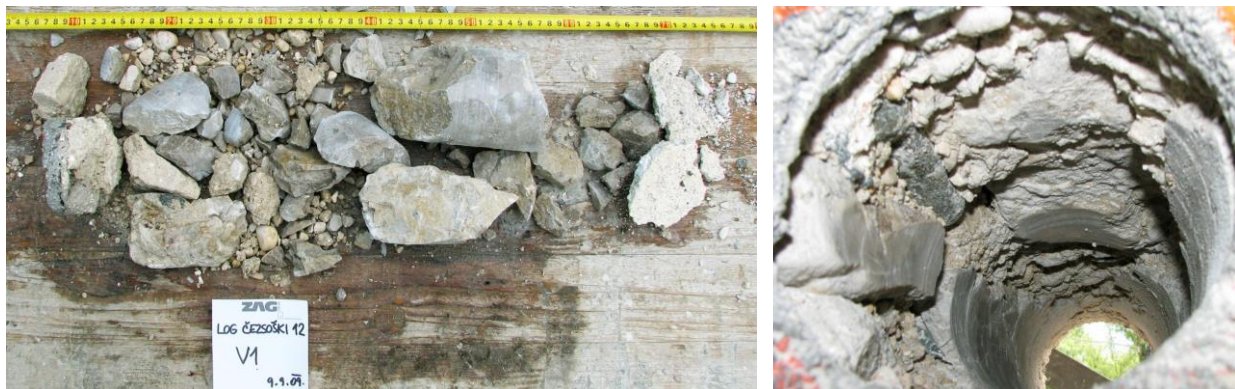
Figure 5: Less effective grouting - the grout is present but didn't connect together the stones and mortar

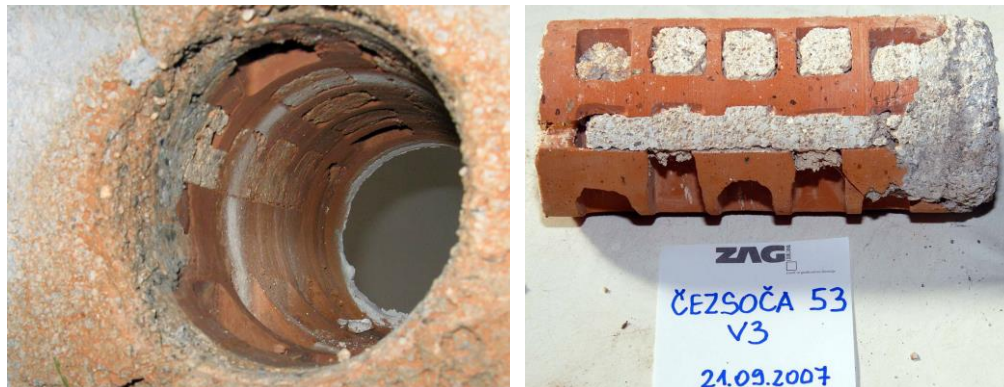
Figure 5: A retrofitted brick masonry wall: a) the surface of the borehole, b) the core

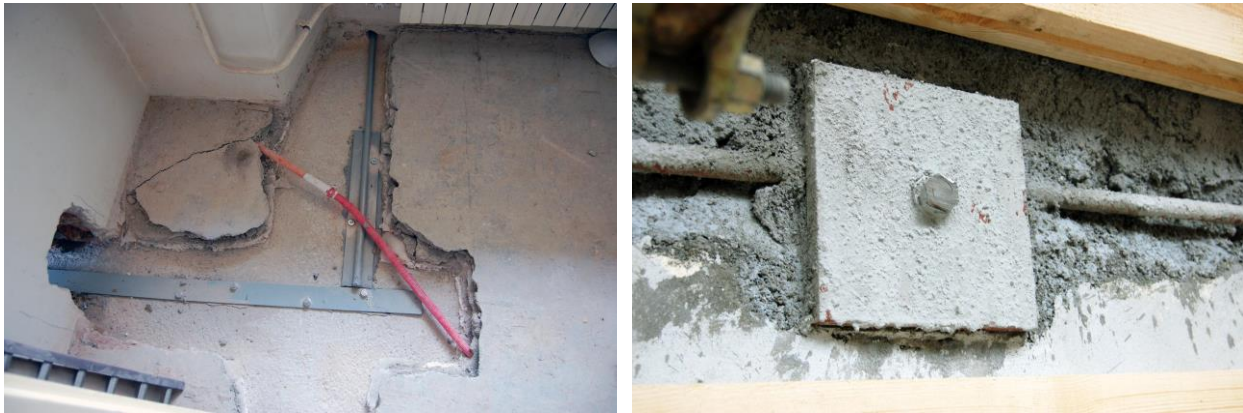
Figure 6: Connecting RC slabs and exterior walls: a) Steel bars welded to flat steel elements that are screwed into the RC slab, b) Steel anchor plate and steel tie along the wall
