## SEISMIC ANALYSIS OF THE WEST BLOCK PARLIAMENT BUILDING IN OTTAWA – CHALLENGES AND APPROACH

### ABSTRACT

The West Block Parliament Building in Ottawa is currently undergoing major rehabilitation and expansion. The building was built in three construction phases from 1860 to 1909, and has subsequently undergone a series of changes and partial rebuilding. The last significant renovation was completed in the 1960s.

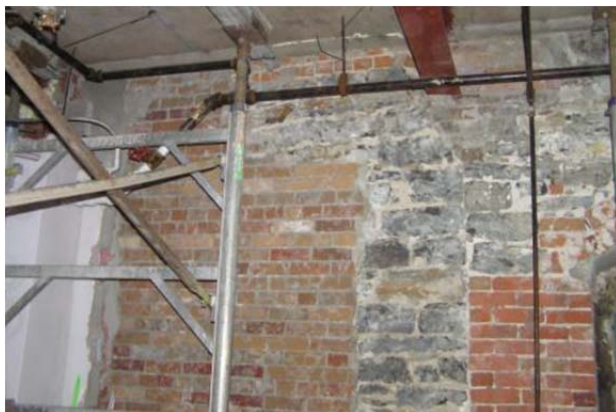
**Figure 4: Brick and Stone Masonry Wall**

The interior loadbearing walls consist of a mixture of rubble core stone masonry and solid clay brick walls. Many alterations in the past resulted in a heterogeneous structure, where brick and stone were often built up together in an irregular fashion (see Figure 4).

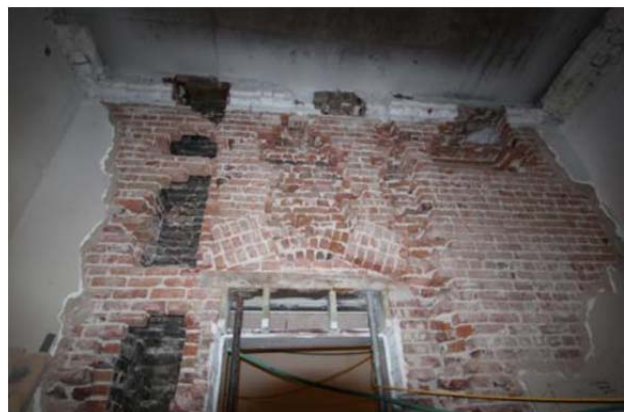
**Figure 5: Wall with Chimney Flues**

The building had an elaborate system of heating and ventilation, built into the clay brick walls. The presence of shafts and chimney flues caused a reduction in wall loadbearing capacity. Ground penetration radar, thermal imaging, and exploratory test openings were used to detect the shafts and other voids in seemingly homogeneous brick masonry walls. It was decided that as a part of the rehabilitation, all shafts, fireplace openings, and voids in walls will be filled using comparable clay brick masonry in lime mortar (see Figure 5).

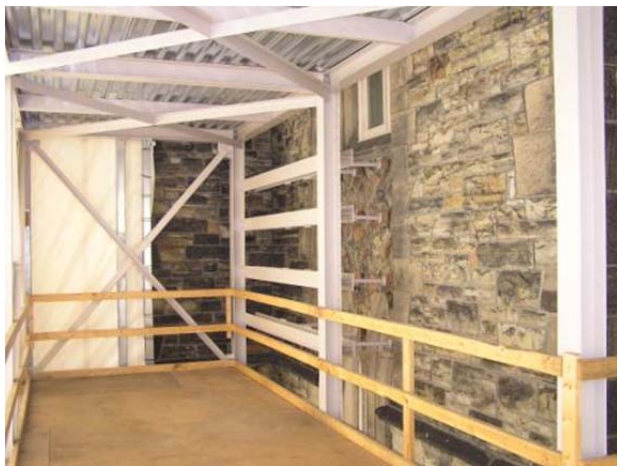
In general, the West Block Building and its components are characterized by a notable structural integrity. However, the building has deteriorated over the last 150 years, mostly due to environmental effects. Substantial deterioration of exterior masonry walls occurred due to irregular and inconsistent maintenance. The results of the two in-situ surveys performed in 1994 and 2001 confirmed progressive wall deterioration. Bulging of the outer stone wythe of random coursed Nepean stone was observed at a few locations. The bulging was restrained by a steel frame enclosure used for the restoration of South East Tower (Figure 6). The investigative openings and subsequent pilot restoration projects indicated delamination of the exterior wall wythe from the rubble core (see Figure 7).

**Figure 6: Emergency Stabilization of Wall Bulging**

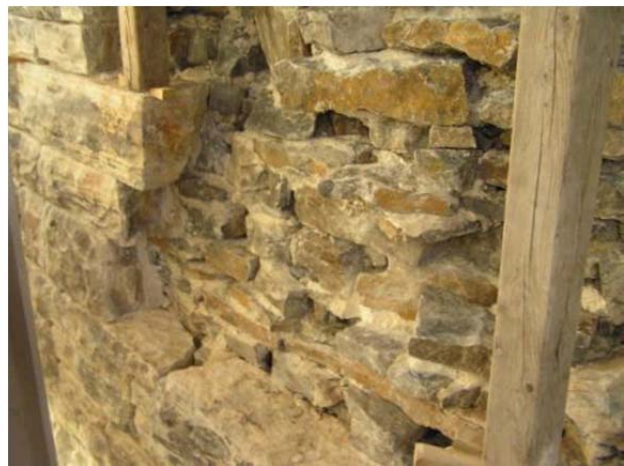
**Figure 7: Evidence of Wall Delamination**

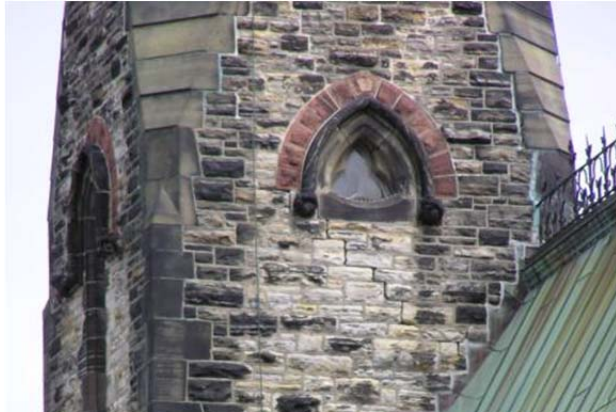
Cracks caused by past earthquakes were observed at several locations. The crack width was likely increased due to water infiltration and freeze-thaw cycles which occurred over many years (Figure 8).

**Figure 8: A Diagonal Crack in the Tower**

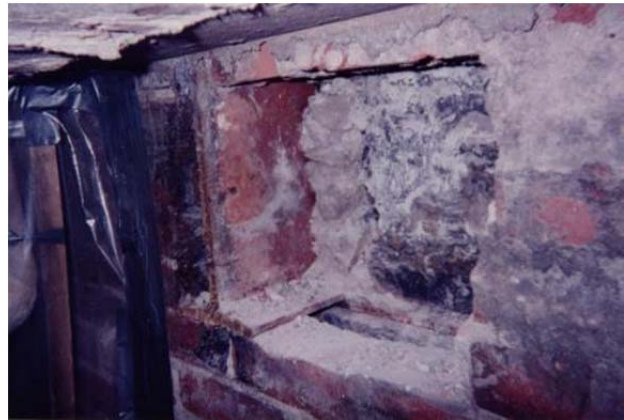
Structural modifications performed in the 1960s altered the original load paths. For example, it appears that the original floor structure was supported by the exterior stone wythe of the cavity walls. The original iron beams, bearing either on iron or stone plates, were embedded into the exterior stone wythes (Figure 9). However, the steel beams installed in the 1960s bear on interior brick wythes of cavity walls. As a result, the load on the exterior stone walls has been reduced; but there is an increase in the wall slenderness due to the absence of wall-to-diaphragm connections. Interior brick wythes of cavity walls, which were not originally intended to carry vertical loading, support the floors now.

**Figure 9: An Original Beam Bearing Detail**

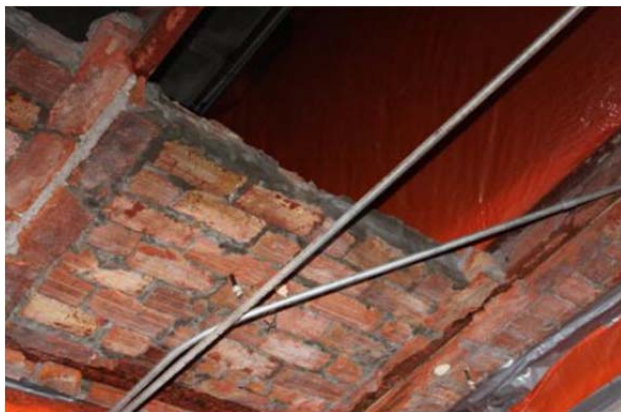
The attic floors are mostly made of hollow terracotta tiles, which are either individually suspended on steel joists or form a flat arch structure, as shown in Figure 10. This floor system has a limited gravity load capacity and is not able to act as a diaphragm for seismic effects; for those reasons, it will be replaced as a part of the current rehabilitation project. Demolition of finishes has revealed many areas with discontinuities in seismic force-resisting system due to the modifications made in 1960s, such as an absence of connections between the reinforced concrete floors and existing walls (see Figure 11).

**Figure 10: Terracotta Attic Floor**

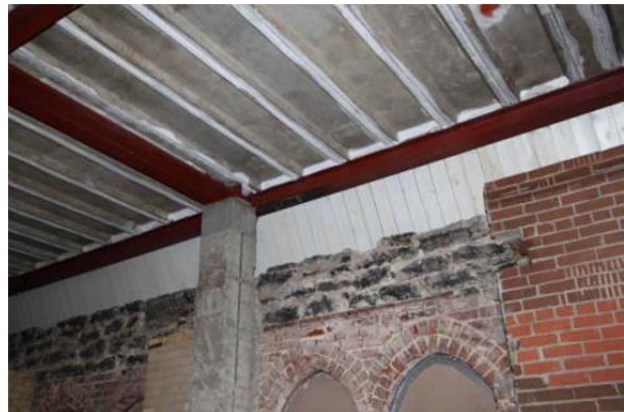
**Figure 11: Floor-to-Wall Connection**

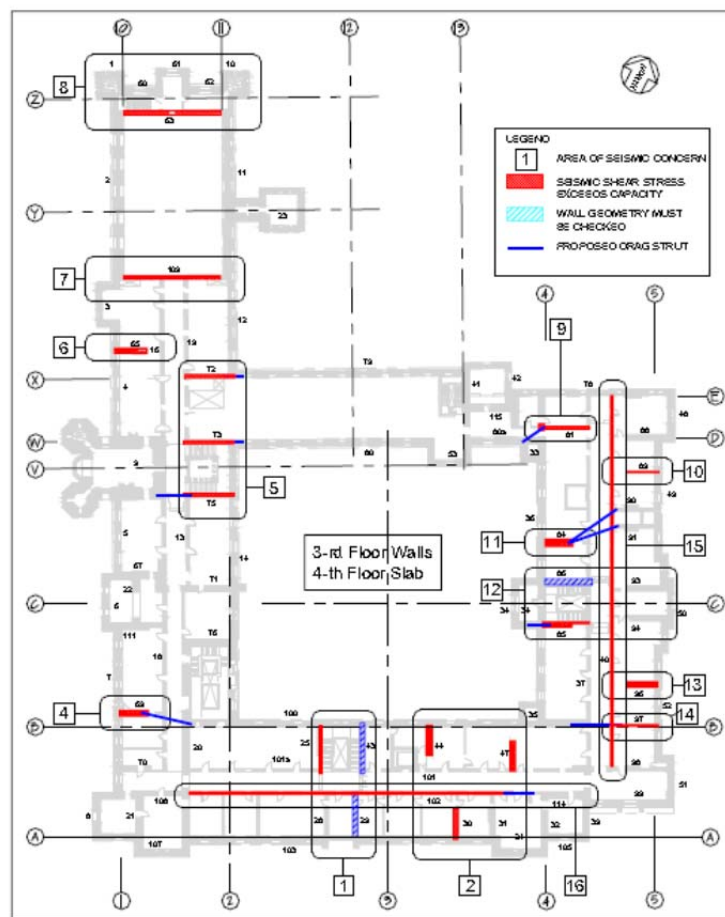
In 2007, Jokinen + Ojdrovic Engineers in Joint Venture conducted a seismic study of the West Block building [3]. Both an equivalent static and a dynamic seismic analyses were performed. The study identified seismic deficiencies in the building, such as shear resistance of existing masonry walls, as illustrated in Figure 12. Other structural deficiencies included shear transfer between walls and floors, diaphragm capacity of existing floors and roof, slenderness of exterior walls and uneven vertical load distribution, etc. Other areas of concern were identified based on visual investigation and in-situ testing, such as cracks in the masonry walls.

**Figure 12: 2007 Seismic study - preliminary concerns - fourth floor level [3]**

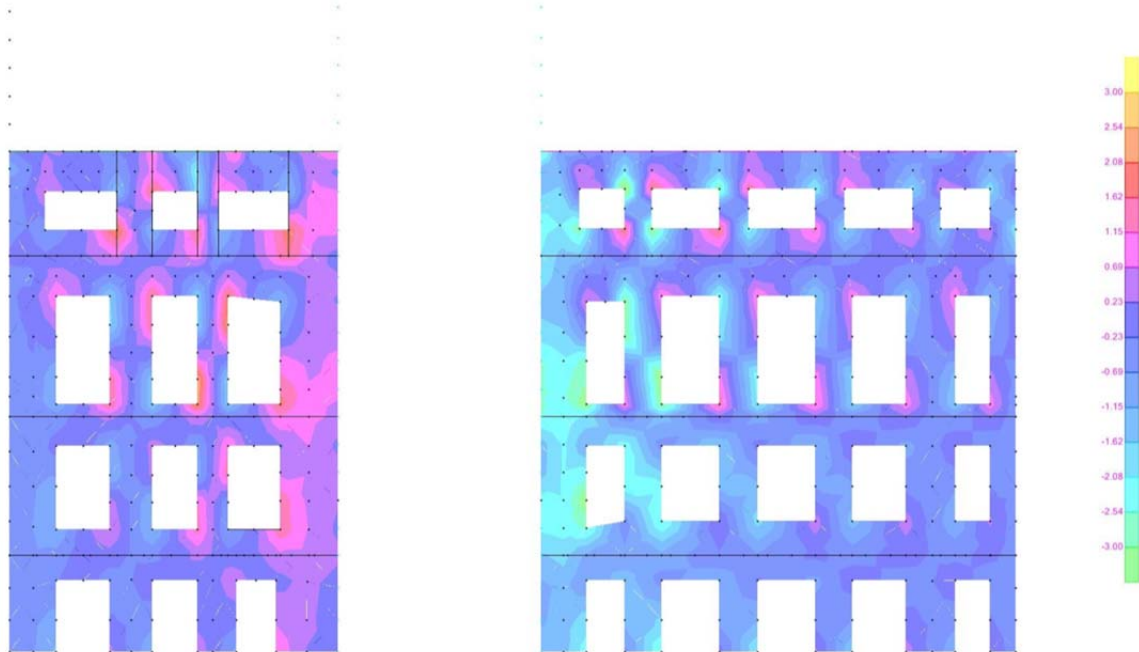
The walls attached to the MacKenzie Tower are subjected to stress levels that exceed the permitted values, as shown in Figure 15. Note that the wall stresses are within 60% of their capacity. The stress capacity was calculated as a sum of 40% of wall weight plus 0.2 MPa.

**Figure 15: Stress Contours in Walls Attached to the MacKenzie Tower for Earthquake in North-South Direction**

Note that space between the two walls shown in the figure is occupied by MacKenzie Tower, which is attached to the building. In the contemporary construction, an expansion joint would prevent situation like this, however the creation of an expansion joint in an existing heritage masonry building would not be acceptable. In this case, an independent “catchment” structural system will be designed to provide the support to the floor slabs and catch the debris around the MacKenzie Tower in case of a catastrophic earthquake.
