## SEISMIC VULNERABILITY OF MONASTERY TEMPLES OF STONE MASONRY

**Durgesh C Rai<sup>1</sup>, Vaibhav Singhal<sup>2</sup>, Tripti Pradhan<sup>3</sup> and Neha Parool<sup>4</sup>**

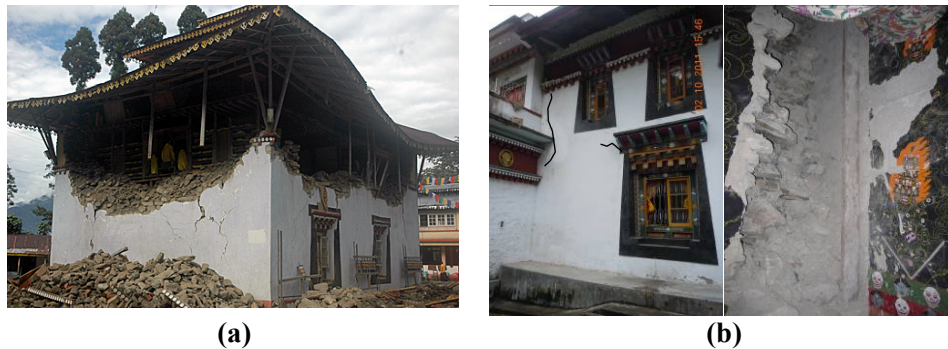
In the September 18, 2011 event several monasteries suffered varying degree of damages ranging from cracked walls to total collapse. Heavy damages were observed to exterior walls at several monasteries, e.g., total collapse of a village temple at Lachung, partial collapse at Ringhem Choling monastery at Mangan (Figure 4a), delamination of walls and cracks in Samten Choling monastery temple, Lachung (Figure 4b).

**Figure 4: Common damages observed (a) Partial collapse of wall of Ringhem Choling monastery and (b) Shear cracks and delaminated wall painting at Samten Choling monastery.**

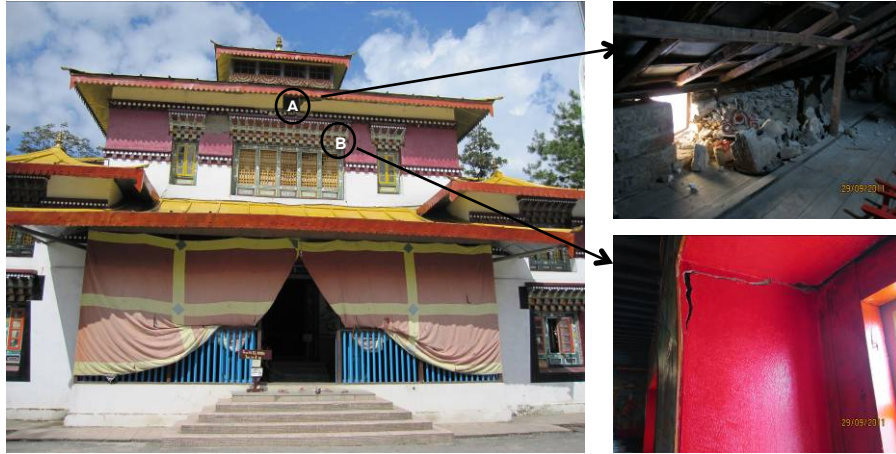
Enchey monastery at Gangtok, retrofitted after the 2006 Sikkim Earthquake also suffered moderate damages in the 2011 event [5]. The out-of-plane failure around the opening was observed in the unretrofitted portion of third-storey wall as shown in Figure5. Similar damage to the exterior wall built in stone laminates was also observed at Labrang monastery (Figure6). After the 2006 earthquake, the collapsed roof was replaced by a truss roofing system supported on steel columns erected around the shrine room. Steel joists connected to columns were also inserted below the timber floor to relieve the load on the timber beams and walls.

**Figure 5: Damages observed on the front wall of third storey at Enchey monastery**

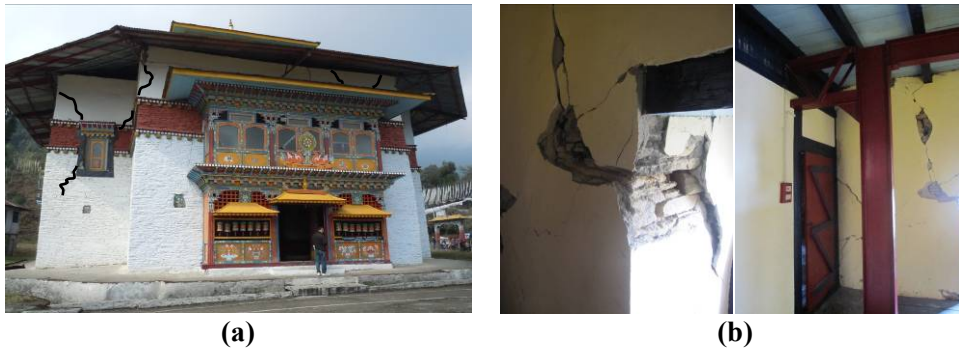
**Figure 6: (a) Cracks on the exterior wall of Labrang monastery and (b) Exposed stone laminates during the recent damage and steel columns and joists used in the retrofit**

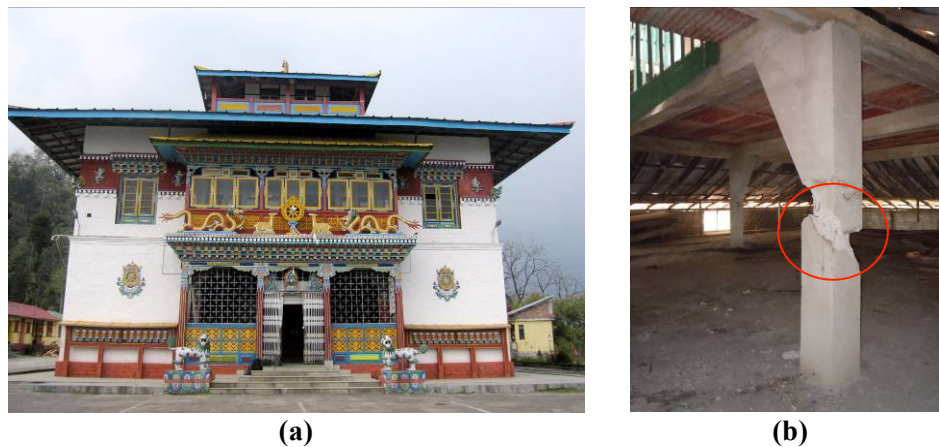
Phodong monastery which is a mixed construction of RC frames and load bearing masonry walls suffered no damages to the exterior walls (Figure 7a). However, the RC columns were severely affected because of short-column effect due to the presence of deep haunches at the beam-column junctions as shown in Figure 7b. The haunches were supposedly provided to increase the lateral load resisting capacity of the frame, which in turn created a short-column effect causing the brittle shear failure of columns.

**Figure 7: (a) Phodong monastery, interior RC frame with exterior stone masonry wall and (b) Damaged column due to short-column effect induced by the presence of deep haunches**

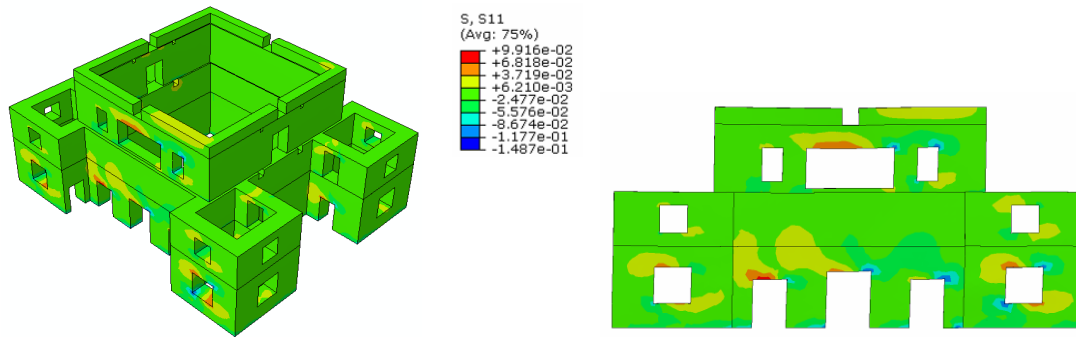
In order to identify the stress critical zone in the structure, a uniform static horizontal load taken as 20% of the weight as per the Indian seismic code was applied in both the directions. Table 4 summarizes the stresses obtained by response spectrum analysis and lateral load analysis. The maximum tensile stresses observed at the corner of openings exceeded the lower bound cracking value of 0.08 MPa [9] (Figure13). The location of maximum stresses was same as the location of damage observed during the 2011 earthquake (Figure 5).

**Figure13: Areas identified with critical stresses (x-direction)**

The FE analysis highlights the vulnerable portion of stone masonry walls at upper stories and especially around openings. The interior wooden frame of building is relatively robust which also in correlation with no damage observed during the earthquake. The short period and hence their behavior is dominated by acceleration response. In order to reduce/mitigate damage in future earthquake it is suggested to reinforce/strengthen the masonry around openings and control deformation of timber diaphragm which may induce out-of-plane deformation demands
