CLAYBANK BRICK PLANT – A FUNCTIONAL AND BUILDING ENVELOPE/ WATER DIVERSION RECOMMENDATION FOR A HISTORIC BUILDING

P. Glanville¹

ABSTRACT

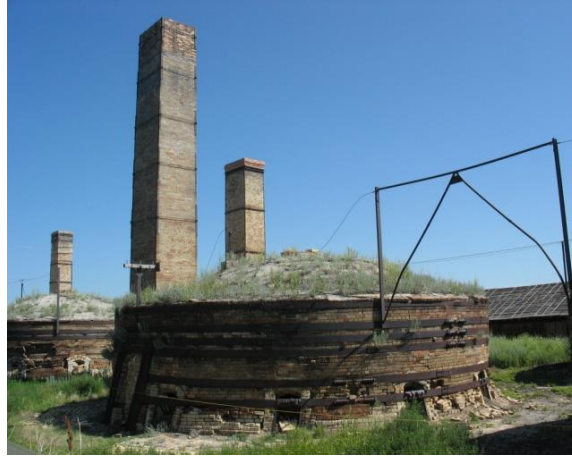
From a site visit conducted in the summer of 2012, it was observed that a number of kilns have suffered significant deterioration due to water damage particularly those abandoned at the south end of the site. The kilns appear to have received damage from the ground up due to wicking of ground and subsurface moisture, and from the top down, from inadequate diversion of water from the domed surface to the exterior kiln walls, and from the dome surface itself.

The soil, which would have been dried out and desiccated during the productive years of the plant, has, since the kilns' shutdown, had increases in moisture content. The ground would have undergone yet another form of swelling at different rates depending on surface drainage, exposure to sunshine or shade, or vegetative growth. These differential movements would likely cause distress and shear cracking in the kiln walls [3].

In addition, the groundwater and soil contain high concentrations of sulphate salts. Masonry in direct contact with the ground would have absorbed sulphates through porosity and dissolved due to moisture wicked through evaporation of the surfaces. As concentrations increase, osmotic attraction pressures develop due to the chemical differences between the high concentration area near the brick face and the low concentration area of the groundwater, further increasing the rate of water movement to the evaporation front resulting in evidence of sulphate residue and chemical effects on the exterior kiln walls. This would also have occurred within the kilns where heat concentration would have increased rates of evaporation [3].

Figure 4: Example of abandoned kiln as example of advanced deterioration showing foundation settlement, mortar and masonry deterioration and biological growth.

As a result of site conditions and continued deterioration of the structure, the best course of action would be to underpin the foundation, replace damaged brick and repoint with appropriate mortar and improve site drainage. In the event that underpinning is cost-prohibitive, water diversion is recommended for the over-all site [3].

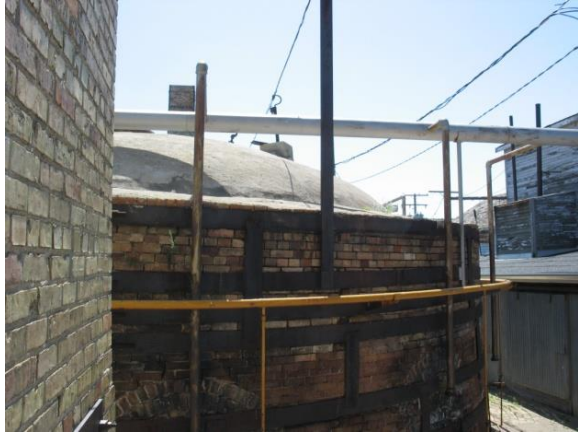
Of the kilns that have suffered less deterioration, it appears that while the masonry walls required repointing, the majority of deflection within the dome has occurred as a result of inadequate diversion of precipitation and consequent moisture infiltration from the exterior dome surface.

JC Kenyon Engineering's first assessment of the exterior wall was conducted in 2005 and determined the deflection was apparent at the base of the exterior walls where there was pressure on the steel bands. In 2011 JC Kenyon Engineering also made additional visual observations related to the deterioration of the kilns due to moisture penetration from the domes [5]. Based on observations during site visits in 2012, a further assessment of the kilns was conducted to determine how the deflection at the base of the domes affected the performance of the structures. The analysis included an examination of the steel bands, the outward deflection at the base of the domes and the effects of the deflection at the base of the domes. Their analysis delved further into the activity of the dome by examining the performance of its lunes and voussoirs and the effects on the exterior wall to determine the total outward thrust on the wall. Further concerns investigated were characteristics of radial cracking in the dome, as well as deflection between the dome base and oculus [6].

Figure 5: a) Pattern of efflorescence and ceiling deflection in kiln 4 appears to coincide with the exterior dome configuration. b) Exterior dome configuration at kiln 4. Note the flat surface at the wall to dome connection. Kiln 4 is not as deteriorated as the older kilns as seen in Figure 4.

As both the geology and topography of the site, as well as configuration of the domed surface factor into the deterioration of the structures, diversion of water from the structure and site was recommended. This included installation of flashing to dome-to-wall surface connection and positive diversion off of and away from the structures. Reparging the roof surface of the exterior dome surface was also recommended to prevent further infiltration of moisture in from the exterior dome surface.

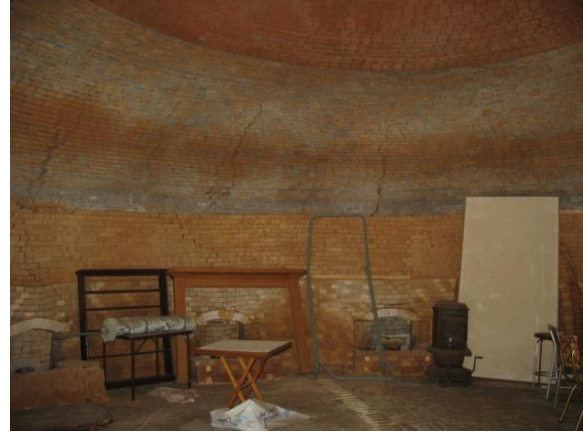
b)

The bowler hat shape of the dome has created a concave area on the exterior where efflorescence appears on the interior surface. The exterior shape from the oculus down to the walls has provided a profile that allows water to shed onto the face of the walls. Although there was mortar deterioration on the wall surfaces of these structures as well, those domes that shed water onto the wall surface, but which had a more consistent dome shape, presented less interior surface deflection and efflorescence. Significant biological growth has accumulated on the older kilns, particularly on the north face of the structures where the surfaces are moister and shadier than those exposed to the south.
