STRUCTURAL INVESTIGATION OF MASONRY KILNS AT CLAYBANK BRICK PLANT NATIONAL HISTORIC SITE

ABSTRACT

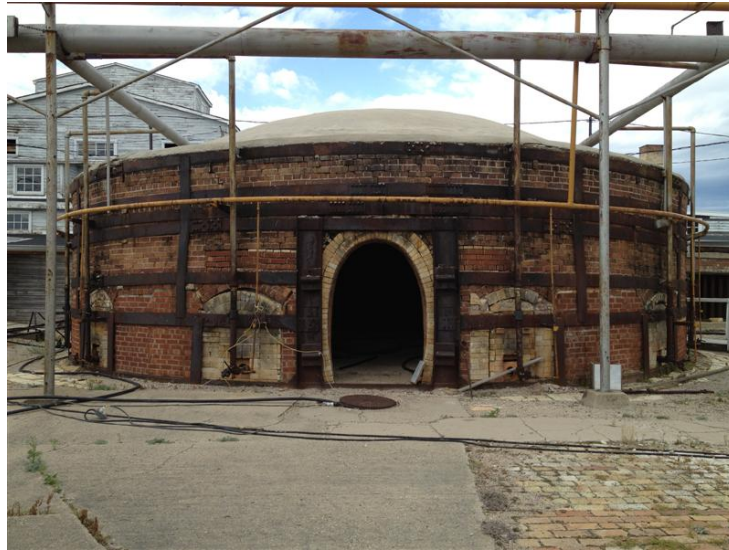
Photo 1: Kiln #1- a typical example of the existing kilns

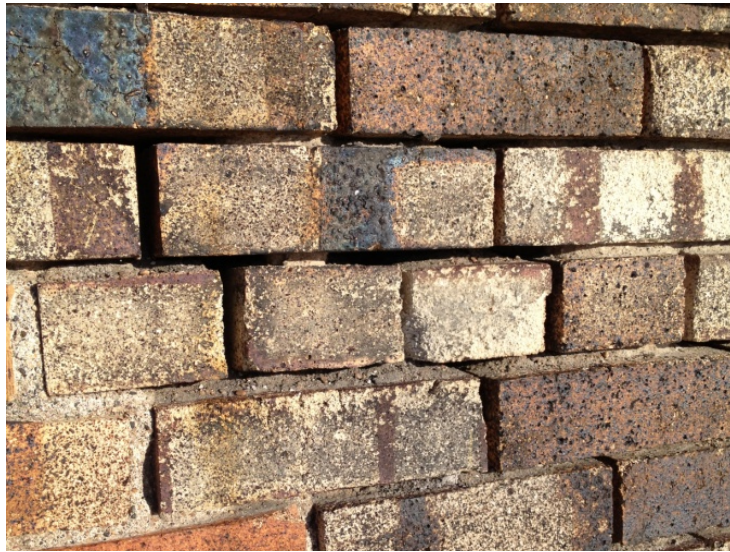
The exterior mortar joints had deteriorated (See Photo 2) with the joints at the top of the wall in the worst condition. No protection from rainwater running off the dome had been provided, which allowed water to run directly into the mortar joints at the top of the wall. In some locations the remaining mortar could be easily brushed away, and in other locations moss or other vegetation had started to grow.

Photo 2: Kiln #1- A typical example of deteriorated mortar joints

Water penetration into the masonry structure seemed to be one of the primary causes of deterioration and structural damage. On the exterior of Kiln #4, the mortar joints had deteriorated to such a point that the brick was beginning to deteriorate, affecting the ability of the walls to resist differential movement below the foundation and effectively transfer forces from

the dome to the load bearing walls and steel bands. Repointing of the brick was clearly a necessity to properly preserve the structures.

Once the analysis was complete, the focus turned to preserving the kilns. Water penetration was clearly the most important and least costly external factor that the kilns could be protected against. It was recommended that mortar joints be repointed and that the cracks in the roof be filled. On one of the kilns it was necessary to remortar the entire dome of the roof.

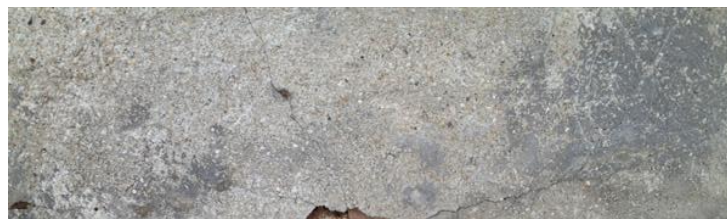
The dome roofs each had minor radial and horizontal cracking in the exterior cement. On Kiln #9 some of the cement had delaminated from the bricks below and there was clearly a void in the area between the dome and the wall interface (See Photo 3).

Photo 3: Kiln #9- Exposed face brick at the perimeter of the dome roof

The inward deflection of the domes was interesting because it appeared to correlate with water penetration that had occurred in the dome roof. The discovery of voids below the mortar around the perimeter of the dome on Kiln #9 led to the conclusion that a cavity had formed between the layers of brick within the dome. During the summer water would likely be able to escape the voids (as was seen by the efflorescence and mineral deposits at the radial cracks), however in winter months melted water would not have the ability to drain. As the captured water froze the bond between the vertical firebricks and mortar would break, allowing larger voids to form. At the base of the dome a void between the inside layer of firebrick and the horizontal firebrick would allow ice to build up against the vertical firebrick and force it inward.

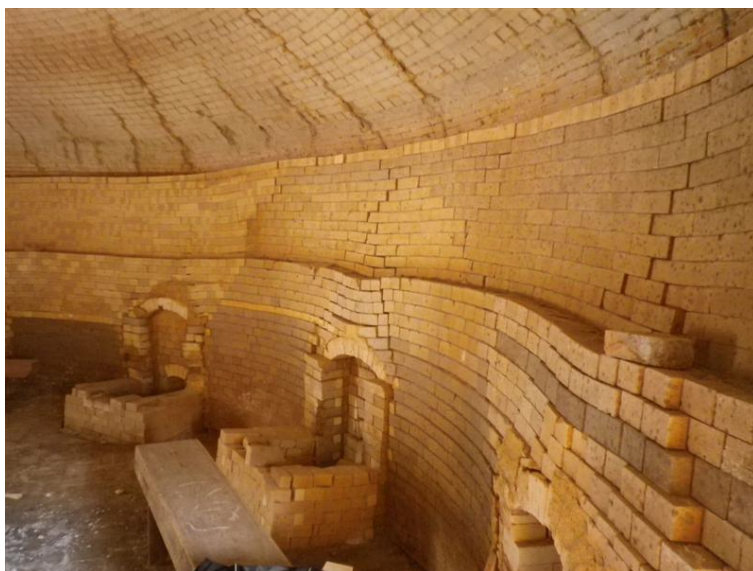
The interior walls of each kiln could not be seen due to a protective firebrick wall that was constructed approximately 25 mm inside the load-bearing wall (See Photo 4). The firebricks were drystacked with no mortar between the bricks. The top of the firebrick wall was not level at several locations. One of the contributing factors was that the arches above the fireboxes had partially collapsed. The firebrick walls had also experienced lateral movement, but did not appear to be at risk of falling. Considering that there were no similarities between the firebrick wythe and the load bearing wythe, it was concluded that the two wythes acted independently.

Photo 4: Kiln #1- Interior firebrick wall

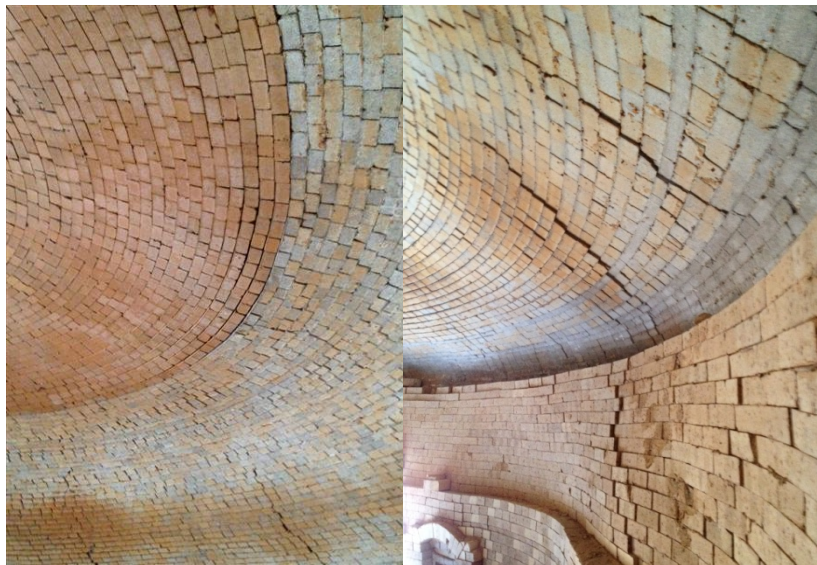
In Kiln #9 a horizontal crack was present along a portion of the dome that had deflected inwards at the base of the dome. Similarly, another horizontal crack was observed half way up the dome (See Photo 5). At location the colour of the bricks changed, which led to the conclusion that part of this dome had been rebuilt. The horizontal crack was located at the interface of the two brick types. Efflorescence was also observed at the dome/wall interface.

Photo 5: Kiln #9- Horizontal cracks half way up the dome and Deflection at the base of the dome

The observations from Kiln #6 were then applied to Kiln #9. The exterior walls of this kiln did not show indications of inward deflection. However, two potential failure mechanisms had started to form. These were at the interface of the two brick types in the roof, and at the location of inward deflection at the base of the dome. From the evidence in Kiln #6, it was clear that the bricks could slide out from the adjacent bricks if they were no longer held in compression. Considering that a horizontal crack had formed in the roof of Kiln #6 (indicating a lack of compression between the bricks) it was concluded that those bricks could also slide out and fall to the ground.

Due the number of assumptions that would be required to determine the cause of the inward deflection of the dome on Kiln #9, observations of the abandoned kilns were used to understand the potential failure mechanisms that could occur. From those observations it was determined tourists should not occupy Kiln #9 as there is potential that individual bricks could fall from the roof.

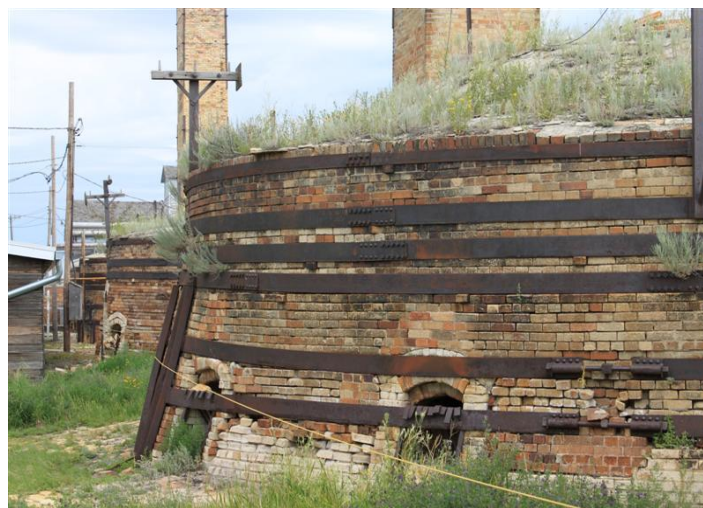
We were able to access Kiln #6 which was abandoned in 1971. This kiln was constructed the same way as Kiln #9 and displayed the most extensive deterioration of all the kilns (See Photo 6). For example, the exterior walls of the kiln had started to break apart due to eroded mortar joints and freeze thaw cycles, the steel bands on the lower portion of the wall were broken or loose, and the arches at the door appeared to be leaning inwards. The exterior parging on the dome had also become home to many native plant species.

Photo 6: Kiln #6- Exterior wall

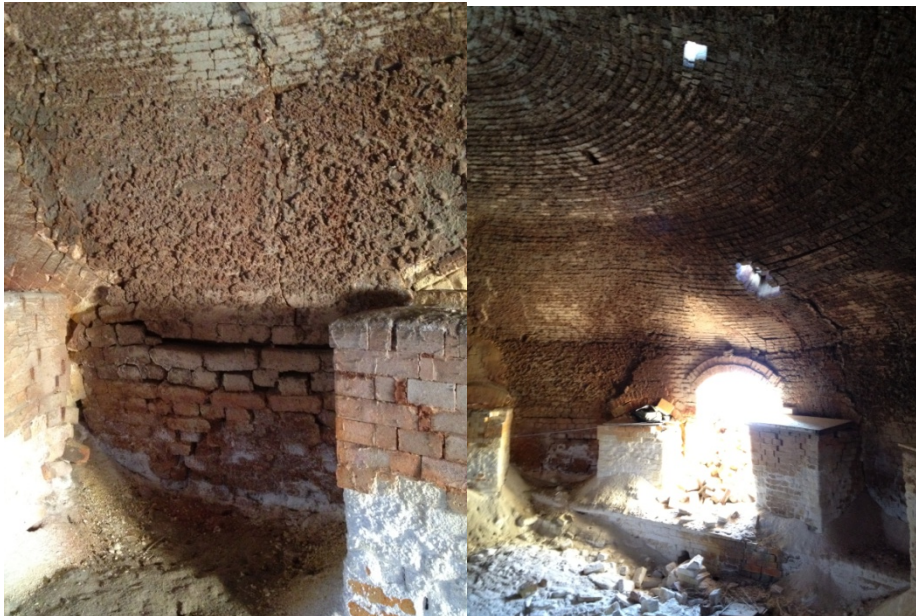
Inside the kiln, radial cracks were present in the dome along with a horizontal crack that occurred near the crown. At several localized locations around the base of the dome the bricks had also deflected inwards in a similar fashion at Kiln #9. At the worst location, bricks were no longer held in place by the compressive forces of the dome and had fallen out leaving a clear opening to the outside (See Photo 7).

Photo 7: Kiln #6- Interior deflection of the walls and dome
