Jasper, Alberta
May 31 - June 3, 1998

DETECTION AND DELINEATION OF VOIDS IN
REINFORCED AND NON-REINFORCED MASONRY

Dr. A. Rhett Whitlock, P.E., and J. Eric Peterson, P.E.
Whitlock Dalrymple Poston & Associates, Inc.
Manassas, Virginia USA

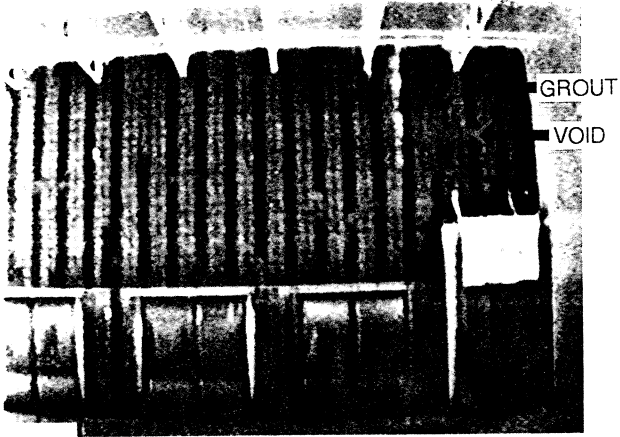
Infrared thermography is an excellent non-destructive test method for the detection of voids in masonry construction. Infrared cameras are used to detect thermal radiation and produce a visual display of surface temperature differences. Flaws such as voids or delaminations below the surface of a wall system create an air gap which affects the heat flow through the wall. Small variations in surface radiance are recorded and used to detect defects below the surface. In a reinforced masonry application, the radiant energy from the surface of a grouted cell is significantly different from that of a voided cell. These differences can be created by internal heating/cooling of the building or through solar energy gain on the exterior surfaces. Using a thermal camera to capture images on videotape, the radiant energy signature is easily observed and reviewed. Grout cells, for example, appear as vertical lines on the surface of the walls. Interruptions or staggers in these lines indicate voids or discontinuities in the grout cells. Fig. 3 shows an infrared image of a grouted wall that contains voids.

Fig. 3 — Infrared image of grouted and reinforced concrete masonry wall.

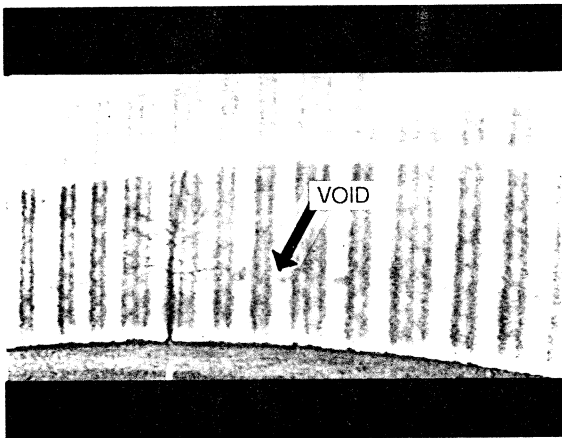
Additional testing and verification of the infrared data was provided by performing test borings in areas identified as defects. The test boring data indicated that many of the smaller voids observed using infrared were in fact caused by allowing small quantities of core insulation to fall into cells prior to the grouting operation (see Fig. 4). Other areas were simply forgotten and remained ungrouted above a certain level.

Fig. 4 — Infrared image of small voids as a result of misplaced insulation in grouted cell.

A structural analysis was then performed to determine the actual reinforcement spacing requirements to provide adequate resistance of the design forces. The infrared data was used with the results of the structural analysis to develop a quantity estimate of repairs for the buildings.

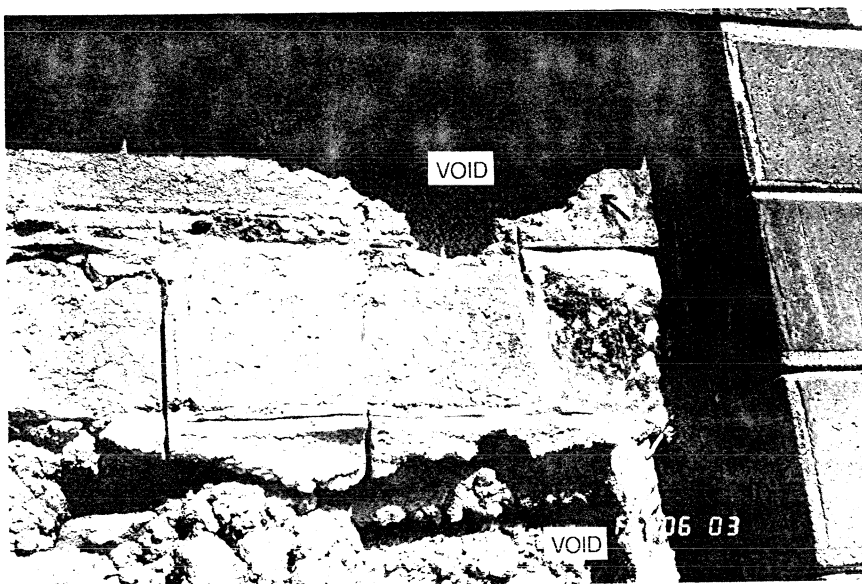
Random demolition provides exact information about the condition of the walls, but only in the area tested. This information may or may not be typical of the conditions throughout the remainder of the structure. To draw reliable conclusions regarding the condition of other locations, a statistically significant number of test areas must be opened by demolition. This procedure may provide a reasonable estimate of deficient quantities, but it will not provide guidance on the locations and is, therefore, worthless for repair purposes. The labor and material cost of performing random demolition and then repairing the test locations can be prohibitively expensive and time consuming. Additionally, if the building is occupied, the building owner may prefer a less obtrusive alternative as random demolition is noisy, unsightly and creates large quantities of dust. In other cases, access to reinforced masonry may be restricted by interior walls, drop ceilings, or other exterior finishes and structures. Fig. 1 shows an example of an exploratory opening in a composite brick and concrete masonry wall.

Fig. 1 — Exploratory opening in a composite brick and concrete masonry wall containing voids in the grouted collar joint.

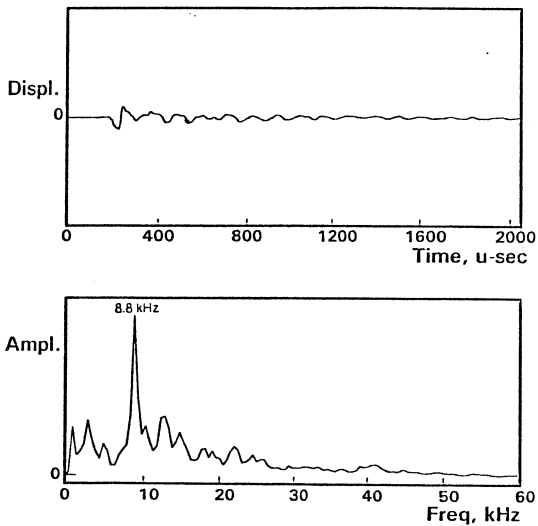
Fig. 5 — Typical solid masonry block response.

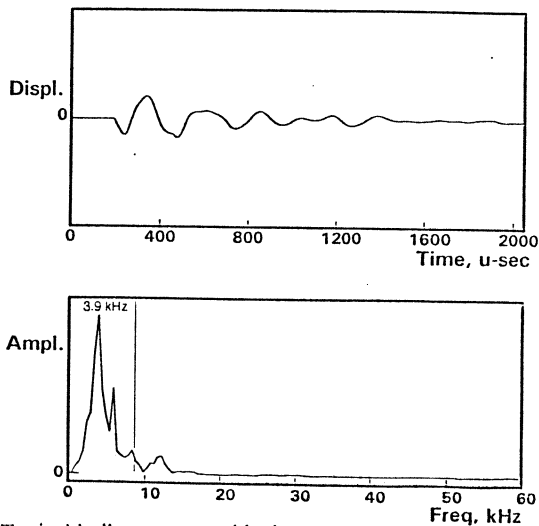
Fig. 6 — Typical hollow masonry block response.

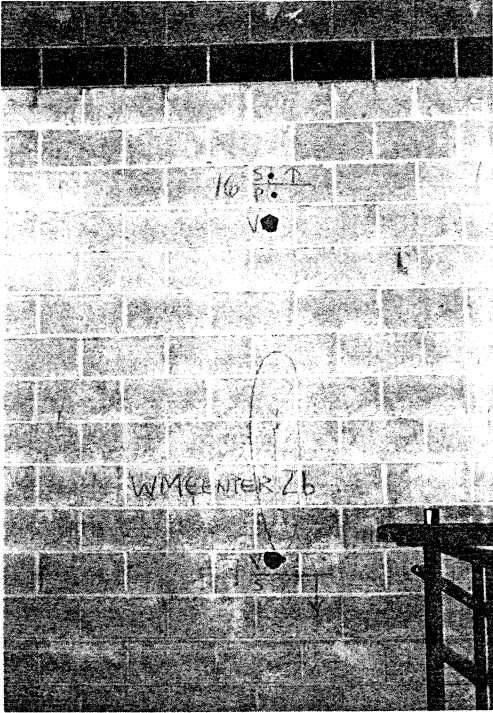
Infrared thermography again was employed to identify grout voids in the masonry cells. Because the buildings were not occupied at the time of testing, testing of the walls was performed using principles of transient solar loading. Areas of grouted masonry provided a heat sink which gained and lost heat slower than the voided areas. Unfortunately, many areas of the building walls were obstructed by exterior appurtenances and column pilasters. Therefore, impact-echo was used as an alternate method in these areas. Because the exterior walls were constructed of split-faced units, impact-echo testing was performed on the interior side. Tests were performed on successive blocks in areas known to be voided and known to be solid grouted to check the effectiveness. Signals observed in areas of well consolidated grout could be identified by large frequency peaks corresponding with the approximate thickness of the wall (see Fig. 5). Areas which contained no grout behaved as a thin plate vibrating flexurally providing dominant low frequency peaks which would normally be identified as signals corresponding to depths much more than the actual thickness of the walls (see Fig. 6). The two very different signals made locating and delineating the voids relatively easy. Test borings in these locations verified the results of the impact-echo data (see Fig. 7).

Fig. 7 — Verification of impact-echo testing.

As before, this information was compiled and used in combination with a structural analysis to develop repair procedures and quantities.
