TERRA COTTA INSTALLATION: THE EVOLUTION AND DEVELOPMENT OF ANCHORAGE SYSTEMS

M.E. Novesky¹ and E.A. Gerns²

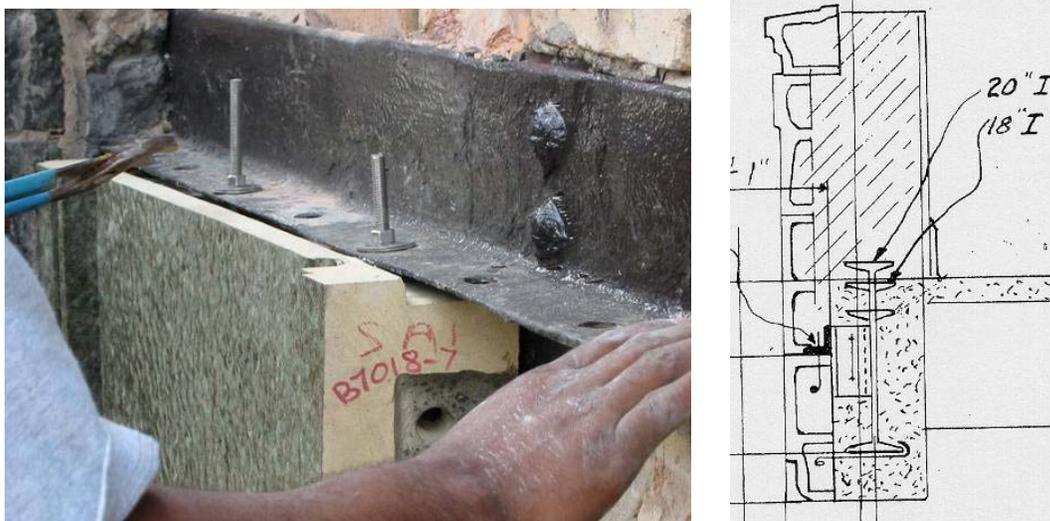
Figure 2 - Installation of new hung terra cotta units (left), original detail of spandrel section

Often the extent of deterioration of the supporting steel components and the resulting terra cotta distress necessitates reconstructing portions of the facade. At several shelf angle locations, the corrosion of the embedded steel necessitated the replacement of the supporting steel and repair or replacement of the damaged terra cotta units. The expense of fabricating new terra pieces, particularly unique pieces, as well as a general philosophy of maintaining existing fabric as much as possible, resulted in the development of various techniques of repairing and reinstalling existing terra cotta. The use of epoxy and various pinning techniques were successfully employed for pieces that were installed in a bearing condition. Relying on the epoxy bond, even when supplemented with pins, is generally not advisable for hung pieces because of the lack of redundancy in the system. Due to the significant cost of reconstruction, all accessible existing lateral anchorage was replaced with new stainless steel components and all readily accessible portions of the supporting steel were treated, replaced or reinforced as necessary (see Figure 2).

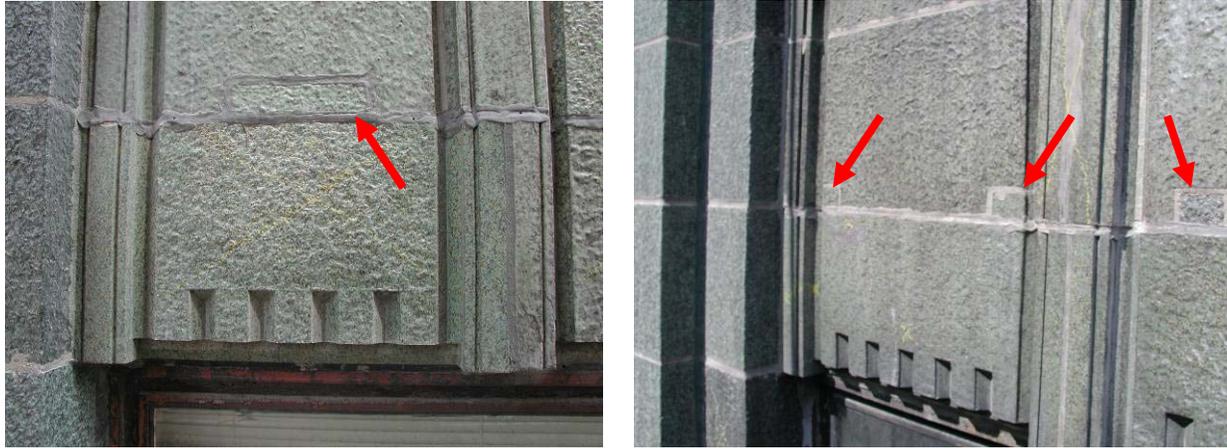
A previous replacement scheme for hung lintel units had been employed prior to WJE's involvement which was an effective economical approach to replacing distressed units, but it did not address the underlying cause of the distress. It is speculated that the previous repairs attempted to limit the removal of terra cotta units above the support shelf angle by cutting out

small pieces at the bottom of the terra cotta units above the shelf angle to access the J-hooks, see Figure 3. Once the new anchor was installed to support the designated unit, a terra cotta dutchman (a partial replacement of the unit) was installed in the openings. While economical, this approach did not address the underlying support steel.

Figure 3 - Previous lintel repairs by others which do not address the supporting steel

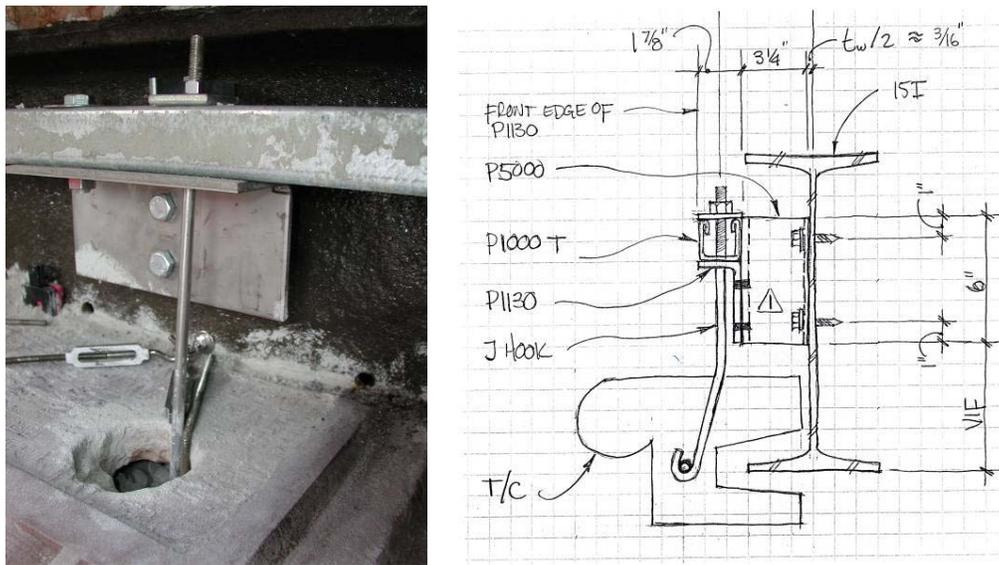
Figure 4 - Hung lintel installation system

Three courses of terra cotta had to be removed, damaged units replaced and original pieces reinstalled at the head of the 16th floor windows including a course of hung lintel units and a course of flat ashlar units. A system was developed that employed proprietary Unistrut members in various configurations. Sections of Unistrut were bolted to the existing steel members or to the new back-up wall. Anchorage for the hung terra cotta window heads consisted of stainless steel bent plates that were bolted to the web of the existing steel floor beam. On top of the horizontal leg of the angles, a continuous stainless steel Unistrut was installed to support the terra cotta units. Horizontal threaded support rods were installed through the full width of the terra cotta window head units as shown in Figure 4. The horizontal support rod was secured in each unit with nuts and washers on the outside face of the outside webs of the units to prevent the rods from moving or slipping out during installation. Once the horizontal support rod was installed,

the unit was captured by the J-hooks (with threaded upper portions) which were suspended from the Unistrut above. The J-hooks extended through a hole in the underside of the Unistrut, through a hole in a stainless steel plate placed on top of the Unistrut, and was suspended from the Unistrut by a bearing nut and washer on top of the plate. Once the unit was in place, vertical adjustments were made by turning the nut above the Unistrut. Lateral support of the hung units was accomplished by hooking bent threaded rods in the hole on the top of the terra cotta unit and back to the existing steel beam. To accomplish a tight fit a "U" shaped bent threaded rod was installed in the top hole of the terra cotta unit and a separate thread rod was hooked to an I-bolt which was anchored into the steel beam. To adjust the two threaded rods, a turnbuckle was used to secure the units in place.

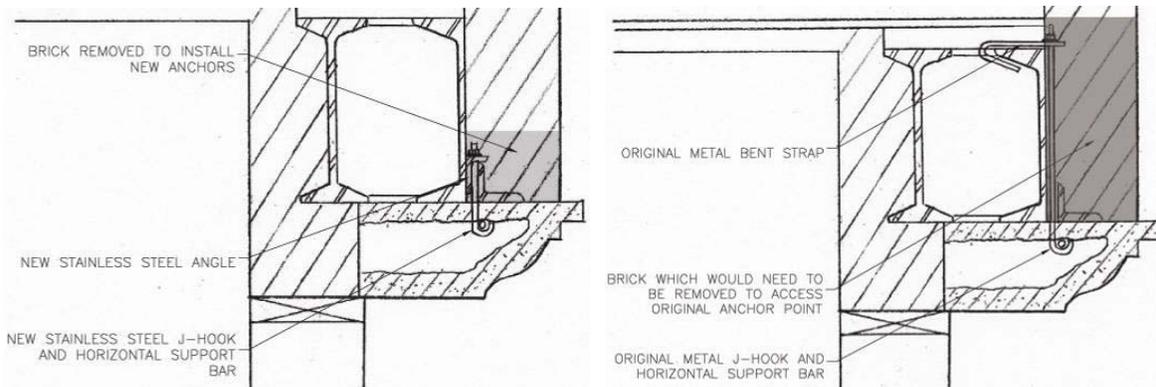
Figure 5 - Comparison of extent of brick removal for alternative assembly

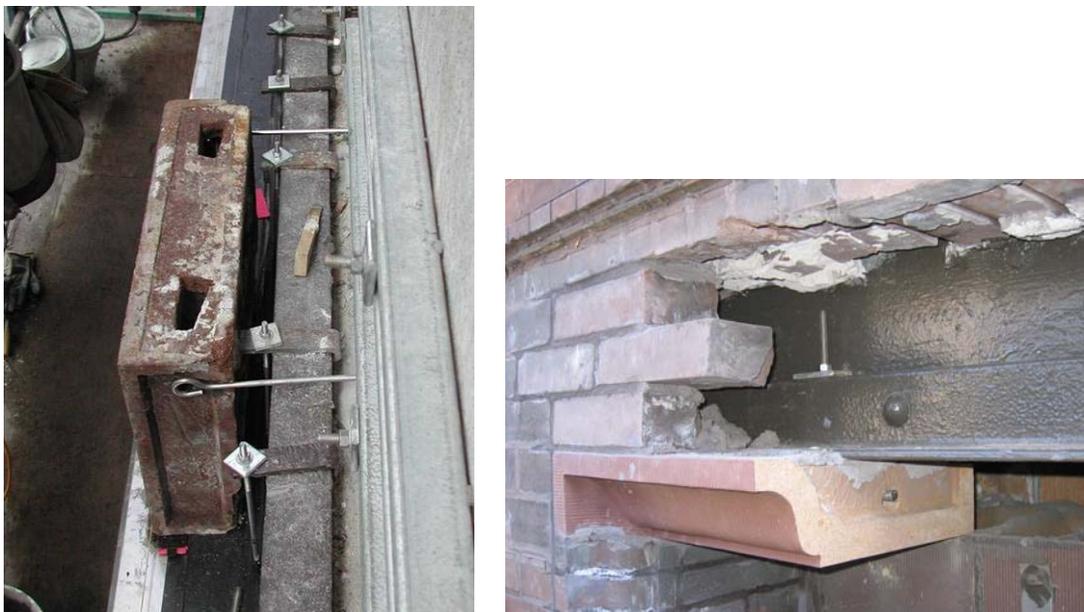
Figure 6 - Terra cotta installation anchorage, a) ashlar units and b) hung lintel

The flat ashlar coursing above the windows was installed by anchoring into the new backup wall at the 17th floor. Hooked rods were installed at the locations of the head joints between the two adjacent units and were epoxied into the backup wall. A pull pin was installed into the side web of two adjacent ashlar units and through the hooked rod (see Figure 6A).

Another terra cotta anchorage configuration had to be developed for typical window lintel replacements. The typical bays were constructed with face brick and decorative terra cotta units around window perimeters; sill, jamb and head units. The structural system at each floor level consists of (from the interior to the exterior) an I-beam, channel (toes facing towards the interior), and an angle attached to the channel with the horizontal leg level with the bottom of the channel. The angle was riveted to the channel with a spacer between the angle and the channel to allow hanger bars to pass through the assembly. The window heads were hung from J-hooks which were connected to a bent steel strap that was hooked over the top of the channel around the flange. The J-hooks originally extended through the gap between the channel and angle, to the horizontal bar which supported the terra cotta units. When these head units were removed, installation of new anchors in the original configuration would have required removal of nine courses of the brick in the spandrel area to access the top of the steel channel. An alternative system was employed, which required removing only two courses of brick to access the top of the angle, see Figure 5 (left). A stainless steel angle, sized to fit into the gap between the angle and the channel was installed such that the vertical leg extended into the gap and the horizontal leg rested directly on the top toe of the existing angle, see Figure 5 (left) and Figure 6b. The new threaded stainless steel J-hooks were installed through the horizontal portion of the stainless steel angle and adjusted with a stainless steel nut and washer.

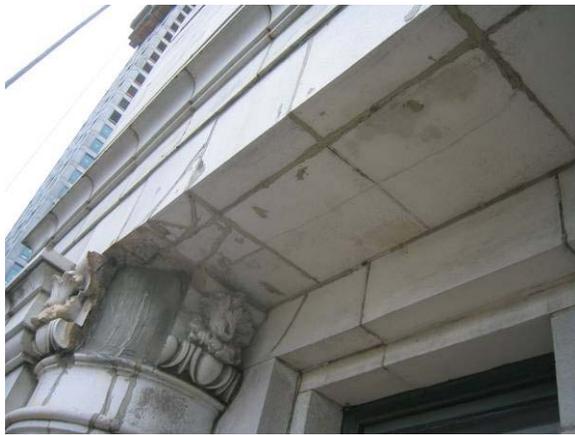
The cracks in the soffit units were caused by corrosion of the supporting J-hooks and the horizontal support rods that typically extended through the full width of the units. The structural framing members were found to be in serviceable condition with only minor surface corrosion. During the removal of the distressed soffit panels, it was revealed that the 12th floor soffit units were supported with different anchorage systems at the two different building sections. Soffits in one area could be reinstalled effectively re-established the original anchorage design with the exception of incorporating stainless steel anchorage rather than carbon steel. The existing holes in the horizontal flange of the built-up I-beam could be reused to install the new stainless steel J-hooks following painting of the original steel.

Figure 7 - Typical cracked terra cotta soffit units (left), new hung soffit detail (right)
