INNOVATIVE OPTIONS FOR MASONRY REPAIR

A.J. Deveau, P.Eng., M.A.Sc.¹, and M. Van Dusen, P.Eng., M.Eng.²

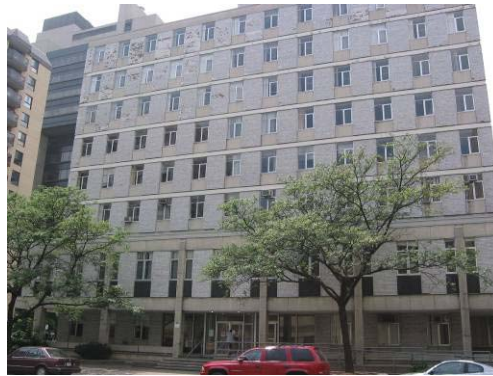
Figure 1 – East Elevation; Extensive Spalling Of Glazed Bricks

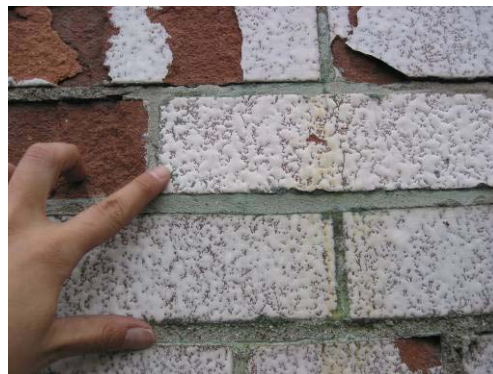
Figure 2 – Close-Up of Glazed Brick Spalls

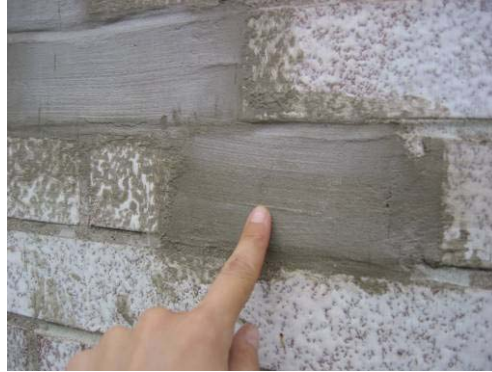
Figure 3 – ‘Parge’ Repair of Spalled Brick

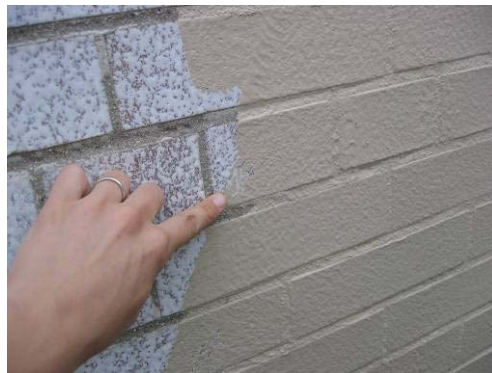
Figure 4 – Application of Elastomeric Silicone Coating

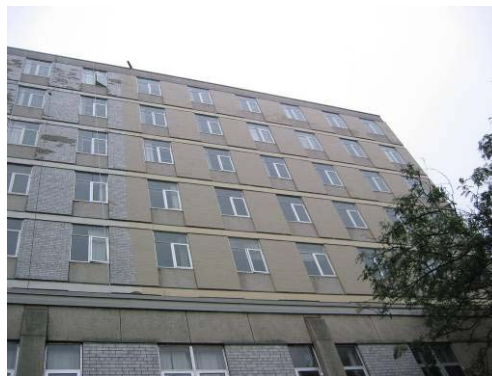
Figure 5 – Work Proceeding on West Elevation

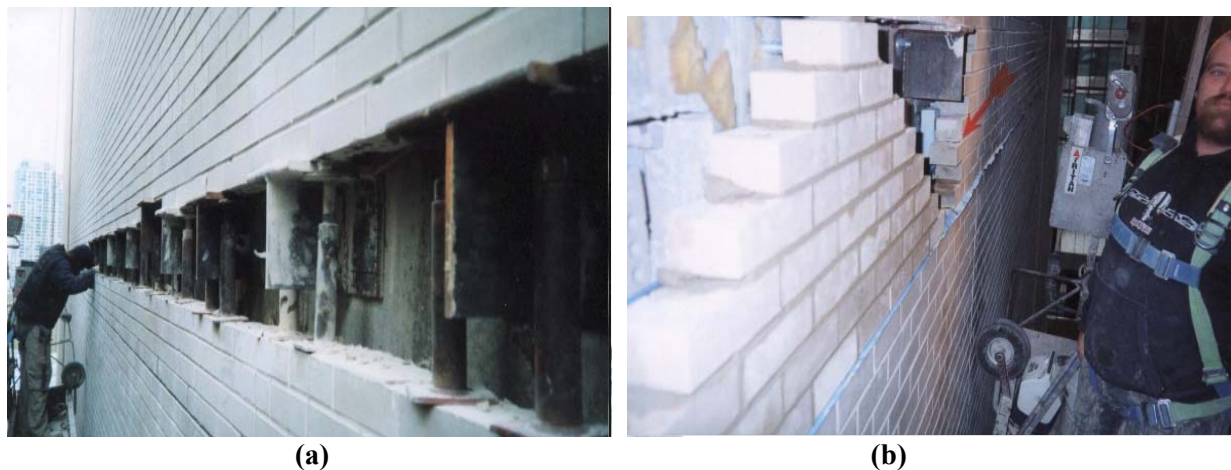
Figure 6 – (a) Temporary Masonry Post Shores in Place while the Inverted Angle Brackets are being Installed; (b) Masonry Being Reinstalled in Sections After the New Shelf Angle has been Installed

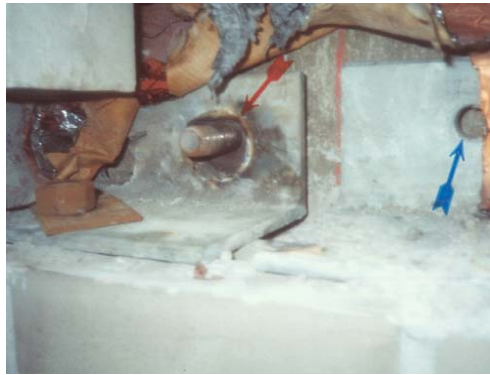
Figure 7 – Shelf Angle Deficiencies Include Missing Anchor (Blue Arrow), Oversize Burnt Hole (Red Arrow), and Lack of Soft Joint Below Angle.

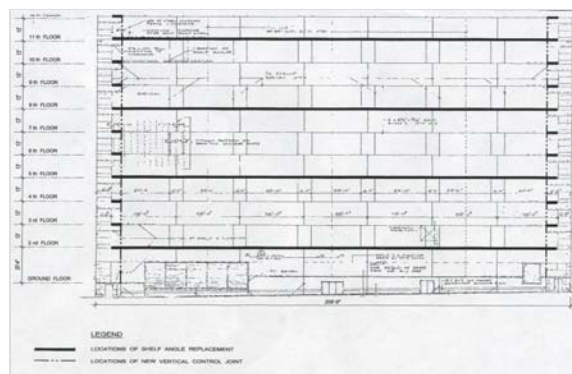
Figure 8 – East Elevation – Heavy Lines Indicate New Shelf Angles to be Installed On Every 3rd Floor (in lieu of every floor as originally installed)

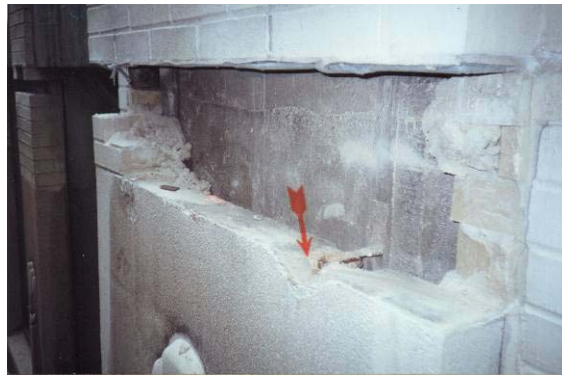
Figure 9 – Typical Spall (red arrow) at Corroding Lateral Stone Connection (brick has been removed from above stone).

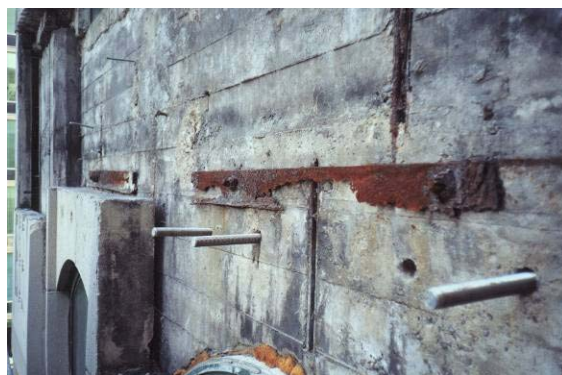
Figure 10 – 15th floor stones removed. 3 previous retrofit anchors and an extremely corroded original shelf angle shown.

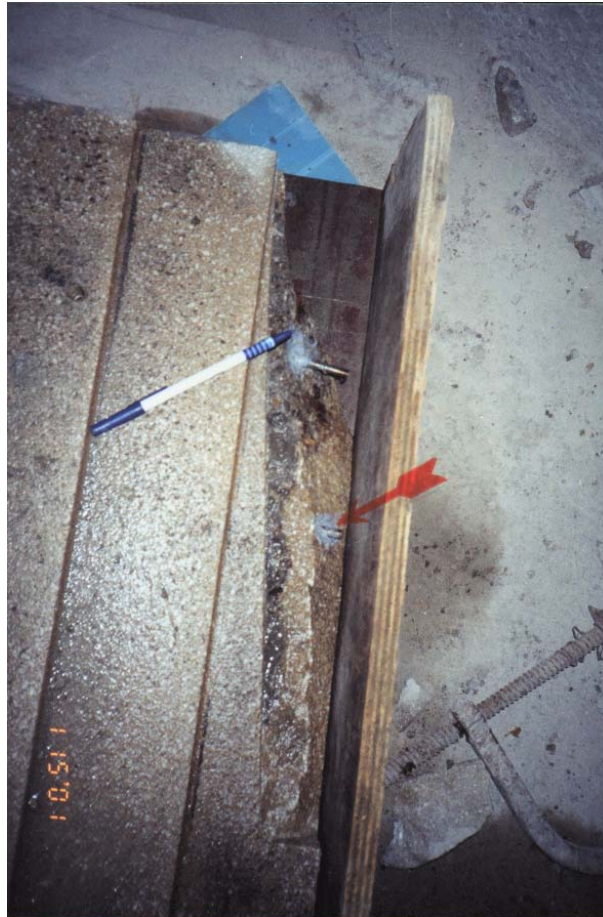
Figure 11 – Cracked Stone (cracked portion removed). New stainless steel dowels installed to ‘stitch’ the cracked portion back to the stone with epoxy adhesive.

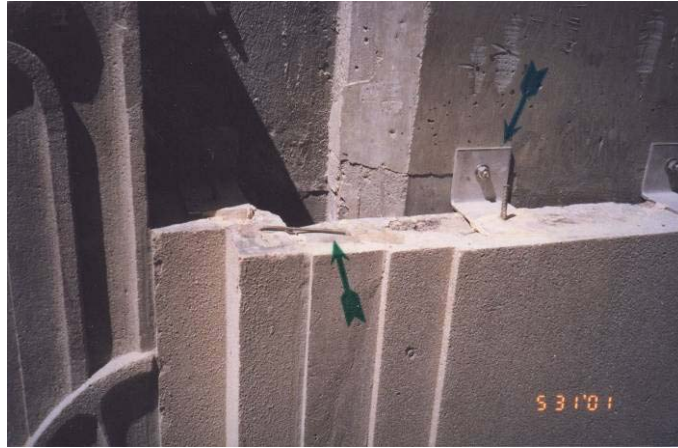
Figure 12 – Reinstalled Stone with New Stainless Steel Supports
