**INVESTIGATION PROCEDURES BASED ON THE
COMPLEMENTARITY OF NON-DESTRUCTIVE AND SLIGHTLY
DESTRUCTIVE ON SITE TESTS: APPLICATION TO THE TWO
CASTLES OF AVIO (ITALY) AND PISECE (SLOVENIA)**

L. Binda¹, L. Cantini², M. Lualdi², C. Tedeschi³, A. Saisi³ and L. Zanzi⁴

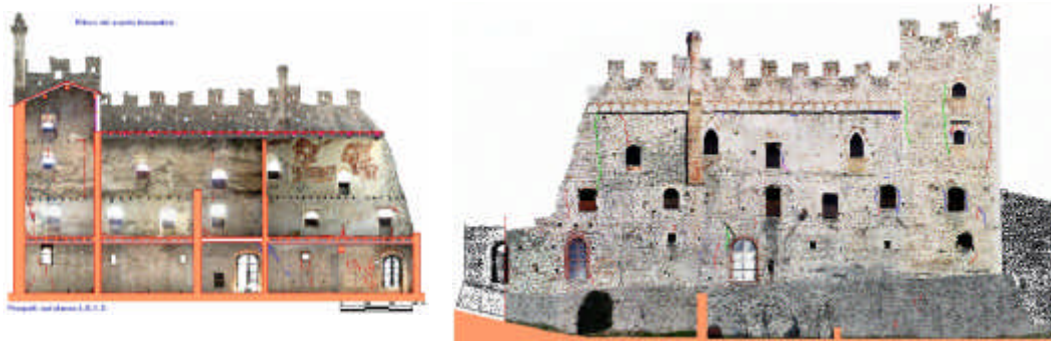
Figure 2 - Avio Castle Crack pattern survey of the South wall

The most damaged among the structures of the Avio Castle is the Tower of the Palace. The cracks are close to the corners (Figs. 2, 5), and around the keystones of the upper arch windows. This could reveal the lack of connection of the outside walls, particularly in the upper part of the Tower where the timber floors are missing. Furthermore, cracks repaired with a dark grey mortar are visible, showing the long term existence of structural problems.

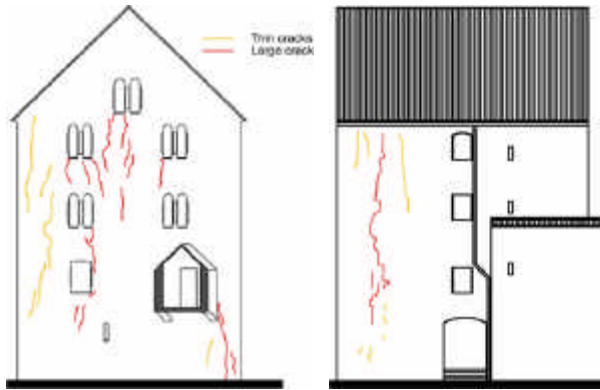
Figure 3 - Pisece Castle. Crack pattern survey of the Tower in the South and East side

The castles have similar problems from the point of view of the structural characterisation of the stonework masonry. Extended crack patterns are visible on the main walls of the towers and many rooms are characterised by remarkable vertical cracks crossing the wall section (Fig. 2, 3). The crack-pattern survey and classification together with a mapping of the discontinuities and of the masonry textures was carried out in order to have an important evaluation of the existing structural state of the building.

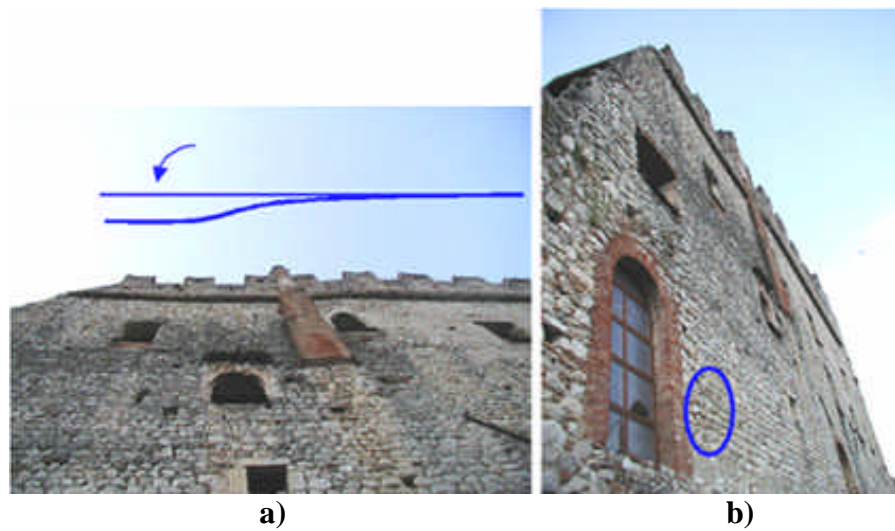
Figure 6 - Avio Castle. Deformation of the South facade toward the valley

A significant deformation of the western upper corner in the south wall (Fig. 6a) is visible. This deflection does not produce wide cracks and could date back to the collapse of the closer Tower at the end of the XIXth century, when the corner did not have any covering and bond.

Fig. 6b shows that the outside wall is out of plumb with stone expulsion, which produces a crack pattern in the internal room. The cracks have similar slope.

The wall of the Avio Castle at the basement level (Fig. 6), shows an evident out of plumb and some cracks which are monitored. Due to the large deformation, it was important to inspect the internal characteristic. Radar tests were carried out on parallel profiles in order to reconstruct the internal morphology. The radar inspection showed less compact materials in several areas (Fig. 15) that could be interpreted as local detachments of the two leaves of the masonry (Fig. 16). Fig. 16 shows the reconstruction of the radar profiles, enhancing the targets in a sequence of depth slices. Several voids are readable in the radargrams corresponding to the leaf interfaces. This conclusion was confirmed also by direct visual inspection. The material found is very poor with weak or even locally missing mortar (Fig. 17).

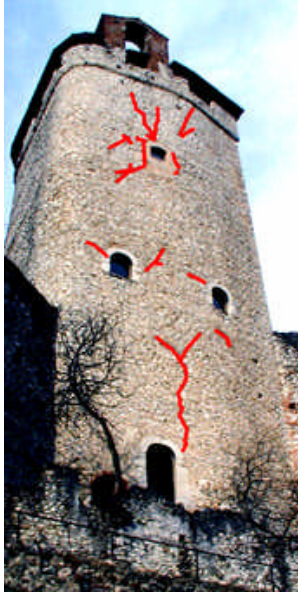
Figure 7 – Avio Castle. Crack pattern of the Mastio

Another significant crack pattern is easily visible on the Mastio Tower (the oldest and tallest one), at the moment not yet monitored (Fig. 7).

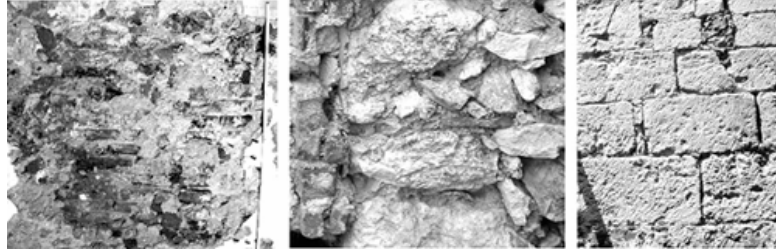
Figure 8 – Pisece Castle. Masonry typologies: irregular stones and regular bricks (POS1), irregular (POS4) and regular in stone (TOW3)

The Castle of Pisece seems to be characterised by 3 different masonry typologies, as reported in Fig. 8, irregular stones and regular bricks, irregular and regular in stone. The tests carried out have also shown that the real characteristic of the walls can also be detected from the knowledge of their section.

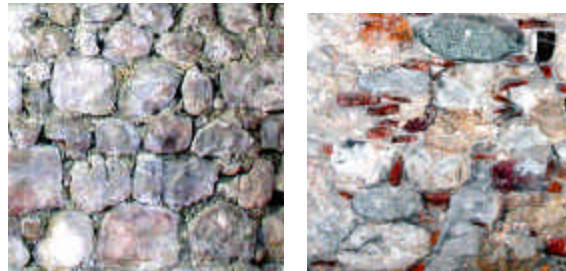
Figure 9 – Avio Castle. Masonry typologies of the external walls and of partition walls

Fig. 9 shows the main masonry typologies of the Avio Castle. Three main masonry typologies can be distinguished: the external walls, most ancient, and the internal partition walls, in general not connected to the previous ones. The presence of cracks, in fact, stresses the discontinuity. The third masonry typology is the one of the Mastio.

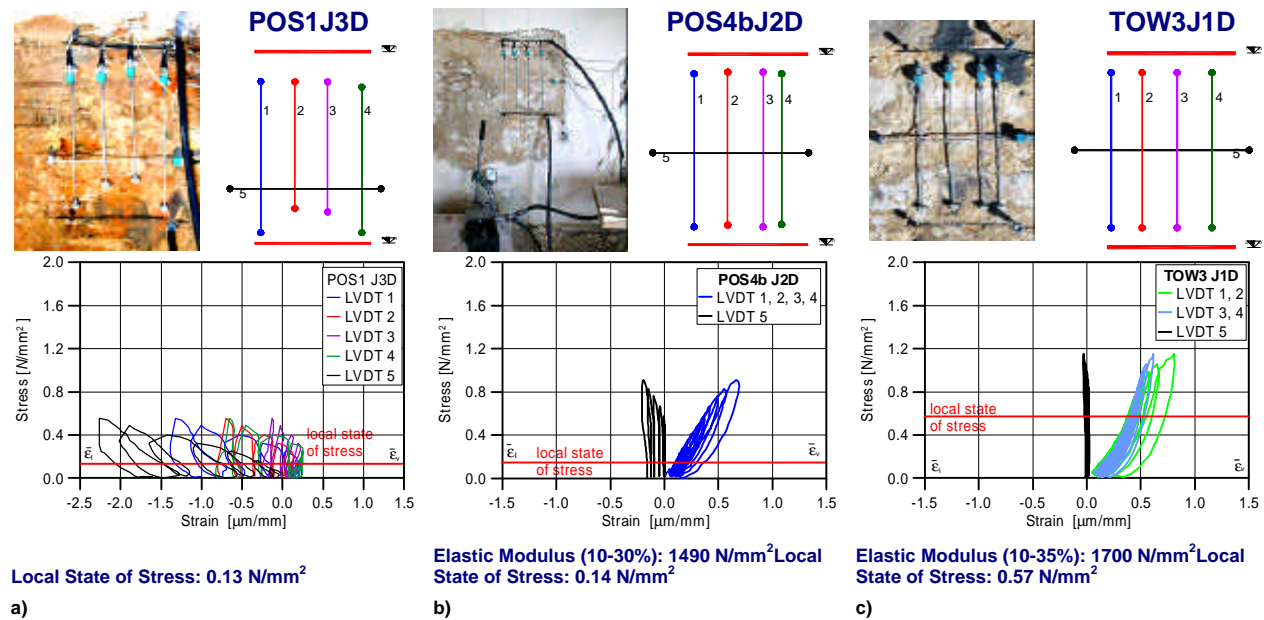
the wall characteristic that revealed the presence of a wide void, a fireplace, enclosed by a thin brick wall. The measured vertical elongation is due to the instability of the thin wall produced by the compression. The measured vertical elongation is due to the instability of the thin wall produced by the compression.

Figure 10 – Pisece Castle. Mechanic characterisation of the masonries typologies by double flat jack. The picture shows the stress-strain curves, the local states of stress, the tested masonry texture and the acquisition geometry and position. In POS1J3D the strain gauges measured vertical elongation due to the thin wall instability produced by the compression.

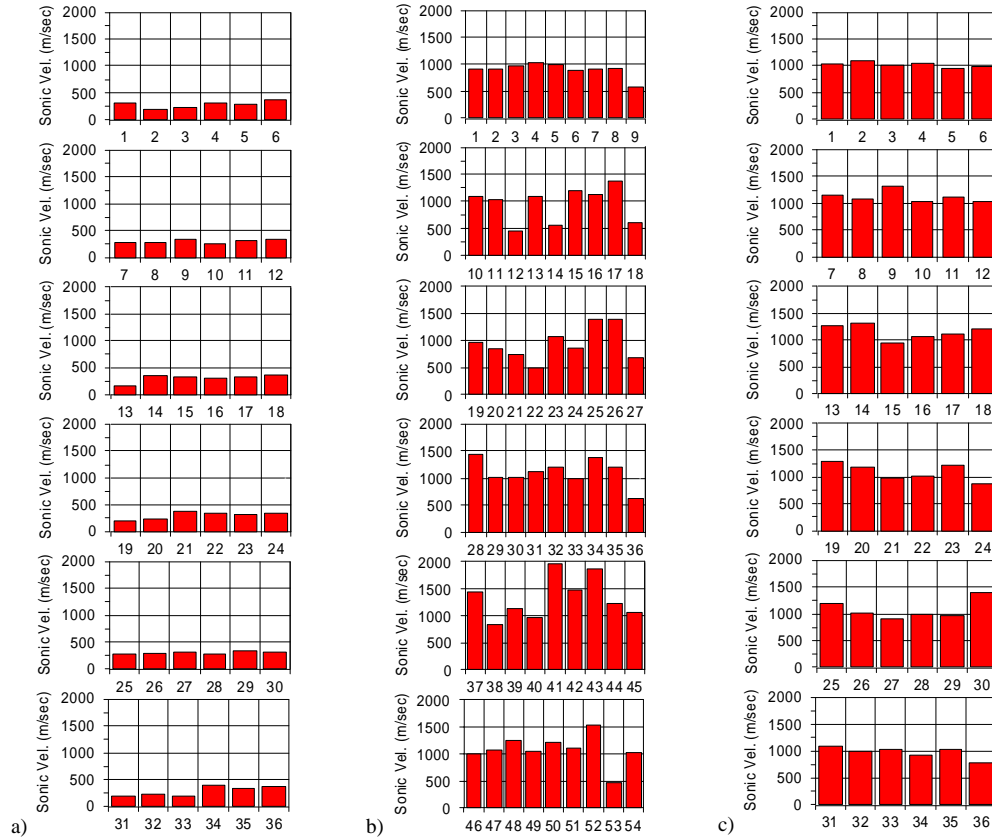
The unknown masonry morphology affected the results. Sonic tests, in fact, revealed the presence of a cavity behind the tested area. This is very clear considering the low sonic velocity measured (Fig. 11). The videoboroscopy inspection of Fig. 12 confirms this observation, revealing the presence of a real fireplace. The superficial brick masonry texture appears irregular. Figs. 10 and 13 show the results of the single and double flat jack tests, respectively, on the Pisece and Avio Castle. The tests allow classification of the masonry quality.

Figure 11 – Pisece Castle. Characterisation of the masonry typologies by sonic tests. The histograms show the pulse sonic velocities acquired by transmission in different points at 6 levels. The low values Fig. 11a could indicate the presence of a cavity.

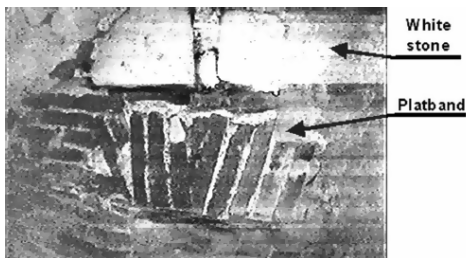
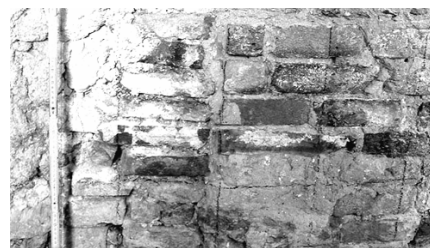
Figure 12 – Pisece Castle. Videoboroscopes and detail of the masonry in the position POS1

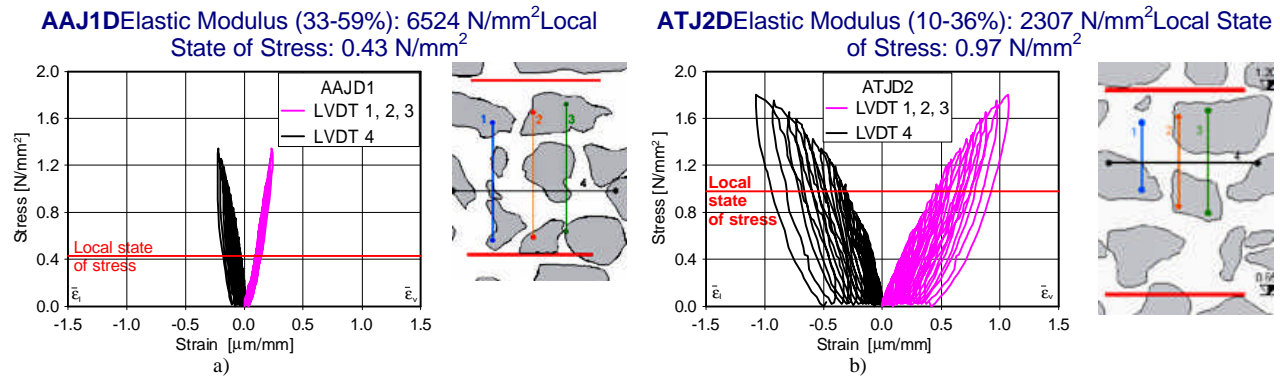
Figure 13 – Avio Castle. Mechanic characterisation of the masonries typologies by double flat jack. The picture shows the stress-strain curves, the local states of stress, the masonry texture in the tested area and the instrumentation geometry and position. The ATJ2D result shows a more deformable masonry and an higher state of stress then AAJ1D area.

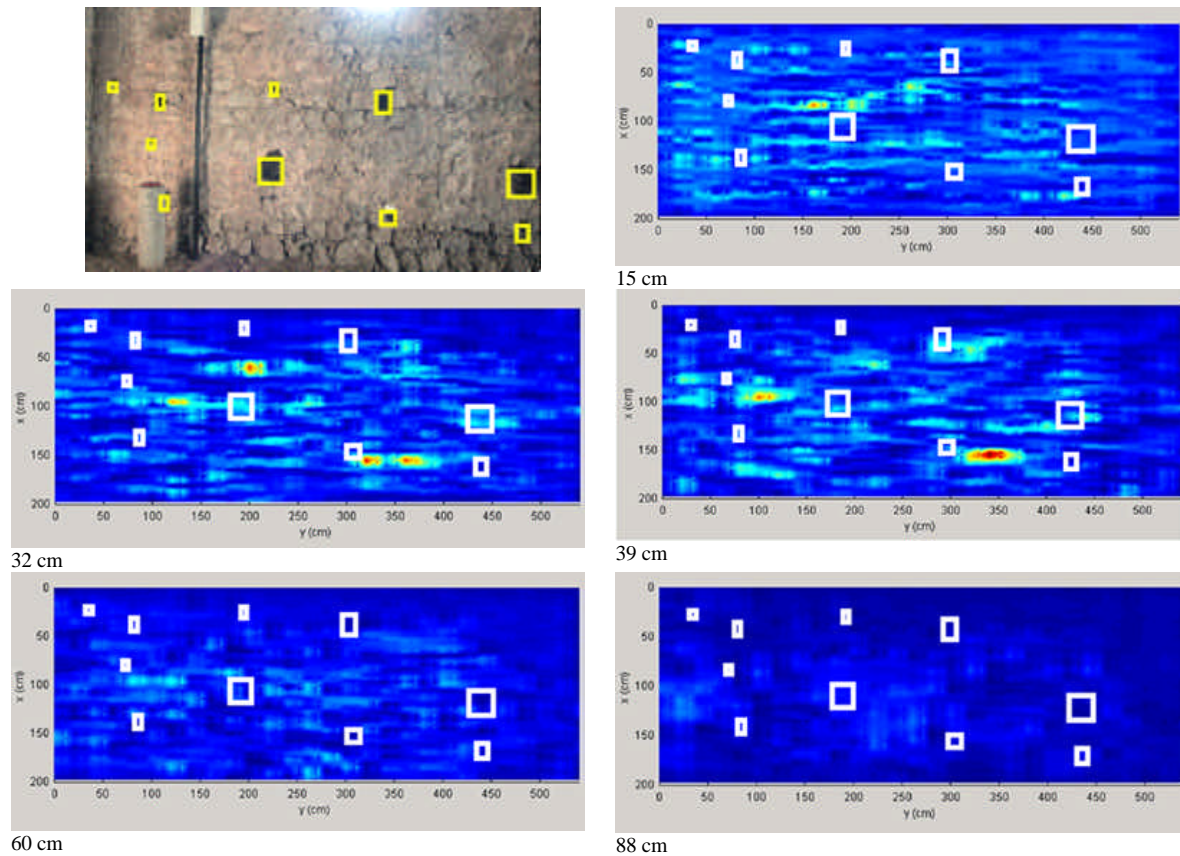
Figure 16 – Reconstruction of the radargrams respectively at the depth of: 15, 32, 39, 60, 88 cm. The elaboration enhances the presence of internal voids (red spots). White boxes identify the positions of surface cavities and missing stones

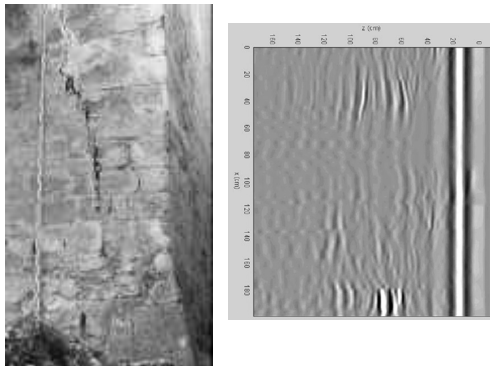
distance from the corner of 70 cm. The inspection was carried out in order to verify if radar was able to detect the presence and the depth of the wide cracks visible on the corner (Fig. 19).

The acquisition geometry has great importance on the effectiveness of the test for this type of application. In fact, the possibility of surveying the wall from a surface that is nearly parallel to the cracks is essential. Fig. 19 shows the processed radar profile rotated vertically to facilitate the correlation with the adjacent picture of the side of the tower while Fig. 20 presents the interpretation of the main reflections and diffractions apparently associated with three main cracks running at three different depths from the surface.

Figure 19 - Cracks as observed on the adjacent wall and processed radar section

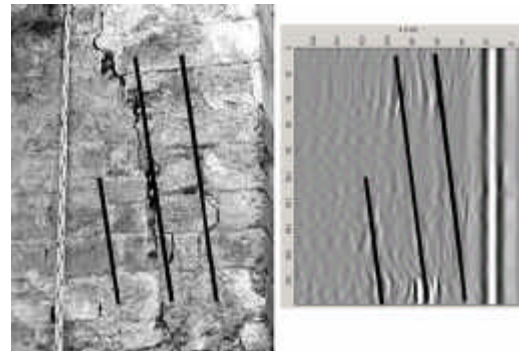
Figure 20 - Interpretation of the vertical radar profile. A system of three main cracks seems to be detected by the radar profile at increasing depth from the surface

These results show that radar profiles can detect the position and the depth of cracks when they are in corners of towers and massive buildings.
