THE SUANKULARB COLLEGE, BANGKOK, THAILAND – A CASE STUDY OF THE RESTORATION OF A LATE 19TH CENTURY THAI SCHOOL BUILDING

K. Roachanakanan¹ and A.B. Nichols²

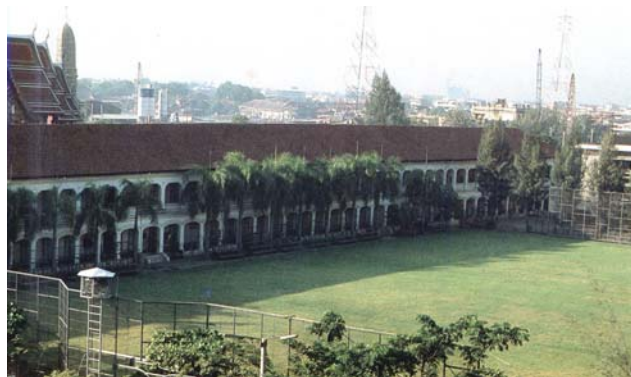
Figure 2 - Suankularb Building before Renovation

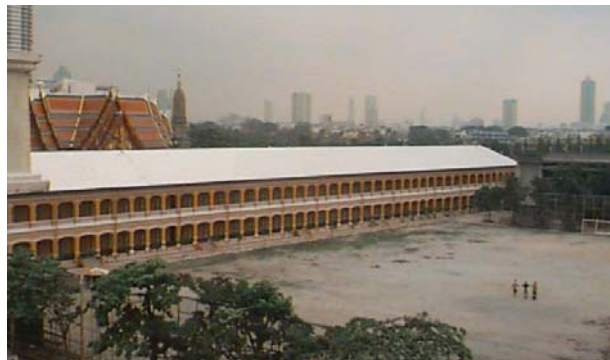
Figure 3 - Suankularb Building after Renovation

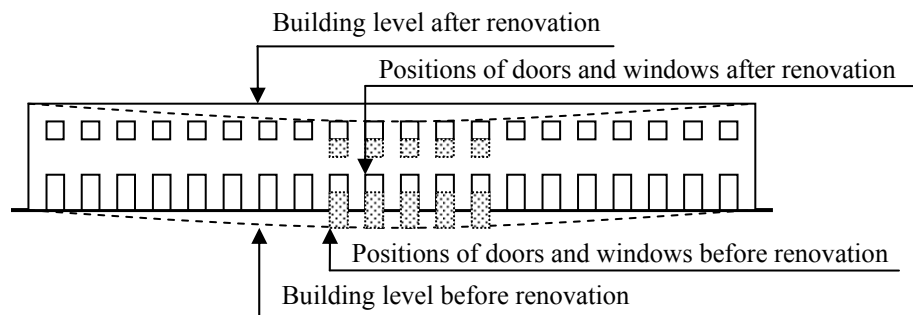
The design team from the Department of Fine Art relied on a condition survey and building measurement survey to select the appropriate solutions for the problems of the building [2]. Since the design team needed to stabilize the entire building structure and protect the building from further settlement due to the deteriorated original foundation, they decided to reinforce the entire structure and build a new foundation to support the building. Figure 4 illustrates the building settlement and restoration levels. Because the soft soil could not support the building, micro-piles were used to support the new foundation and reinforced beams adjacent to the footing wall were used to stabilize the entire building structure. These micro-piles transferred the load of the building to a deeper soil layer strong enough to support the building weight. Concrete columns placed in the middle of the walls were used to stabilize the deteriorated masonry walls. The masonry columns in the arched corridor were repaired by repointing and replacing the existing plaster with new plaster. These columns were not reinforced. However, the columns that were severely deteriorated were repaired using reinforced concrete (Figure 5).

Figure 4 – Building Settlement

The existing roof was found to need repair and replacement (Figure 6). The design team proposed to replace the existing cement tiles with light-weight cement tiles. The new roof tiles were selected to replicate the original roof appearance, although the tile was smaller and lighter. The exterior and interior walls were repainted as the original scheme indicated in the archives of the Department of Fine Art [2]. To address the settlement of the building, the height of the wall was increased instead of lifting the entire 200 metre-long structure (Figure 4).

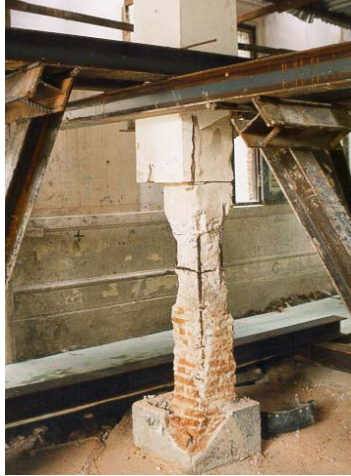
Figure 5 - Reinforced Column

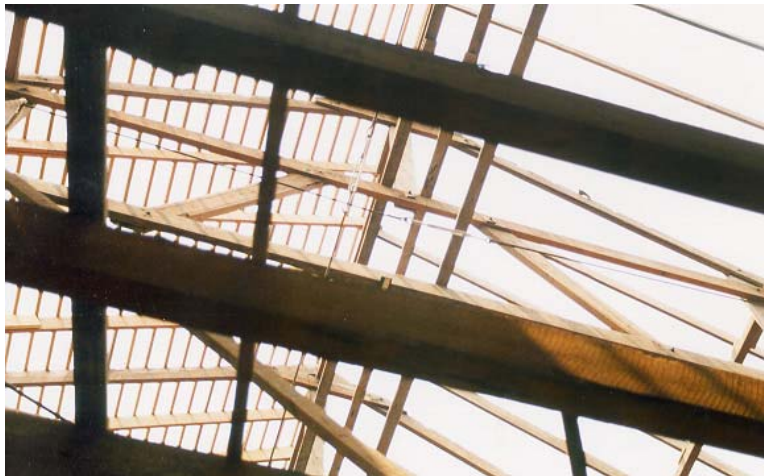
Figure 6 - Roof under Construction

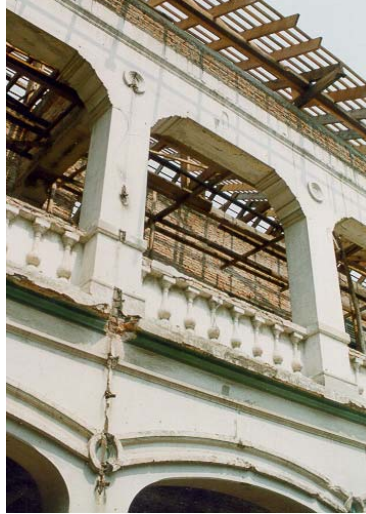
Figure 7 -Existing Arches and Moldings

As indicated in the condition survey, the entire building structure was vulnerable to collapse and in bad shape due to many cracks in the walls and columns (Figure 7). The contractor had to temporarily stabilize the entire building structure for the safety of the workers by using scaffolding and steel cables. The reinforcement of the walls with new concrete columns was used to permanently stabilize the entire building [5]. This prevented the walls from collapse while the reinforcement of foundation was being performed. After the existing floor was removed to repair and replace the deteriorated materials, the floor was reinstalled at the higher level as indicated by the architects. This increased the floors on the first and second floors 45 cm (18 in.) higher. Because of the increase to the floor levels, all windows and doors on both floors had to be removed and the lower levels of arches and thresholds on both floors also had to be increased. In order to elevate the windows and doors, the contractor added a few courses of bricks to the existing walls. This increased the height of windows and door sills approximately 30-40 cm (Figure 4).

In addition to the damage to the walls and additional weight from the previous roof renovation, moisture from underground water (rising damp) contributed to deterioration of the existing walls and columns. The deteriorated columns of the arched corridor (Figure 7) were repaired by replacing the damaged plaster which had been affected by moisture from rain. The walls had

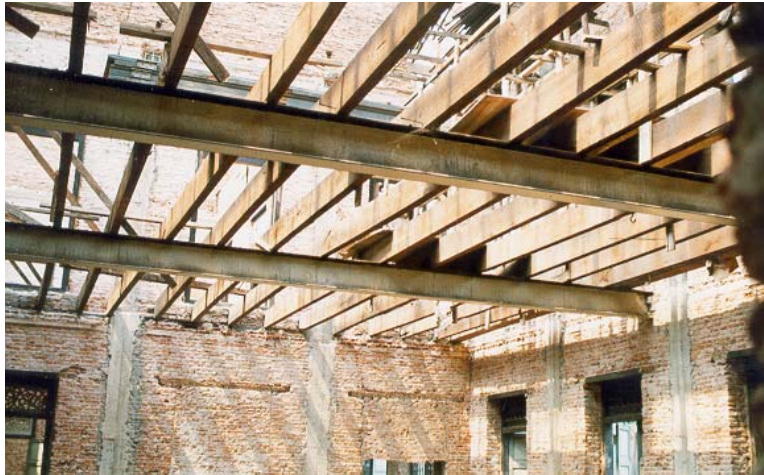
Figure 8 - Original Structure of Second Floor

The construction began with demolition of the interior. Many pieces of timber on the second floor were removed and salvaged to reduce the amount of new timber needed because timber 7.50 by 10.50 cm (roughly 3 by 4 in.) was hard to find locally. Figure 8 illustrates the original structure supporting the second floor and new reinforced concrete columns in the masonry walls. The terrazzo floor on the first level was removed and replaced with wood flooring which was the original material. When the first and second floors were removed, the foundation was exposed. The soil was excavated in order to drive reinforced concrete micro-piles around the building perimeter. The contractor placed about 400 25-metre micro-piles to support the building structure. These piles were put every 1.20 metres along both sides of the existing foundation of unreinforced concrete grade beams. New reinforced concrete ground beams were cast on top of the micro-piles to stabilize the existing foundation. Figure 9 shows placement of the micro-piles, indicated by the vertical reinforcement. In Figure 9, the new concrete ground beams cannot be seen due to the formwork at the lower left of the figure. When the new concrete ground beams reached sufficient strength, the existing foundation was cut by drilling cores to allow the workers to insert steel girders into the gaps in the foundation. The cut holes, steel beams, and cores are shown to the left in Figure 9. This effectively separated the existing foundation, transferring the

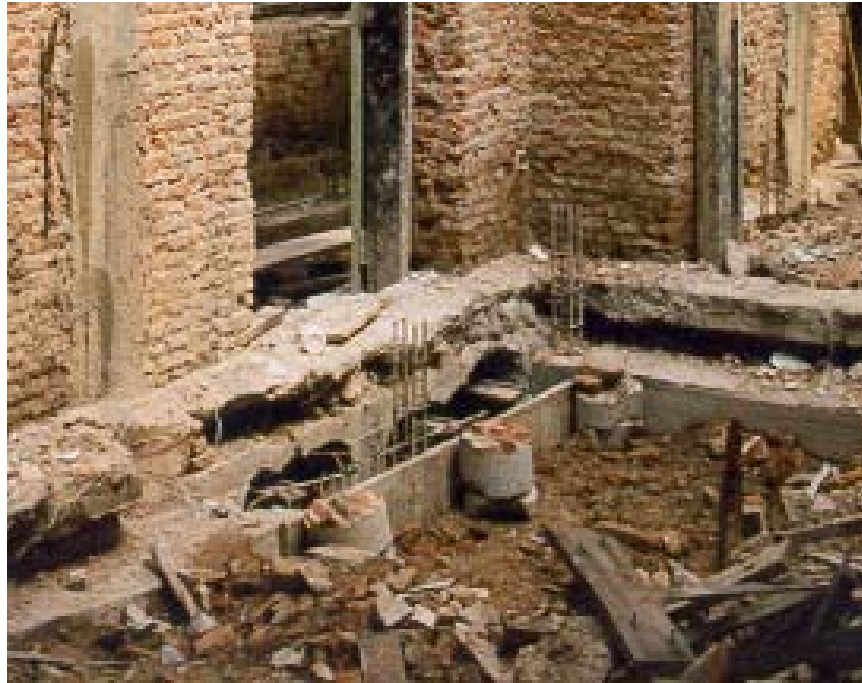
Figure 9 - Micro-piles, New Ground Beams, and Coring of Existing Grade Beam

building loads to the steel girders supported by the new concrete ground beams on the micro-piles. Reinforced concrete beams were cast above the steel girders on both sides of the existing footing as shown to the right in Figure 9.

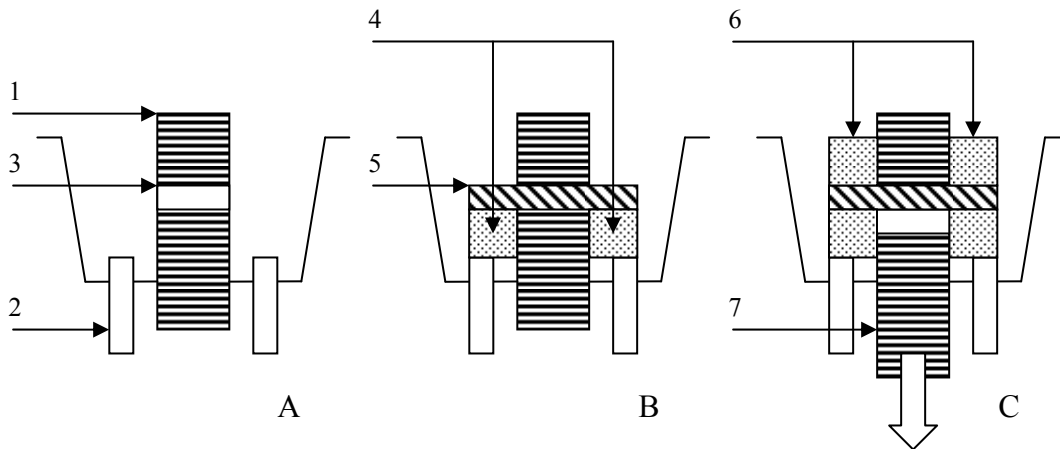
Figure 10 - Sequence of Foundation Stabilization

Figure 10 shows the sequence of foundation stabilization.

- A. The soil was dug to expose the existing foundation (1).
Micro-piles were driven into the ground (2) and the existing foundation was cut (3).
- B. New ground concrete beams were cast on the top of the micro-piles to support the steel beams (4), and the steel beams were cast on the new concrete beams (5).
- C. Other concrete beams were cast on steel beams to stabilize the upper part of the existing foundation (6).
The lower part of the existing foundation was free to settle (7).

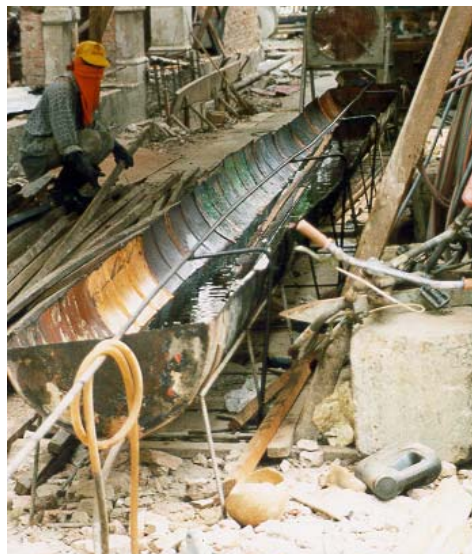
Figure 11 – Trough Used for Termite Protection

While the walls were being reinforced, the roof was removed. Most rafters were usable; however, many had rot at the end due to moisture damage. The contractor attempted to keep as many rafters as possible because the same size rafters were not readily available in the local market [5]. The rotten parts were cut and patched by nailing pieces from other rafters. This was strong enough to support the new roof tiles and helped reduce project costs of new materials [5]. When the roof structure was removed, steel cables were used to provide lateral support for the walls. The top part of every wall was tied with the strong points on the ground by steel cable to keep the walls in position. After the entire building structure was permanently stabilized, all temporary steel cables were removed. To protect the roof timber from damage by termites, the contractor chose to dip the timber into a specially constructed trough containing a chemical treatment (Figure 11) rather than painting the timber which was considered to be too time consuming.
