A CASE STUDY IN STRUCTURAL RENOVATION AND MASONRY RESTORATION

William D. Bast, P.E., S.E.¹ and Terry R. McDonnell, P.E., S.E.²

A four-story unreinforced brick masonry building in Cleveland, Ohio was studied for the purpose of performing structural renovation and restoration of the brick, terra cotta and limestone masonry façade. New Code provisions from International Building Code 2000 (IBC) and International Existing Building Code 2003 (IEBC) were applied. A reinforced concrete addition to the building was designed to carry the bulk of the seismic load. An opinion of cost was developed for the masonry façade restoration.

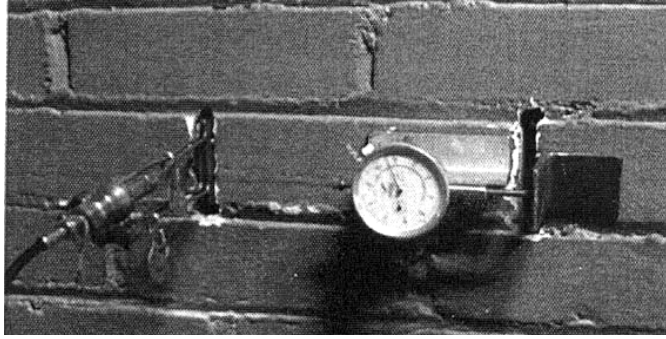
Material design strength information was gathered on the exterior wall and steel columns through a process of material testing. The steel framing was researched and determined to have a yield strength equal to an average of approximately 190 MPa (27.5 ksi). The exterior load bearing brick was also tested for shear using a Coulomb in-place shear test (see Figure 3). This test was performed in accordance with guidelines specified within the IEBEC A106.3 guidelines. The in-situ mortar shear design value, v_t , was determined to be an average of approximately 1.39 MPa (201.5 psi), a surprisingly high test result for a ninety year old exterior brick wall that has been continuously exposed to the elements. The testing was performed by PSI, a professional engineering testing agency in Cleveland.

Figure 3 – Coulomb in-place shear test according to IEBC A106.3

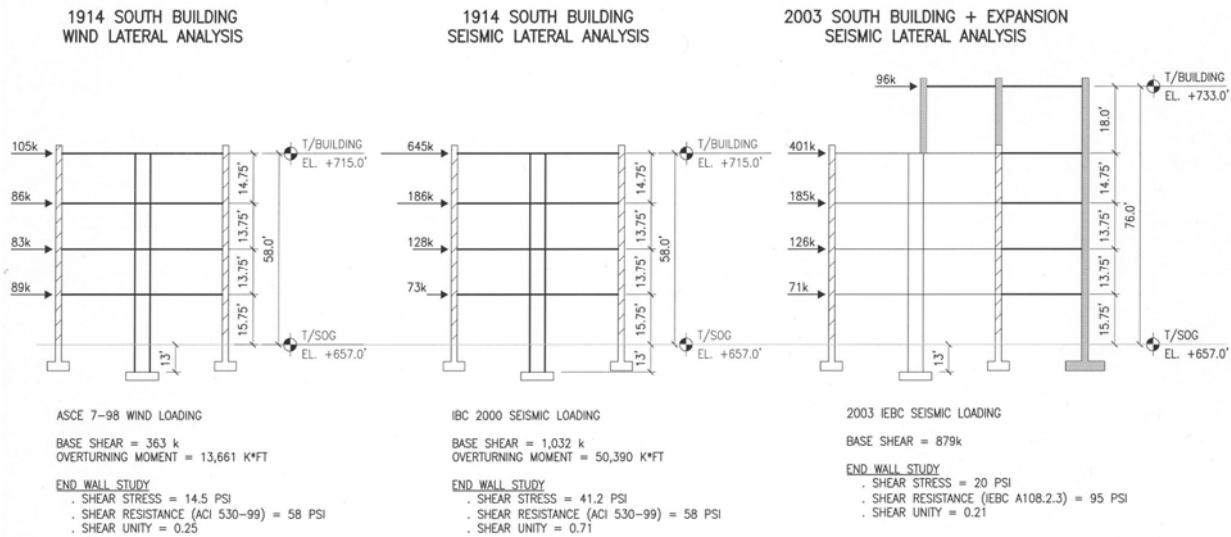
The first step in the structural evaluation of the lateral system was to compare the lateral loads from the original building design in 1914 with the Code required loads within the City of Cleveland at present day (refer to Figure 4 below). The lateral analysis procedure is described later in this paper and was constructed within ETABS[®]. The results show that the minimum required demand that the 1914 South Building must resist has increased by 400% due to new Code requirements and updated information kept by the U.S. Geological Survey for the geology within the State of Ohio. This is much larger than the 5% overstress limit permitted for renovated structures by IBC Section 1614. It was therefore determined that retrofit of the existing system would be untenable, and a new lateral load path must be developed in order to renovate this building.

Figure 4 – Lateral Load Analysis Summary on the portions of the 1914 South Building.

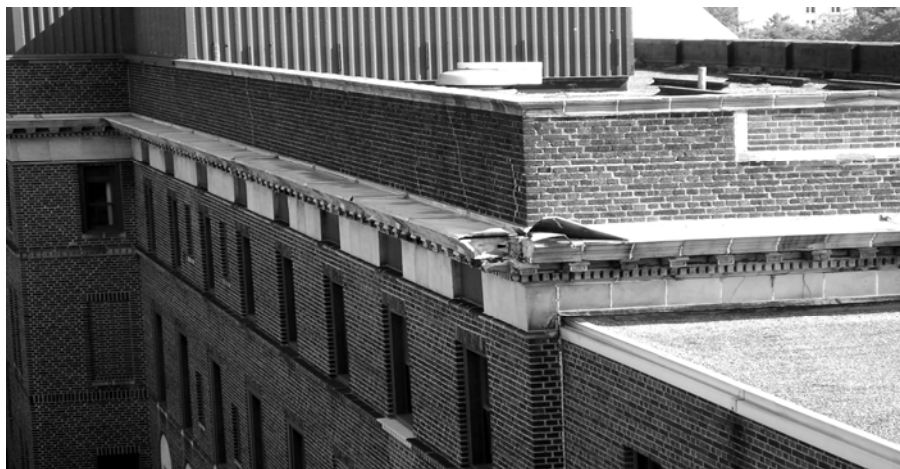
A particularly interesting detail that was identified early in this process involved the structural steel elements that supported the terra cotta cornice near the top of the building. The cornice already had an infamous history—an 890 N (200 lb) piece of it was found lodged in the roofing of the nearby, lower building roof. This piece was later identified as having fallen from the southwest corner of the South Building cornice (see Figure 5).

Figure 5 – South Building cornice, southwest corner

The construction manager's field personnel pointed out to us one day that a significant horizontal crack within the brick masonry, noticed only from inside the building, occurred below each floor. Upon further field study, the horizontal crack was revealed to be a large joint separation, only at the uppermost floor of the building, resulting from corrosion of an embedded steel angle that ran continuously along the length of each brick wall. Beneath this angle we discovered the ends of structural WT members, spaced at roughly 600 mm (2 ft) on center. The angle running perpendicular to and on top of the WTs did not appear to be connected in any way to the WT elements.

Without removing any more of the cornice, we were able to determine that the WTs provided support for the dentil work observed within the cornice construction, and that the angle on top of the WTs may have been added during construction simply to tie down the cantilevered steelwork. We also determined that significant corrosion of this angle had pushed the parapet wall upward and would require full rebuilding of this upper part of the masonry wall in order to achieve structural stability as well as weather tight construction.

Replacing the terra cotta cornice and rebuilding the parapet wall were two items that were glaringly absent from the preliminary budget prepared by the local specialty contractor; our engineering opinion of cost for the East elevation was consequently much higher, around \$725,000 for the repairs to the façade elements.
