## CATHEDRAL OF PORTO, PORTUGAL: CONSERVATION WORKS 2003-2008

This paper presents selected works carried out at the Cathedral of Porto, Portugal, as a case study that challenges current recommendations for the conservation and restoration of architectural heritage. The historical information is briefly reviewed and the general conservation approach for the different works is addressed. Afterwards, the aspects regarding the strengthening of the towers, diagnosis of a chapel, strengthening of the transept and diagnosis of the main façade are addressed.

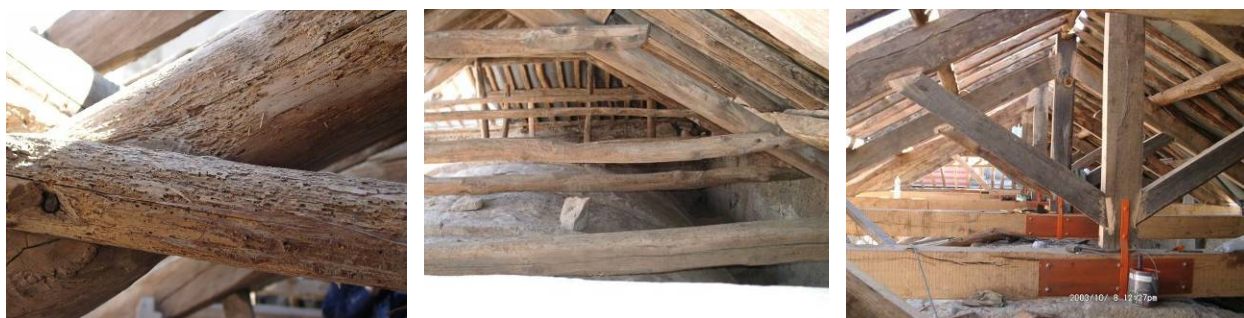
**Figure 2: Works in Roof Structures Included Cleaning, Application of Biocide, Application of Preservation Products, Consolidation, Strengthening and Local Replacement. Other Experts Were Responsible for Diagnosis and Specific Treatments.**

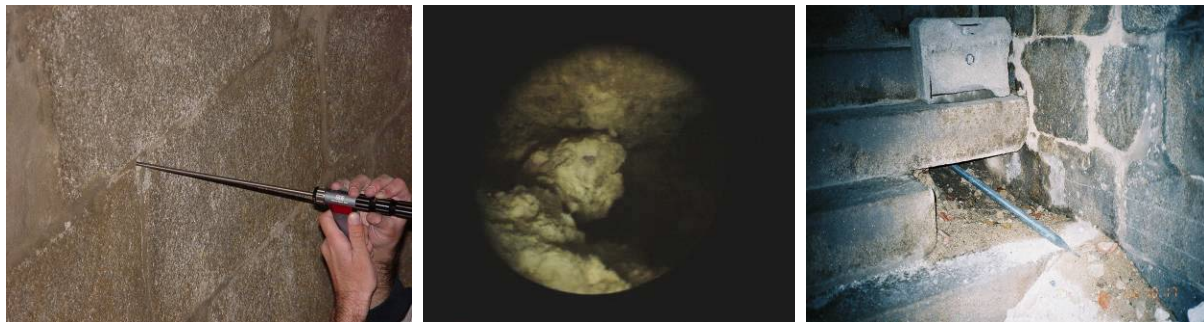
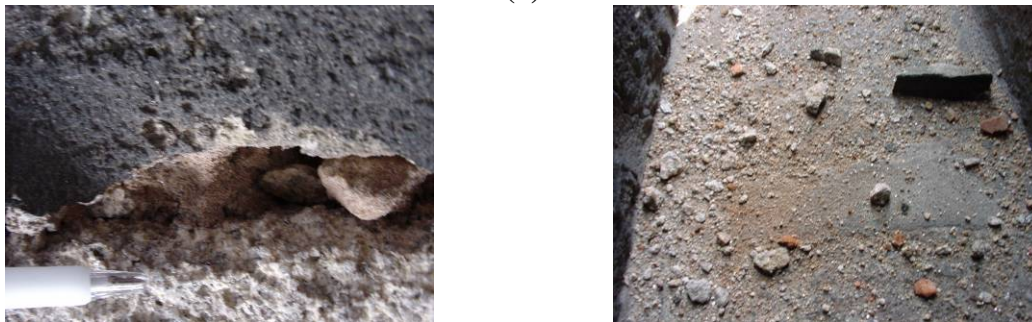
The constitution of the masonry walls from the towers was characterized using visual inspection, both by removing stones of the outer leave in the interior of the tower and by using a boroscopic camera inserted in cracks or in holes drilled in joints, see Figure 7a. From the inspection, it was possible to conclude that the three-leaf walls have external leaves of granite ashlar with a thickness ranging from 0.30 to 0.70 m, while the middle leave is made from loose smaller stones and / or silty soil, see Figure 7b and Figure 8. The combination of heavy rain in Porto, strong winds in the top of the hill where the Cathedral is located, and the open joints in the external masonry face, results in a wet infill even in the summer and the continuous washing out of the infill.

**Figure 7: Visual Inspection to Define the Constitution of Masonry Walls: (a) Boroscopic Camera and Inspection Openings; (c) Loss of Material Through Cracks in the Middle Plane of Walls Through Existing Openings.**

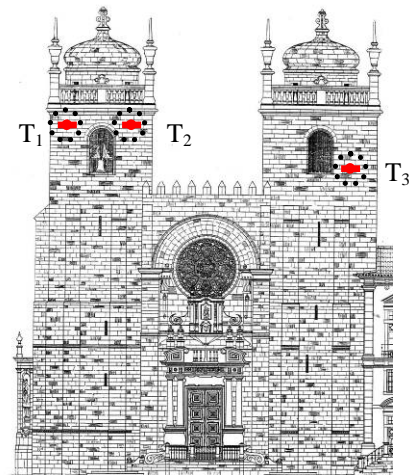
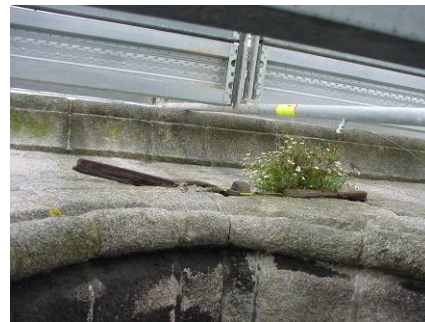
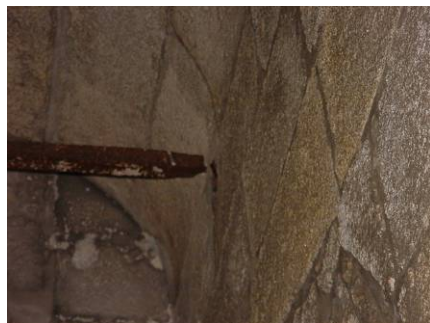
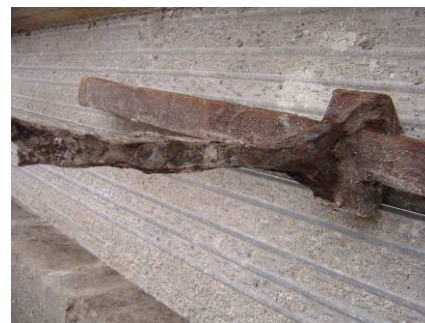
The towers exhibit distributed cracking and significant out-of-plane movements. The existing damage resulted in the past addition of three iron ties (date unknown), see Figure 9a. Tie  $T_1$  presents a severely deformed anchorage and tie  $T_3$  is corroded and broken, see Figure 9b. It is stressed that the separation between the East and West façades of the South tower continued after tie  $T_3$  was broken. It is also noted that the masonry walls in the vicinity of the anchorages are also deformed, as expected due to the application of a large point load.

**Figure 9: Ancient Tower Ties: (a) Deformed Anchorage ( $T_1$ ); (b) Details of Broken Tie ( $T_3$ ).**

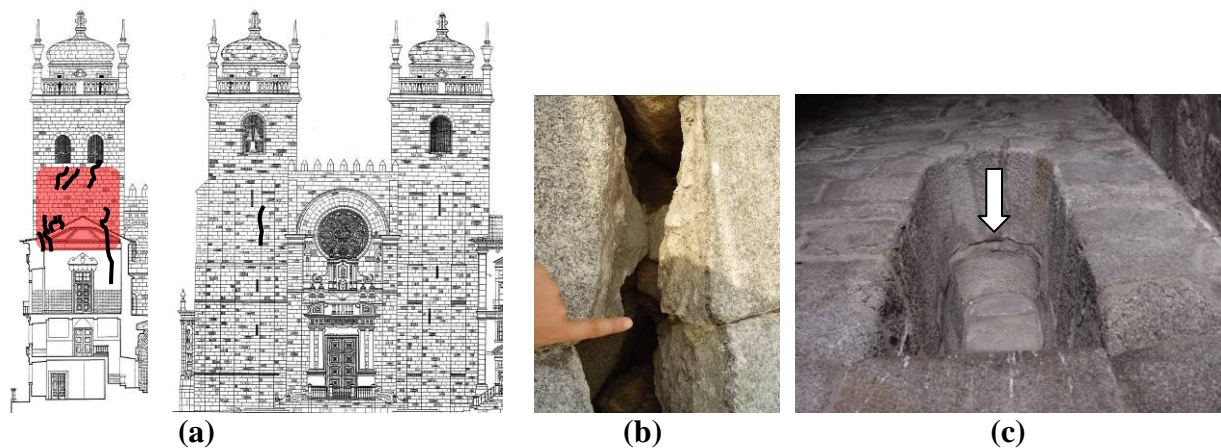
The South tower is more damaged than the North tower. Figure 10 exhibits the location of severe cracks and out-of-plumb walls in the South tower. Also the East façade of the South tower presents out-of-plane movements to the exterior. It is noted that the internal walls of this tower are straight, indicating crumbling or desegregation of the walls, with major cracks and voids in the interior. The separation between the internal and external leaves of the walls is further confirmed by the longitudinal cracking observed in most of the openings. Figure 10c illustrates such cracking, with a maximum width of some centimeters. Finally, it is noted that the North tower presents severe distributed vertical cracking at the base. This cracking is only visible in the internal (medieval) face, while the external face seems undamaged. Moreover, the very large thickness of the walls is not replicated in the South tower. For these reasons, it is believed that the damage is not recent and the helicoidal staircase belongs to the structure of an older tower. Finally, the misconception of the structure supporting the bells and clock in the North tower is also noted, see Figure 11.

**Figure 10: Cracks up to 0.20 m Width: (a) Location of Severe Cracks and Out-of-Plumb Walls, in the South View and Main Façade; (b) View of External cracks and Typical Active Cracks Parallel to the Walls at the Openings.**

adequate connection between the external leaves and severe water infiltration in the walls contributed to the existing damage and to the loss of material in the rubble infill. Here it is again stressed that the Cathedral is located at the top of a hill, the external masonry joints have lost all mortar and it was found that the rubble infill was wet by the end of the summer. Besides other damage, the most relevant feature is that the North tower is divided in two similar channel-shaped parts, from mid-height to the top, with full cracks along the West-East direction (in the other direction, the existing ties kept the tower together), and the South tower is bulging outwards both to South and to East (the existing West-East tie is broken).

The solution adopted for strengthening consists mostly of a steel ring in both towers, aiming at confining the structure along the two orthogonal directions, in the sole location possible, see Figure 12a,b. The rings are made with welded stainless steel plates (class AISI 316L), connected to the towers using long, inclined stainless steel anchorages inside of a cloth duct to prevent generalized injection, see Figure 12c-e. The length of the steel profiles is defined so that the elements can be transported to the location through the existing doors and can be easily assembled in situ, without any further welding. In the North tower, the ring also aims at providing a support for the stone pavement for the bells. The reason being that the stone columns are much deteriorated and possess presently no structural function and the stone struts have very deficient conception, see Figure 11. Here it is noted that it was decided not to recuperate the structural function of the columns (e.g. using injection) because the lower level seems to indicate insufficient strength of the inner core. The steel ring is made of channel profiles ( $240 \times 120$  mm and  $200 \times 100$  mm height). In the South tower, a set of two ties was provided to the ring, because it was possible for aesthetic reasons and they are a witness of the ancient broken tie. The ring must cross the staircase at a selected location because the complex internal structure of the tower does not allow otherwise. Due to the lack of internal stiffening elements, a much stiffer steel frame is needed and the steel ring is made of H profiles ( $180 \times 180$  mm). Due to the bulging outwards of the East and South façades, and the severe cracks in the corners, several short ties have been added to the structure to stitch the East and South façades, and two long ties through the core of the South façade have been added to connect the West and East façades, see Figure 12f. Figure 12g presents details of the two types of anchorage plates adopted (circular plates and specially designed crosses).

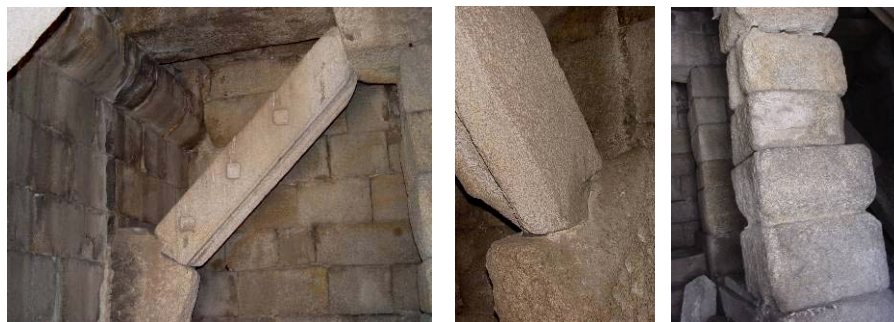
**Figure 11: Deficient Structural System to Support the Bell Stone Level Floor.**

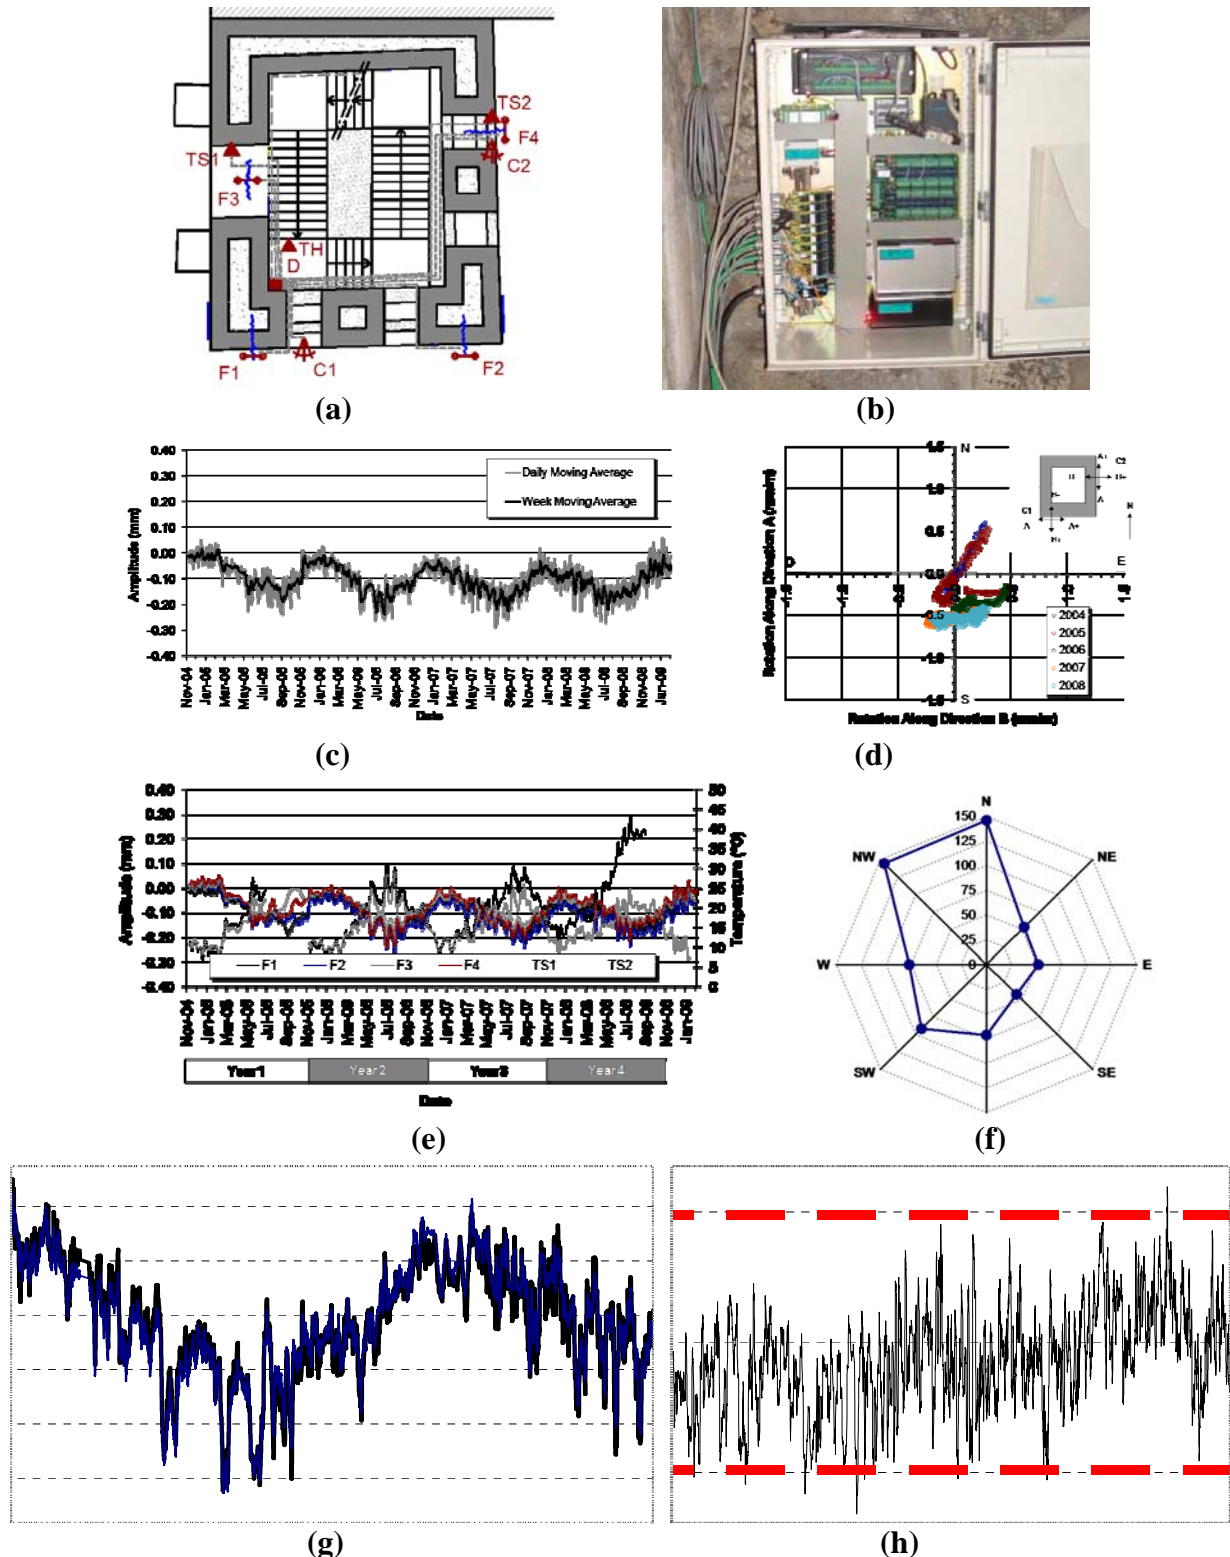
Figure 13: Monitoring system: (a) Applied sensors; (b) Datalogger; (c) Typical Crackmeter Results; (d) Typical Tiltmeter Results; (e) Week Average of Crackmeters vs. Temperature; (f) Maximum Wind Speed in Anemometer; (g) Typical Crackmeter Results Measured (Black) vs. ARX Model (Blue); (h) Typical 95% Confidence Interval in Crackmeter.

The measurements in the crackmeters (amplitudes lower than 0.3 mm) and clinometers (amplitudes lower than 0.6 mm/m) are rather small and they follow the temperature measurements, see Figure 13c,d,e. The wind speed measured indicates that the direction of the gust wind is North / Northwest, with velocities up to 150 km/h, see Figure 13f. An autoregressive exogenous (ARX) model [2] indicates that the measurements of the cracks are of good quality and the variations are explained by the environmental effects and not by crack opening, see Figure 13g,h. A similar conclusion holds for the measurements of stresses in the steel ties. The values in the tiltmeters are low but a rotation seems to be observed in the South tower, around 0.01°/year or 0.1°/decade, see also [3].

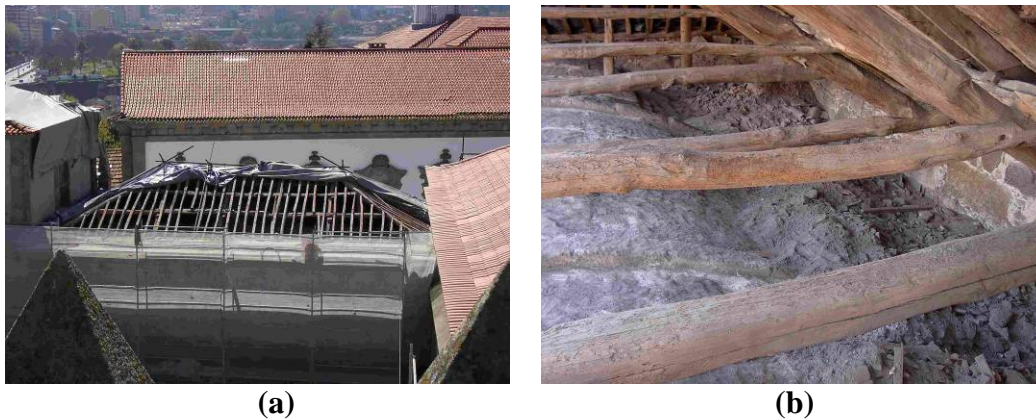
The Saint Vincent Chapel is located next to the South wing of the Cathedral cloister. During the restoration works of the roof, it was found that the extrados of the chapel vault was filled with rubble resulting from old demolitions see Figure 14. Also, and as usual in several historical constructions, the timber roof was partly supported by the vault, using later added struts. The issue addressed here is the stability of the vault and the convenience of the removal of the infill.

**Figure 14: Roof of Saint Vincent Chapel: (a) Aspect of Restoration Works; (b) Aspect of Vault Infill with Rubble.**

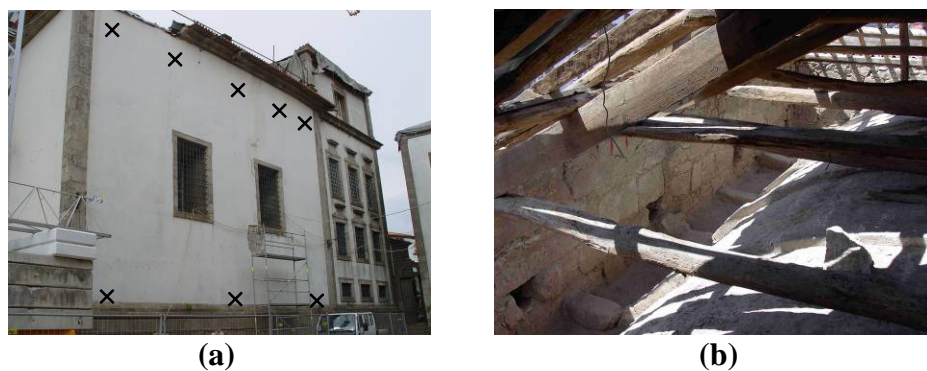
**Figure 16: Infill Removal: (a) Location of Topographic Targets for Monitoring; (b) Aspect of the Cleaned Vault.**

The infill was removed but, for safety reasons, it was recommended to accompany this task with topographic measurements, see Figure 16a. The targets were read always at early morning to reduce temperature effects, daily during the process of infill removal (one week) and weekly during one month after load removal. Approximately 35 m<sup>3</sup> (7000 kg) of rubble were removed from the vault and no movements were recorded in the targets. Figure 16b demonstrates that the vault was never conceived to accommodate infill, and a timber roof existed at the level of the vault, before the construction of the vault and the new roof at a higher level.

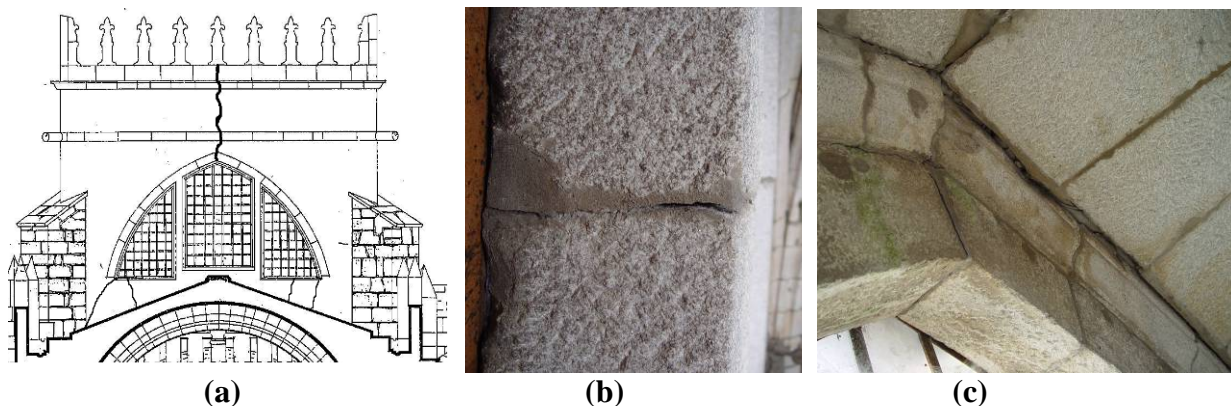
The three walls with windows are cracked at the arch key, with maximum crack widths of 10, 1 and <0.5 mm, in the façades West, North and South, respectively. These walls are also bulging outwards. Figure 18a shows the main crack in the West façade, which crosses the entire section of the wall. Smaller cracks can be also observed closer to the buttresses, under the opening. Figure 18b shows a typical detail of the columns with a horizontal crack due to bending. But the most severe crack in the interior has a width of 25 mm and shows that the vault is separated from the wall in the West façade, see Figure 18c. Due to this crack, the stone slabs of the vault are no longer supported in the side rib and a settlement of about 20 mm can be observed at the key of the vault.

**Figure 18: Examples of Cracks in the Skylight: (a) Exterior, Above the Arch; (b) Interior, Bending of Column; (c) Interior, Separation of Wall and Vault.**

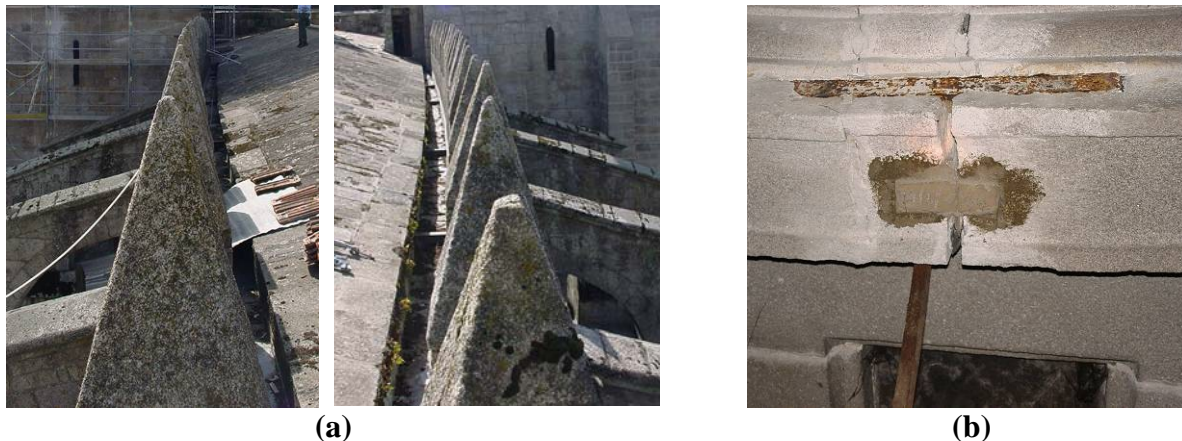
The observation of the damage in the skylight, together with the local relief, the severe separation between the East façade and the chancel, the old documents indicating consolidation and enlargement of foundations and the bulging of the walls of the nave indicate that soil settlements and weak foundations can be the main cause of damage, see also Figure 19.

**Figure 19: Observed Damage in the Vicinity of the Skylight: (a) Bulging of the Walls of the Nave; (b) Cracking Between the Chancel Vault and the East Wall.**

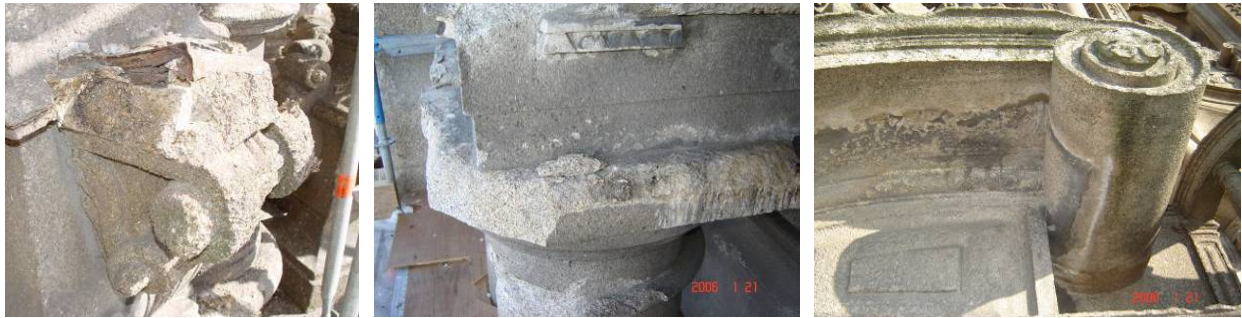
The balcony substructure consists of an almost semi-circular slab, made of granite ashlars that are bonded together with iron dowels. The slab is stiffened by three ribs of the same granite, a central one and two lateral. The loads considered in the balcony include the self weight and the granite balustrade of seven granite columns that also seems to integrate steel dowels, see Figure 25. The pinnacles are massive granite elements, supported in stone shells made of different stone elements. The stone presents severe signs of weathering, which probably results from combined action of cycles of wetting/drying, salt and pollution. Figure 26 shows examples of stone and iron damage, and biological activity.

**Figure 26: Examples of Stone and Iron Deterioration.**

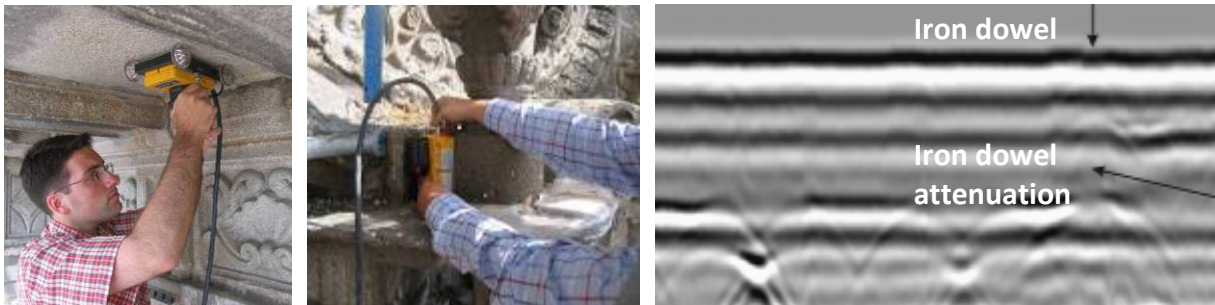
In order to check if the stone elements would be internally connected with iron dowels and also to verify if disassembling would be needed to prevent future damage due to iron expansion, a GPR inspection was performed, see Figure 27. In general, no iron elements were found inside the stone elements, even if many iron cramps are visible externally.

**Figure 27: Aspects of the GPR Inspection.**
