MODERN MASONRY DETAILING IN HISTORIC TERRA COTTA CLADDING SYSTEMS: MISGUIDED INTENTIONS?

Edward Gerns¹ and Renae Brossman²

¹ Principal, Wiss, Janney, Elstner Associates, 10 South LaSalle, Suite 2600, Chicago, Illinois, egerns@wje.com

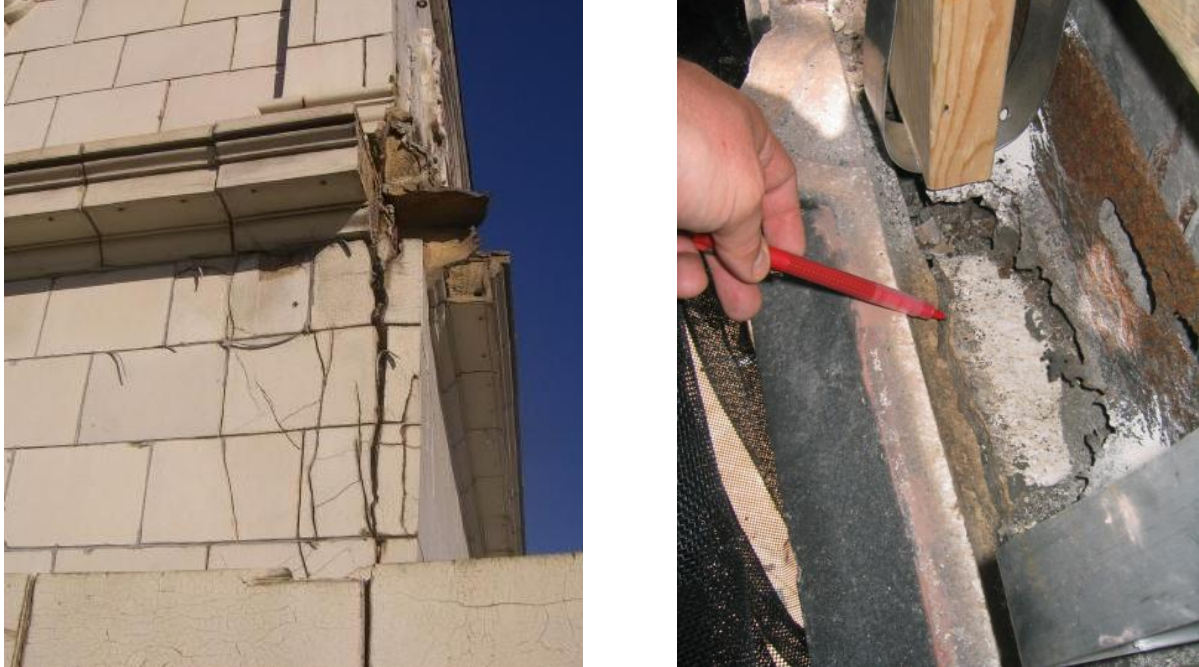
Fired clay masonry undergoes a permanent expansion in the first decades of service. This expansion, combined with frame shortening, was typically not properly accommodated in historic construction and leads to accumulation of compressive forces, additional cracking and subsequent water infiltration (Figure 2).

Figure 2: Representative examples of extreme deterioration due to improper maintenance.

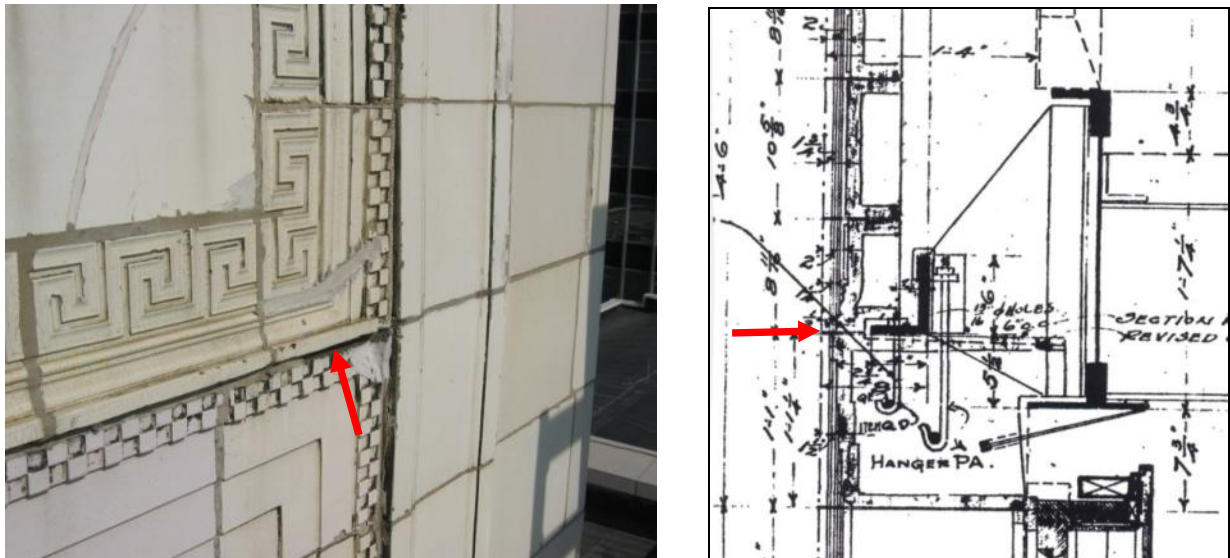
Based on an investigation which included visual inspections and selective removal of terra cotta units, it was concluded that the cracking and displacements are likely the result of accumulated stresses within the facade. These stresses are due, in part, to the inability of the wall construction to accommodate thermal and moisture movements of the cladding materials as well as differential movements between the masonry facade and the underlying steel structure. Limited corrosion scale was also observed which further increased the accumulated stresses.

In continuous vertical facade element such as piers and the fluted pilasters, the effects of moisture expansion, thermal expansion and corrosion scale accumulation combined with the foreshortening of the steel frame under the dead load of the building imparted stresses in the cladding system that lead to localized cracking. Cracking typically developed at points where the facade materials were restrained, such as at locations of steel supports within piers, at intersecting walls elements (piers and spandrels) and at corners of the building. Representative conditions and original details are shown in Figure 3 and 4.

Figure 3: Representative area of flat portion of facade at previous repair location; original shop drawing. Arrow indicates bed joint corresponding to shelf angle location.

In 2007 a repair program was implemented which included identifying distressed units and then repairing or replacing designated units. Following an initial inspection, the contractor removed the designated distressed units which also included units that were not distressed but had to be removed to facilitate access for installation of the replacement units. Additional terra cotta units cracked as a result of the initial removal process and subsequent release of stresses within the units. These units were also removed and replaced.

The repair program included cutting strain relief joints in the masonry across the main facades at each floor line to relieve compressive stresses within the terra cotta cladding. Approximately five

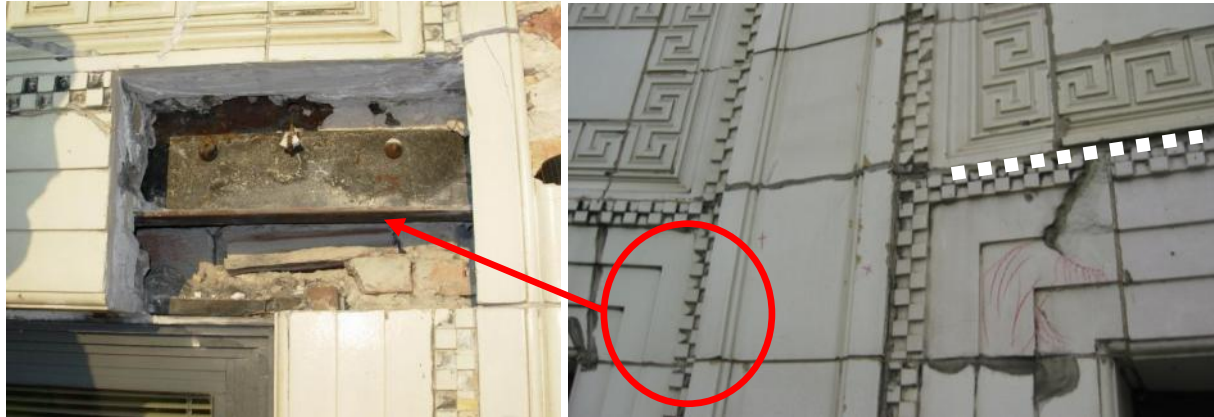
Figure 4: Representative distress in terra cotta. Inspection opening at left was created in projecting bay area. Flashing were installed only on the flat wall areas (dashed line)

The flashings which had been previously installed were essentially ineffective and unnecessary. By sealing the joint at the shelf angle it is likely that more water is actually trapped in the spandrel area than would have been the case had the supporting steel been exposed and painted and the mortar installed into the joint rather than sealant.

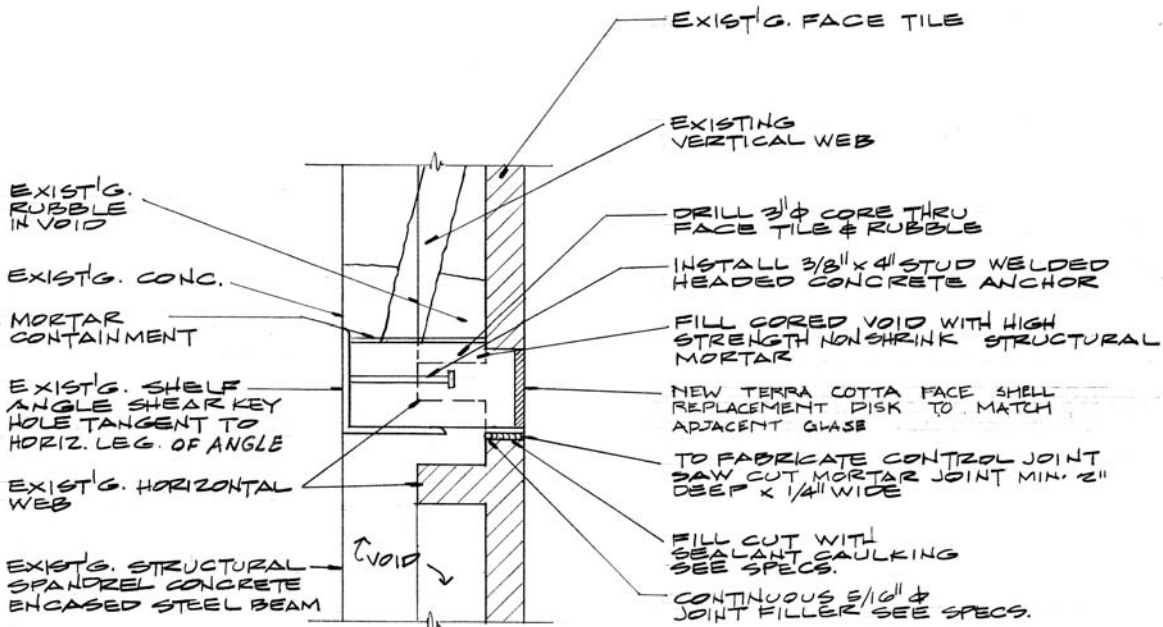
In 1980, repairs were performed to provide additional bearing at the shelf angles at many of the terra cotta spandrel units. These repairs consisted of coring two 7.6 cm (3-inch) diameter holes through the intermediate webs in each terra cotta unit, welding a stud anchor to the existing steel shelf angle at each hole, grouting both cored openings, and patching each cored hole with a thin terra cotta plug (Figure 5). Horizontal expansion joints were also installed below the steel shelf angles to prevent further cracking of the terra cotta cladding due to thermal and moisture expansion.

Figure 5: Original repair detail to support terra cotta ashlar units.

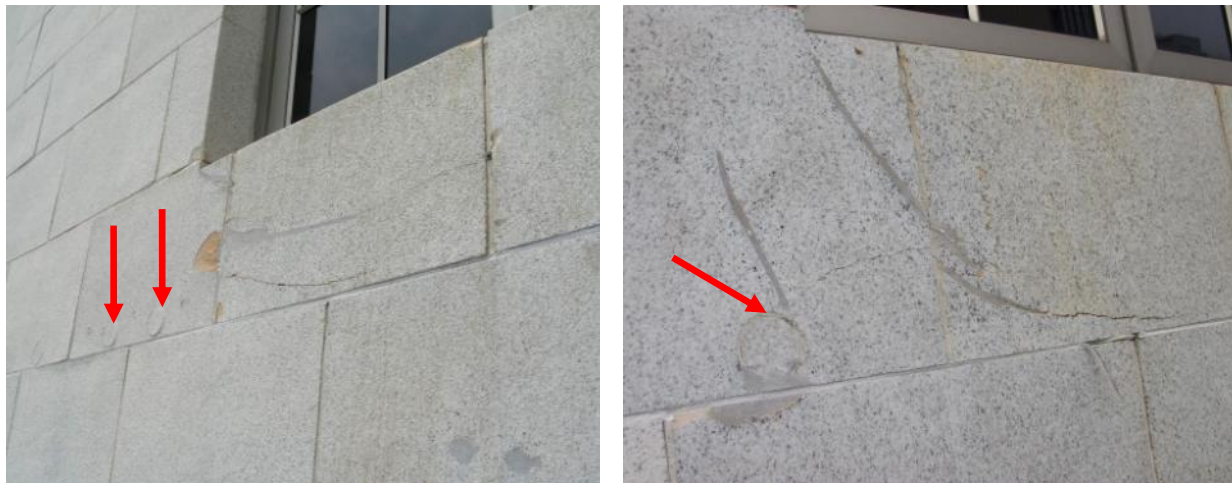
In 2002 an investigation of the terra cotta cladding revealed that many of the previously repaired terra cotta units, as well as adjacent units located under window openings, were exhibiting significant distress including hairline cracks radiating from the cores and more pronounced diagonal cracks in the terra cotta units below the window openings (Figure 6). The supplemental welded stud anchors were not installed in the terra cotta spandrel units located directly below the window openings; however, horizontal expansion joints were saw cut below these units. Cracks typically originated at window corners, extended through a vertical mortar joint, and continued

diagonally downward, sometimes continuing to the soft joint. Cracking was also occurring between the terra cotta face shell and the vertical stiffener webs. In addition to the visual distress, many of the cored terra cotta units were found to be delaminated and loose when sounded with a rubber tipped hammer.

Figure 6: Representative distress in terra cotta. Note locations of previous repairs (arrow)

Subsequent investigation concluded that coring the terra cotta units and saw cutting of horizontal expansion joints below these units caused a redistribution of load and subsequent cracking of the units. By design, the entire gravity load of each floor of cladding was intended to be uniformly supported by the shelf angle, but in reality a portion of this gravity load was being transferred through to the floor level below. In a typical wall section, approximately half of the thickness of the terra cotta unit extends beyond the edge of the shelf angle and is unsupported. A full depth mortar joint installed under this unsupported section allows for a portion of the gravity load to be transferred to the floor below. Installation of the previously described repair appears to have

altered the load path by creating point loads to the floor below since the original mortar joint was only partially removed before the soft joint was installed. The cracking pattern observed below the windows is likely the result of non uniform support across the entire shelf angle since the supplemental repair was not installed in these units.

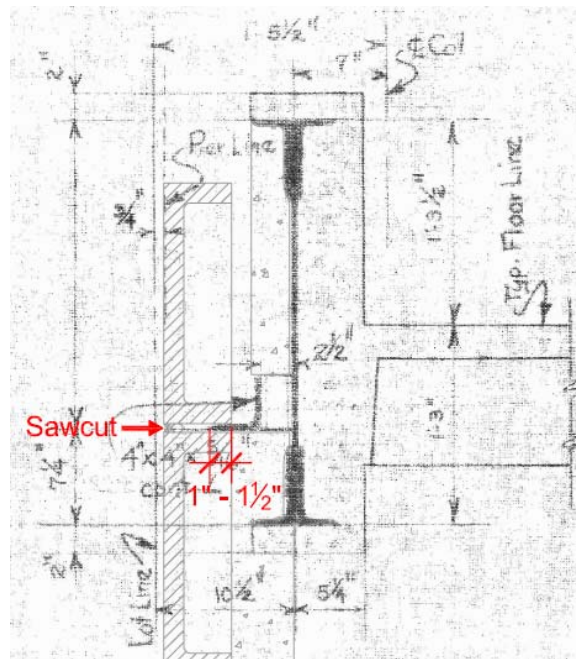
Figure 7: Original architectural detail at shelf angle location. Note bearing area dimension

In the original construction less than one third of the terra cotta was bearing on the shelf angle and a full depth mortar joint was installed under the unsupported section. Therefore, a portion of the gravity load was transferred through the mortar joint to the floor below; creating a mixed load path that was a combination of load-bearing and non-load bearing. When the expansion joint was cut, the gravity load of the terra cotta between shelf angles completely shifted to the shelf angle. Since a significant portion of the terra cotta unit, more than two thirds of the unit was not supported by the shelf angle, a stress concentration developed in the terra cotta unit at the end of the shelf angle where the vertical cracks were observed. It was concluded that the cracking is due to inadequate bearing and redistribution of the load after the horizontal expansion joints were cut.

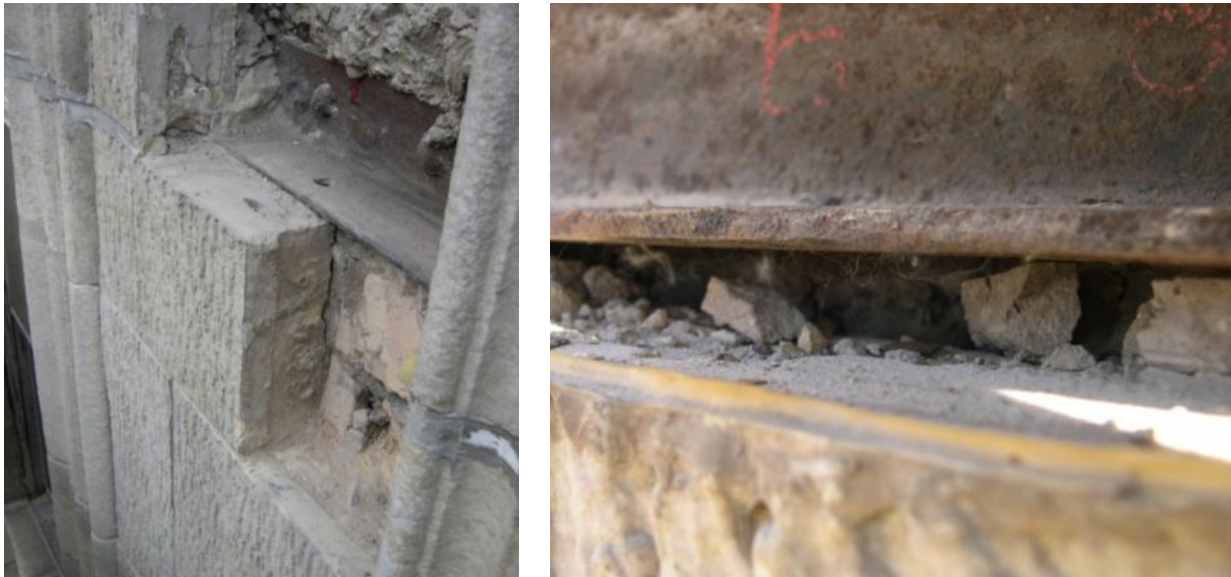
During our investigation, several distress conditions were noted at the terra cotta columns where the joints had been cut including cracked and spalled units above the shelf angle. The most significant distress condition included concealed vertical cracks in the terra cotta webs, which originate where the webs of the terra cotta unit bear on the shelf angle. Representative conditions found during the investigation are shown in Figures 8 and 9.

Figure 8: Representative examples of shelf angle locations with minimum bearing (left) and with expansion joint having been cut below shelf angle (right).

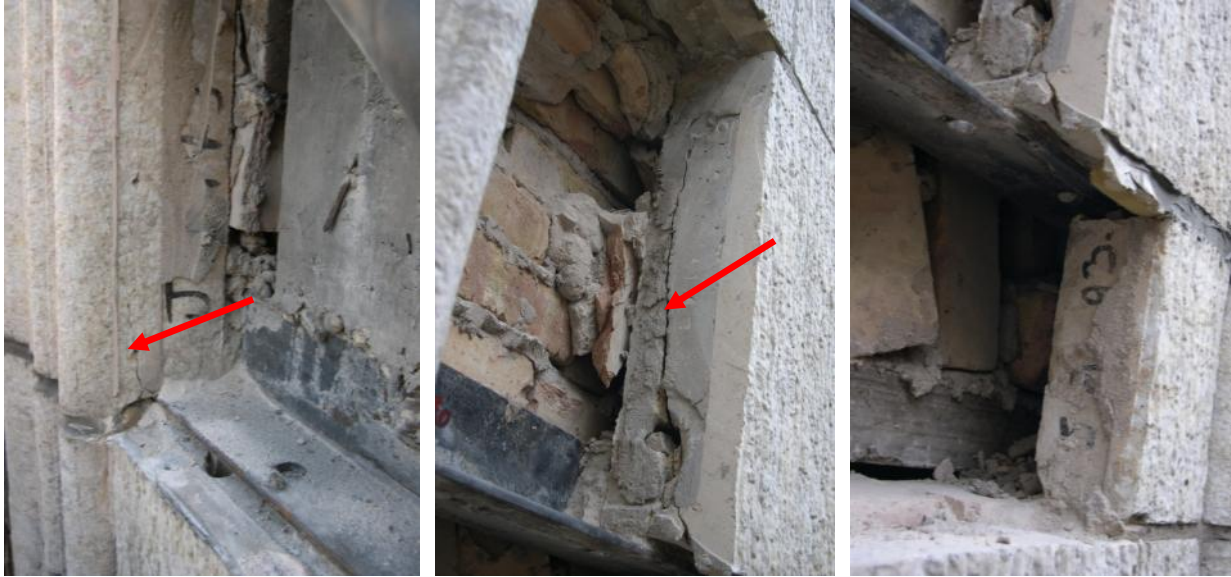
In addition to the distress units above the shelf angle, the terra cotta units below the new horizontal expansion joints were observed to be hollow (no bond to backup materials) and some were loose. It is likely that the lateral support at the top of these terra cotta units was inadvertently eliminated when the horizontal expansion joints were cut.

Figure 9: Representative distress in terra cotta at shelf angle locations.
