11th Canadian Masonry Symposium, Toronto, Ontario, May 31- June 3, 2009

REBUILDING A MASONRY/CONCRETE SINGLE-FAMILY HOUSE FOR ECONOMICAL HEATING AND COMFORTABLE LIFE

B.G. Hellers

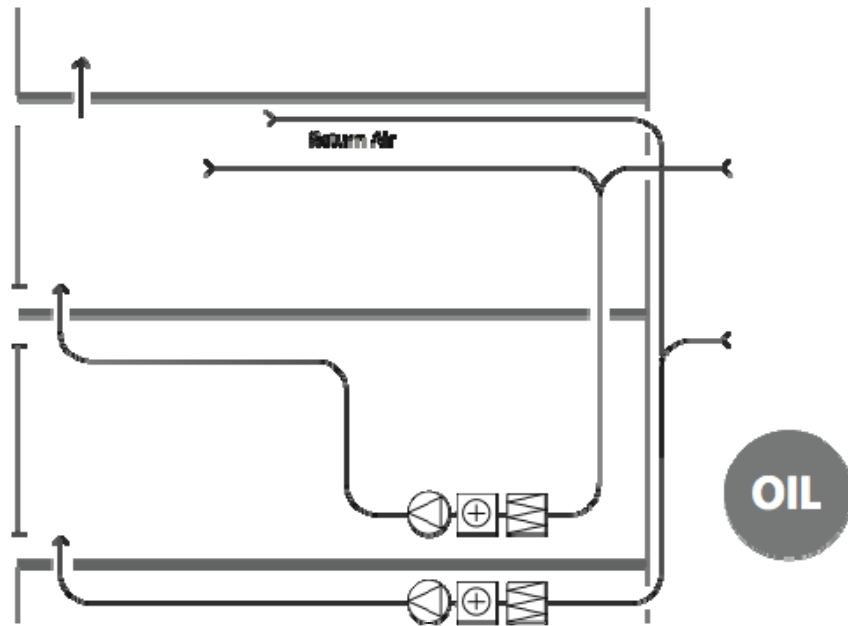
Fig 2. The original heating system, combining heat and ventilation in circulation.

The purpose of rebuilding was to modernize the heating system and to refurbish the whole building for a new owner. The current rule in Sweden [3] is that the energy requirement for heating should not exceed 110 kWh/m²/year. Circulating air should be avoided for hygienic reasons. Also, experience showed that air circulation when exposed to low exterior temperatures may become fierce and unpleasant, in case the insulation is not very efficient. After discussions, the solution was to drill deep holes into the ground rock from which heat is taken to a heat pump, where it is converted into hot water feeding the internal requirements. In addition, insulation had to be improved.

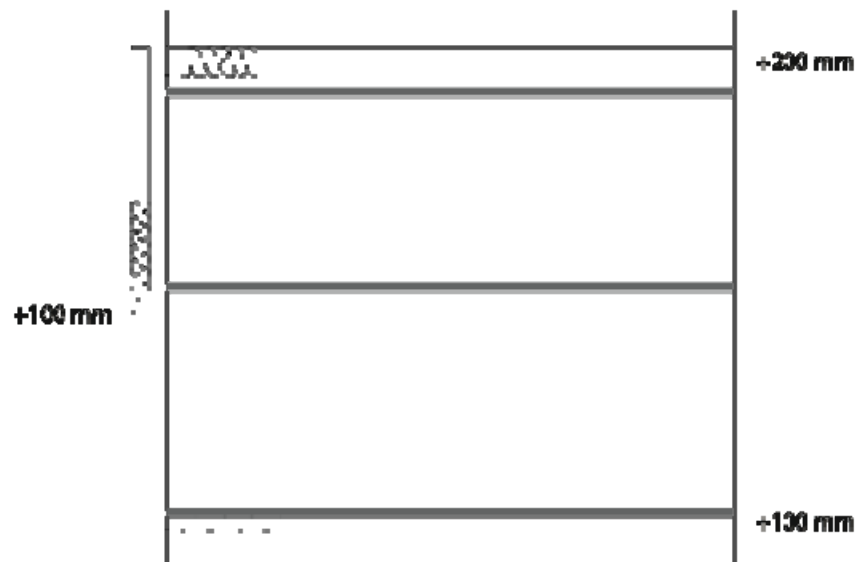
The original thermal insulation was rather moderate, reflecting the low price of the fossil fuel. The insulation was 140 mm mineral wool on the roof, 100 mm mineral wool on the exterior walls, and the bottom floor was left completely un-insulated. The intention was that this concrete floor would serve as a heat exchanger, which is surprising, considering that the return air flow

does not go through the volume under the floor. Apparently, such flow was originally intended but omitted for some practical reason. The consequence should have been to insulate the floor underneath, which happened only now in combination with the rebuilding. Referring to Fig 3, the floor was insulated with a 100 mm foam (polystyrene) insulation glued upwards to the concrete. The roof got an additional 200 mm mineral fibre insulation, a total of 340 mm and had an inward inclination for a quick run-off of rain (the current level of roof insulation in new production would be 450-500 mm, reflecting the fact that heat losses towards the open sky are relatively dominant due to radiation.) Wooden walls of the second floor were given an extra 100 mm mineral fibre insulation, totalling 200 mm. (A current level of wall insulation in new production would be 300 mm.) and brick walls were not touched.

Fig 3. Improving the insulation of all possible surfaces, except masonry

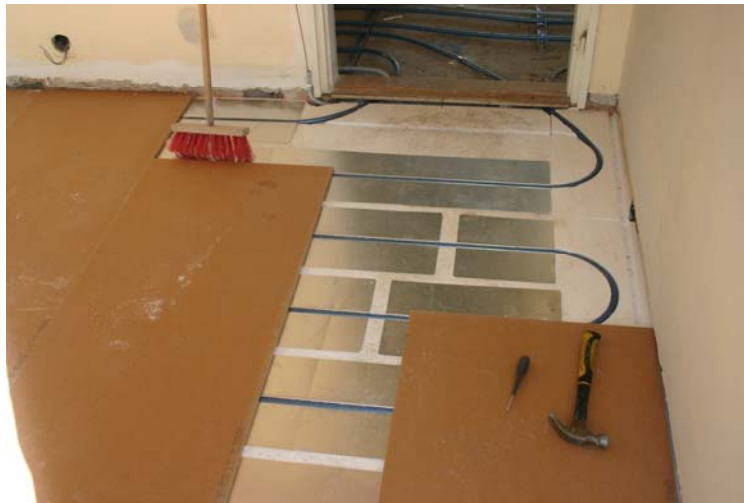
Fig 4. Floor heating system. Circulating hot water on all floors, except natural stone. Pipes buried in polystyrene foam or in concrete on foam

The heating after rebuilding relies mainly on floor heating, which is applied wherever possible. The central floor of the bottom storey was covered with high quality brown lime-stone from Jämtland, which was not altered. Also, for a wooden part of the top storey floor, floor heating was not applied. On all other surfaces of concrete, floor heating was applied after removing the top layer of grout, as shown in Fig 4. After placing an insulating pad, the pipes were embedded in new grout or, if the geometry did not permit, covered by a fibre plate. All wet floors are finished with dense ceramic tiles. All dry floors are covered with carpets, which is in accordance with the original architecture.

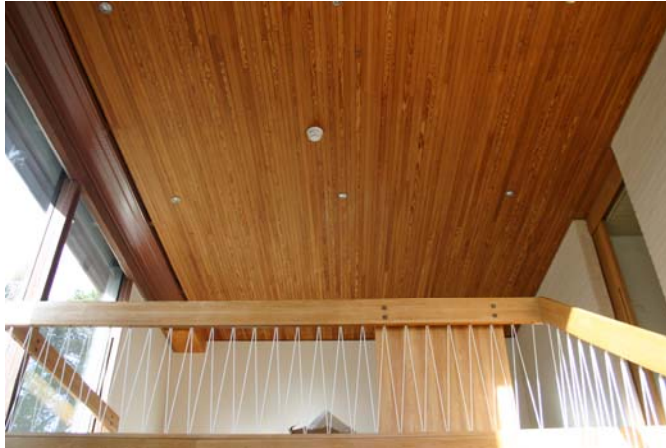
The total height of the glass, covering both storeys, is 5.2 m. To counteract the tendency that air will fall along the glass from cooling, the airflow comes from the vent split at the bottom and in addition, the ceiling element radiates down the glass, as shown in Fig 5. It is believed to be the first application of this new technology in a one-family house and early observations were very favourable.

Fig 5. Ceiling radiation hot-water element (1.5 kW)

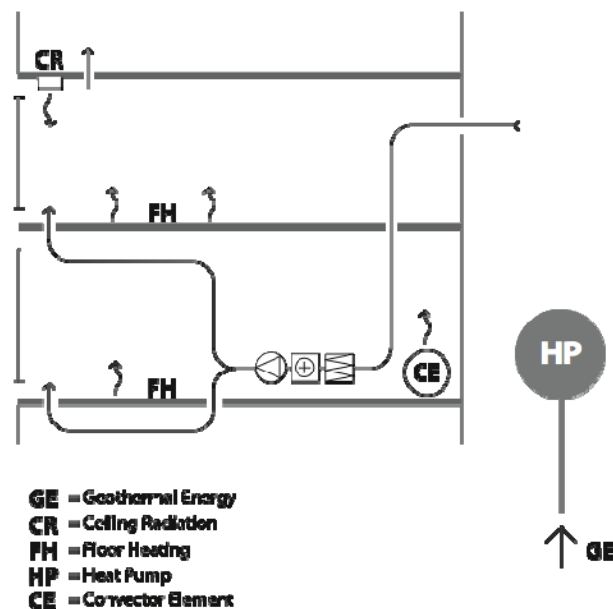
The full heating system is demonstrated in Fig 6. The total depth of the three holes, drilled into the rock foundation, is close to 375 m, adhering to the rule of thumb that the figure in meters should surpass the living area in square meters within the house, in this case 305 m². The ground rock is an indirect source of solar energy of comparatively high reputation in Sweden. It is becoming so popular that its use has to be regulated by the community, in this case Lidingö, by requiring minimum distances between installations, 24 or 30 m, depending on unit size. This is to assure that every installation should operate on the heat surplus stored in the rock, avoiding to cool-off the source.

Fig 6. Total heating system after rebuilding. Geothermal energy feeds floor heating system (primary), convector and ceiling radiation elements (secondary)

According to consultants, the new heating system, demonstrated in Fig 6 is designed to deliver a pleasant climate, thermal comfort improved, at a total of 28,000 kWh electricity per annum (no solar panels yet), down from 110,000 kWh from combined electricity and oil before rebuilding. It means close to 75% reduction of energy but an increase of electricity use. After rebuilding the energy requirement accounts for 90 kWh/m²/year, less than the required 110 kWh /m²/year. The coming winter season will test the accuracy of this prediction. So far, let us enjoy the results, Fig 7.
