11th Canadian Masonry Symposium, Toronto, Ontario, May 31- June 3, 2009

PERFORMANCE OF MASONRY BUILDINGS IN THE AUGUST 15, 2007 PERU EARTHQUAKE

Arturo E. Schultz

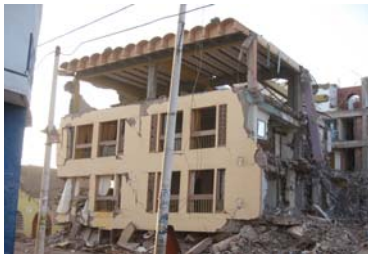
a) Weak First Story

The greatest concern with RC frame buildings, particularly with the older ones, has to do with known vulnerabilities in RC frames that, nonetheless, are left unrepaired or unretrofitted. Figure 9a shows the catastrophic collapse of the Embassy Hotel in Pisco. This building had a weak/soft first story due to the interruption of many of the infill panels in the first story to provide access. A story mechanism comprising the failure of the first-story columns led to instability and collapse of the entire building. Closer inspection of the RC frame members (Fig. 9b) reveals another common vulnerability in existing RC frames with masonry infills in which inadequate transverse reinforcement in the beams, columns and beam-column joints exposes such members to premature shear failure and compression damage. Figure 9c shows a third type of seismic vulnerability that was common throughout the affected region, namely the captive (or 'short')

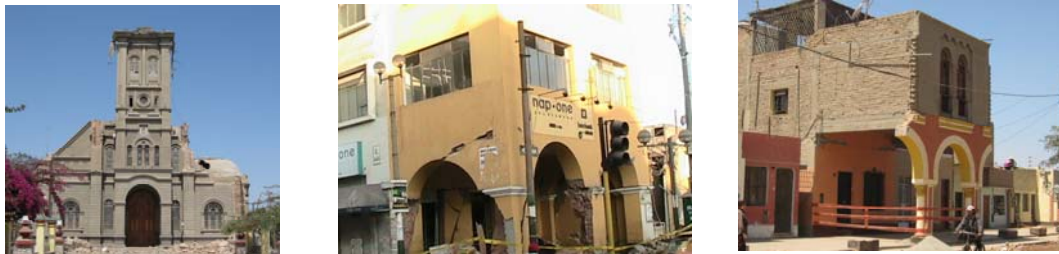
a) Monumental Structures b) Commercial Buildings c) Masonry Arches

Historically, many monumental structures built unreinforced clay brick have performed well by virtue of their massive dimensions. Walls with multiple wythes have maintained stresses sufficiently low to protect the masonry from damage. However, tall bell towers, parapets and large expanses of masonry adjacent to window openings deviate from these ideal conditions. The bell tower and turrets of Our Lord of Luren Church in Ica (Fig. 11a) were slender elements located at the top of the building where seismic accelerations were the largest. As the damaged elements collapsed, they damaged other parts of the church building including the roof diaphragm. Unreinforced brick arches suffered extensive damage in many locations, such as the

commercial building in downtown Ica shown in Fig. 11b. Damage typically initiates at the intrados below the crown of the arch and extends upward. The corner pier of this commercial building was also damaged extensively from biaxial nature of the seismic loading at this location. The arch shown in Fig. 11c is a remnant of a series of free-standing unreinforced brick arches surrounding the Luren Plaza in Ica. The only remaining portions of this extensive structure are some spans that were replaced by reinforced concrete arches in an earlier earthquake, and the one shown in Fig. 11c which was on original unreinforced brick span. The masonry building addition supported on the arch served as lateral support, and the precompression from the weight of the addition altered the stress state in the arch allowing it to survive the earthquake.

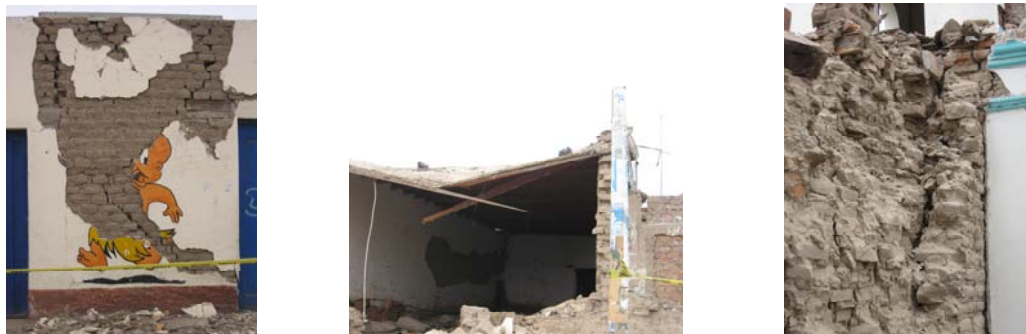
a) In-Plane Damage b) Out-of-Plane Failure c) Wythe Peeling

The performance of adobe buildings included numerous instances of in-plane shear failure (Fig. 12a). Out-of-plane loading would often force out-of-plane collapses shear-damaged walls. Another common damage condition was vertical cracking damage at wall intersections. These intersections were typically achieved through bonding of header units, but the stress demands at these intersections often failed the headers. These vertical cracking failures rendered adobe walls

unable to resist out-of-plane lateral loading, thus leading to out-of-plane collapses as well (Fig. 12b). In monumental structures, the bond between wythes in multi-wythe walls was often disrupted, leading to the peeling of the outer wythes, and the subsequent collapse of the remaining slender wall.

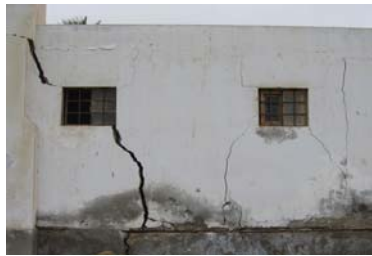
b) Lateral Spreading

Masonry buildings in certain parts of the affected region were subjected to damaging foundation movements associated with geotechnical effects from the August 15 earthquake. The coastal town of Paracas is located 15 km south of the port of Pisco, and the foundation soils underlying Paracas appears to have spread laterally as a consequence of soil liquefaction in the region [2]. The lateral spreading imposed horizontal deformations throughout most of downtown Paracas, and these deformations manifested as continuous cracks throughout the town with horizontal segments in the pavement and vertical segments in masonry walls (Fig. 13a, 13b). In the port of Pisco, which is located approximately 30 km west of downtown Pisco, numerous locations of ground settlement triggered by soil liquefaction were observed. An unreinforced clay brick masonry building owned by the Pisco Port Authority was heavily damaged as a result of the ground settlement (Fig. 13c.)
