ON-SITE INVESTIGATION AND MONITORING FOR THE ASSESSMENT OF A HISTORIC BRICK MASONRY TOWER

An experimental investigation aimed to the evaluation of the state of damage of historic brick masonry structure, referred to as The Bellevue Tower, is presented. The tower was built at the beginning of the 16th century as part of the Ferrero Palace-Masserano-La Marmorata, on the highest part of Biella, in the Italian region of Piedmont, and became the city landmark. The tower has a square plan for the first three lower floors from the ground level and an octagonal plan for the remaining four floors, ending with a stone-decorated cantilevered crowning.

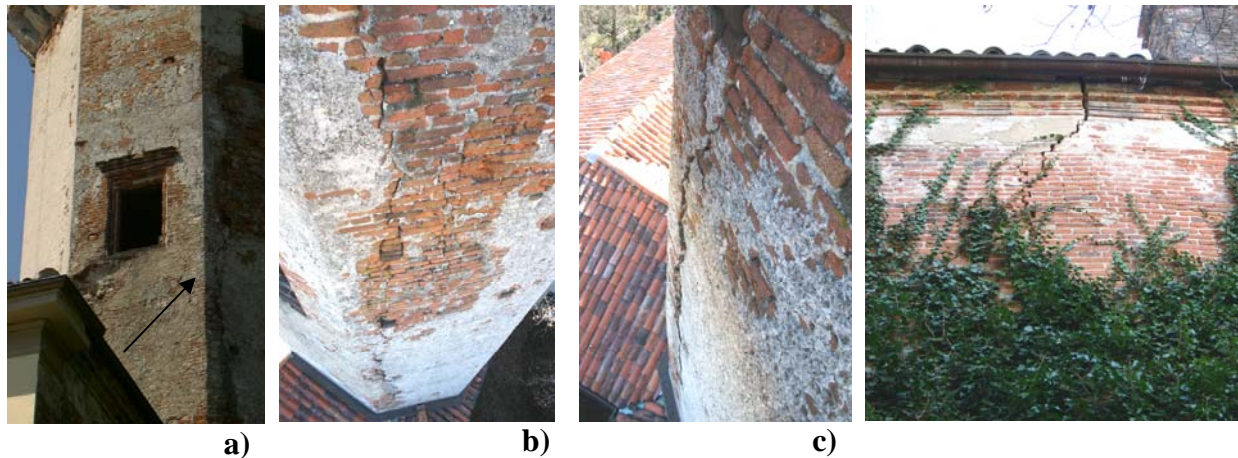
Figure 7: Cracks on the North-East wall of the tower.

In addition to a superficial decay at the crowning (Figures 5 and 6), that mostly worried the owners initially, the tower shows a diffuse damage that induced to carry out a detailed crack pattern survey in order to understand the movements and prevent possible collapse mechanisms. The tower is affected by a major crack pattern, both on the lower square portion and on the upper octagonal one, including the central pillar. Cracks are particularly visible on the South and North-East octagonal fronts and on the corresponding lower portion of the square fronts. On the North-East front an out-of-plane relative displacement can be observed which exhibits a long vertical crack (Figure 7), also continuing on the squared lower portion of the tower.

East and West fronts present diagonal cracks due to shear. This resulted, as shown in Figure 17, from the effects of a soil settlement towards South East and therefore indicating the need of measuring a possible tower tilting [5,8]. This movement could justify the presence, on the front North wall of the palace, of two bending vertical cracks having maximum aperture on the upper end (Figure 8). The crack pattern seems to be also influenced by the inclusion of the tower within the Ferrero Palace: above the level where the tower becomes octagonal and stands out the building, it is no more restrained by the Palace. Here its walls are cut by a thick network of cracks, particularly evident on the Eastern side, presumably due to compression (Figure 7).

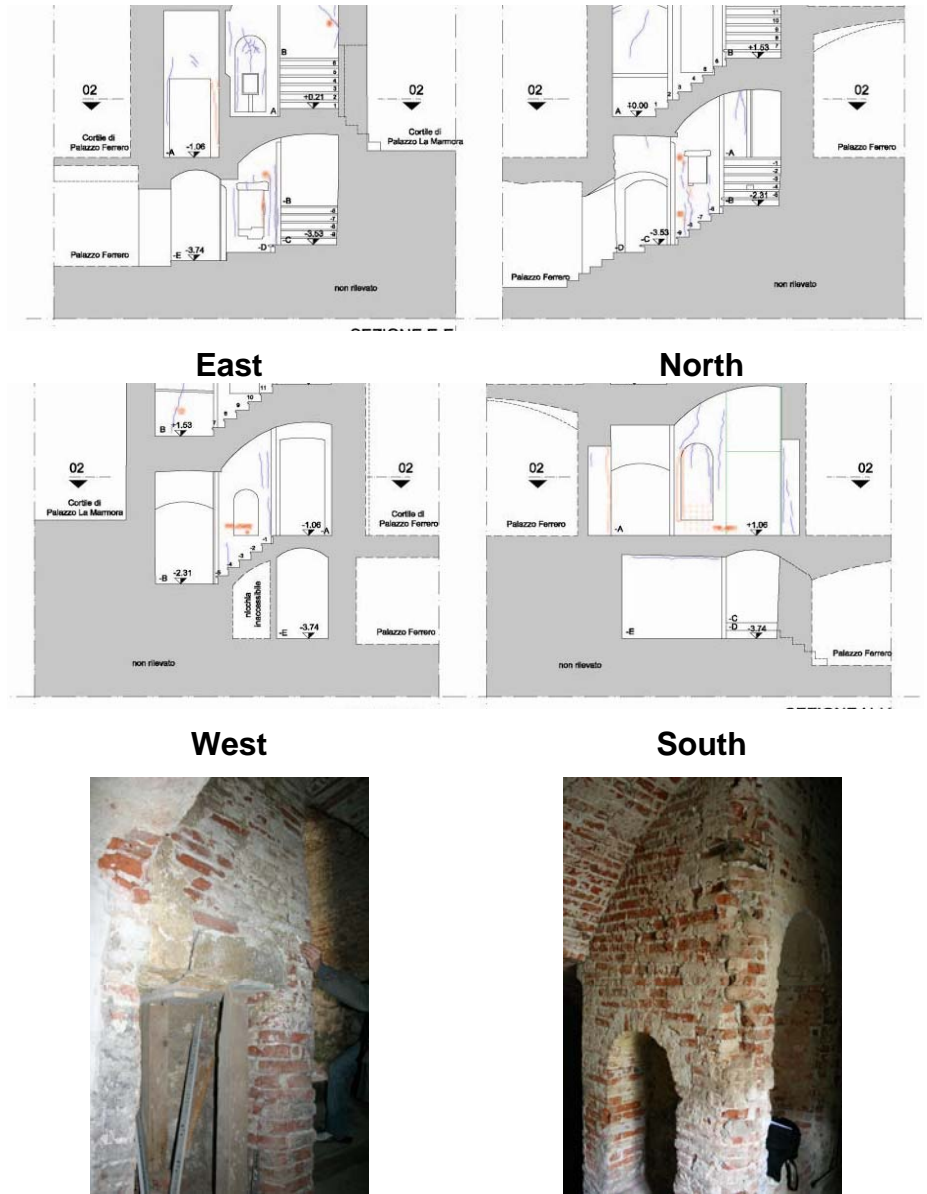
Figure 10: Crack pattern on the central pillar at ground level.

Many of the cracks cut the whole wall thickness, in other cases they only run on the surface. Sometimes the cracks can be interpreted as the results of compression, like for instance those on the central pillar at the ground level (Figures 9 and 10) and those on the South side at ground level (Figures 11 and 12) where very low sonic velocity was also recorded.

The state of damage of the central pillar at the underground level appeared immediately particularly serious due to the presence of diffused vertical cracks, taking also into account the presence of two recesses on opposite sides of the basement that abundantly reduces the solid cross section. On the contrary, the upper part of the central pillar till the crowning presents no cracks.

Cracks 3, 7 on the East wall and 6 on the West wall are affected by significant dilation with the same trend of temperature (Figure 20), whereas cracks 9, 10 and 11 on the pillar are affected by counter-cyclic dilation with respect to temperature (Figure 21). In particular, because since June the pillar has been exhibiting a continuous dilation, and considering the significant vulnerability of slender elements toward sustained compression, a retrofit intervention is in progress to guarantee the pillar safety.

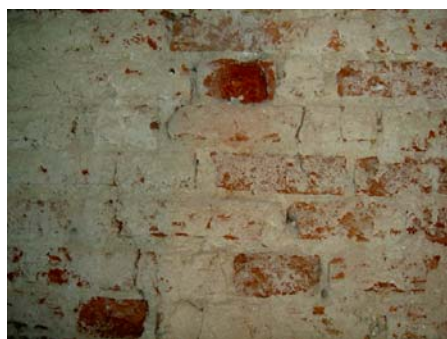
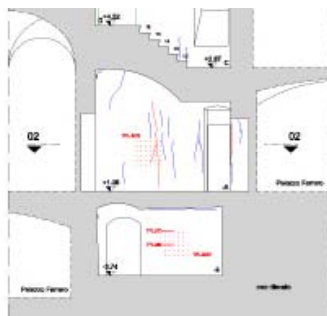
Figure 12: Crack pattern of the South wall at the ground level.

After a visual inspection by means of a mobile platform, pulse sonic carried out by direct transmission on a grid of 750x750 mm and flat jack tests have been carried out to mechanically characterize the masonry and identify the vertical stress distribution [8, 9]. The results of sonic tests (Figures 13 and 14) indicate a particularly low value corresponding to a testing point on the South side at ground level [10]. Differently from the testing point at the underground level, where the masonry can benefit from the confining effect given by the foundations, here, where the wall is laterally free, its masonry quality is worse and shows thin cracks presumably due to compression (Figure 12).

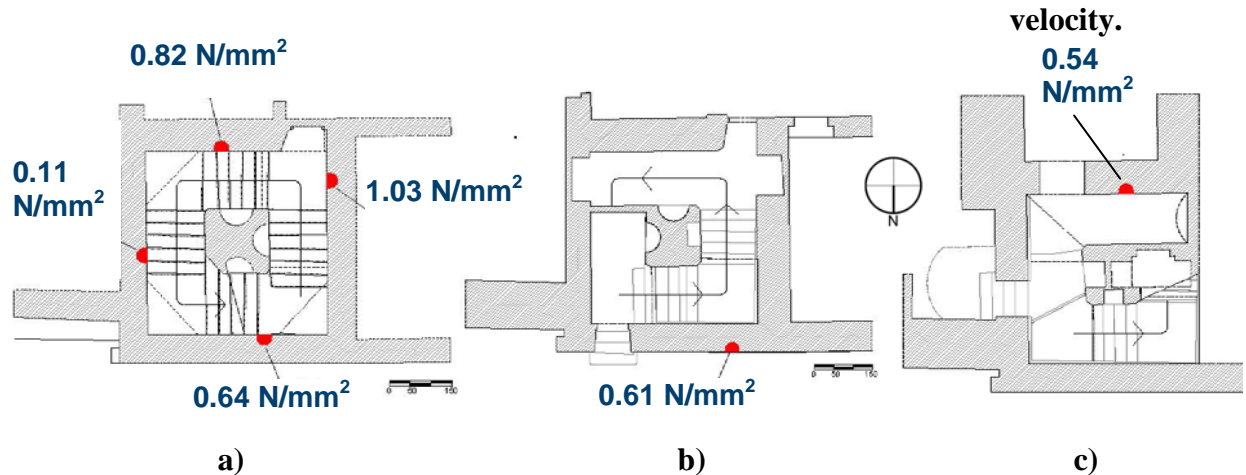
**Figure 15: Results of single flat jack tests: a) at a height of 12 m
b) at ground level, c) at underground level.**

The results of flat jack tests indicate a variation of the vertical stress with height which is reasonably influenced by a complex of factors including the tower geometry, the presence of apertures, the possibility of stress diffusion at lower levels allowed by the continuity with the palace walls, the presence of cracks, etc.

A simple calculation based on the effect of the dead load gives at the base of the tower a uniformly distributed stress in compression of about 0.8 N/mm^2 assuming perfect verticality of the tower. The vertical stress values measured on each of the four walls at a height of 12 m, just below the level where the tower shape turns into an octagon (Figure 15), show a non uniform stress distribution.

Though the highest and lowest recorded vertical stresses are apparently difficult to interpret, nevertheless the presence of bending can certainly be assumed. In particular, it has to be considered that single flat jacks are able to locally measure the vertical stress component only on one face of a wall. In this respect, since all single flat jack tests could only be carried out on the inner part of the walls for accessibility reasons, no information are available on the stress distribution across single walls. However considering on the one hand the extremely low value on the West face of East wall as well as the high value on the East face of the West wall and on the other hand the higher stress value on the South wall than on the North wall, an overall bending toward South East can be assumed, probably due to the tower tilting. This is also responsible of the crack pattern described above and is plausibly due to soil settlement. The hypothesis is confirmed by the results of the geometrical survey subsequently commented.

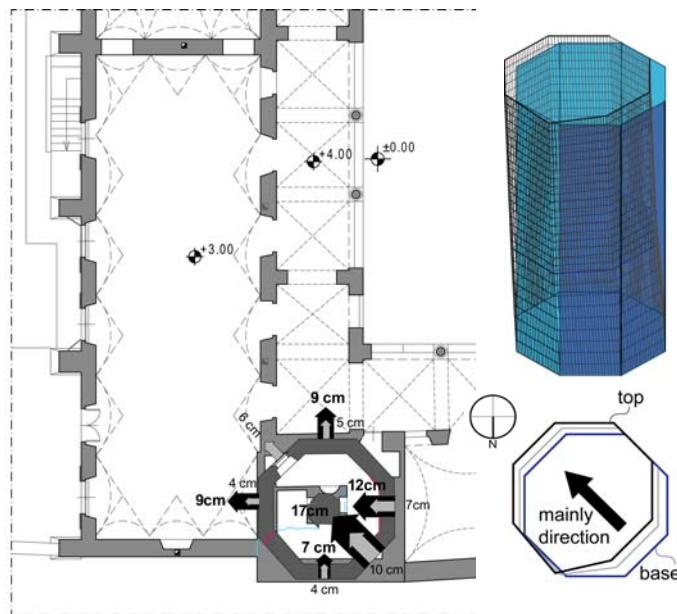
Figure 16: Survey of the tower verticality.

Following all previous considerations, measurements of the tower verticality were carried out both through the plumb and through a topographic survey with a laser integrated theodolite (GEOTOP). The use of two methods was required because of the difficulty to establish a closed polygonal: the “forward intersection” was adopted, keeping the fixed points on the tower, and surveying them from several station points. The survey was carried out only from outside; due to the low visibility of some sides, that were hidden by the roof, the loss of verticality was calculated by using two different zero levels: one at 14.40 m and the other at 18 m. A loss of

verticality was detected mainly in the South-East direction, towards the center of the hall (Figure 13). In fact, this is the direction where the ground slopes and buttresses built on the eastern front of the palace testify that the phenomenon presumably initiated in the past. To better understand the effects of this movement on the tower, also considering the influence of its inclusion in the Ferrero Palace and its interaction with the ground slope, a 3D representation is shown in Figure 16.

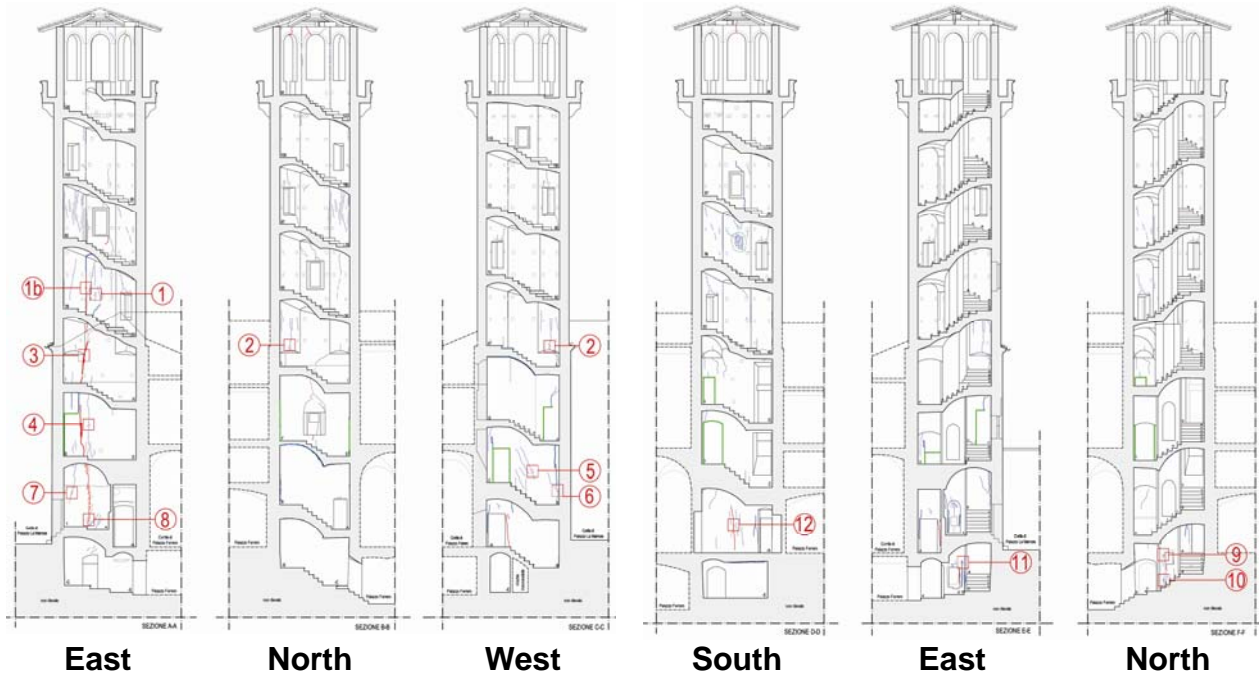
Figure 18: Position of the main cracks subjected to the monitoring campaign.

A monitoring program has been designed to record the possible evolution of the movements of the main cracks over a first period of 18 months to achieve an accurate evaluation of the state of damage and a safety assessment of the building. In addition to temperature data, manual readings are taken on three metal plates at each position, so to know two relative displacement components: a “dilation” one, orthogonal to the crack direction and a “shear” one, parallel to it. The locations of the main cracks subjected to the monitoring scheme are indicated in Figure 18.

Despite the interpretation of some readings cannot be yet univocally given, some interesting overall considerations may be drawn. Some cracks exhibit significant displacements both in the dilation and in the shear direction, generally following a cyclic trend strongly influenced by temperature variations. Considering shear displacement (Figure 19), it is interesting to notice that some cracks are not significantly involved by this component, like cracks 9, 10 and 11 on the central pillar and cracks 12, 1, 2, and 5, where dilation is prevalent. Differently, shear displacement components look particularly evident on cracks 7 and 8 on East wall where it shows a comparable amount but an opposite sense with respect of cracks 5 and 6 on West wall. For East and West wall are parallel, these readings indicate an overall shear displacement of the tower which has to be related to the ground settlement also influencing the tower tilting. The

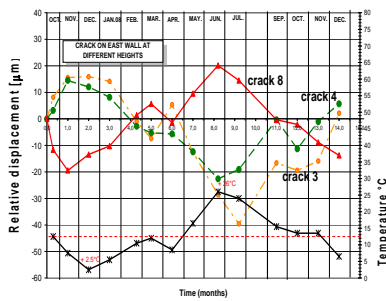
meaning of shear of cracks 3, and 4, which is opposite to that of cracks of the same side, remains more difficult to understand.

Figure 19: Shear on the main wall (cracks n. 3, 4, 8).

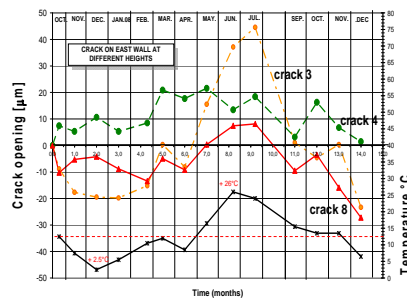
Figure 20: Dilation on the main wall (cracks n. 3, 4, 8).

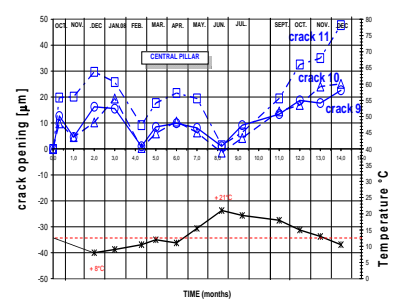
Figure 21: Dilation on the pillar (cracks n. 9, 10, 11).
