11th Canadian Masonry Symposium, Toronto, Ontario, May 31- June 3, 2009

FACADE STABILIZATION: A PROLOGUE TO MASONRY RESTORATION

E.A. Gerns¹ and M.E. Novesky²

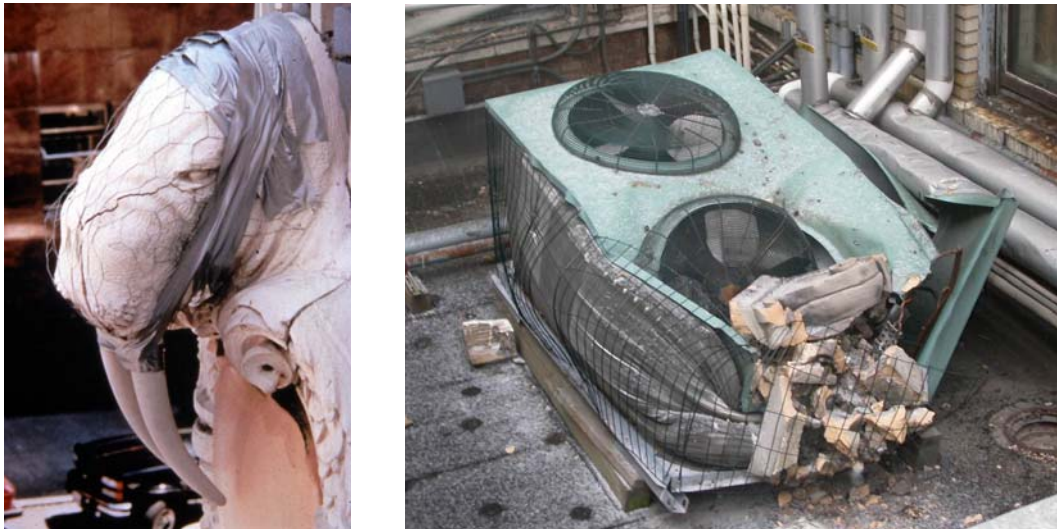
Figure 1: Examples of inappropriate maintenances resulting in public safety conditions.

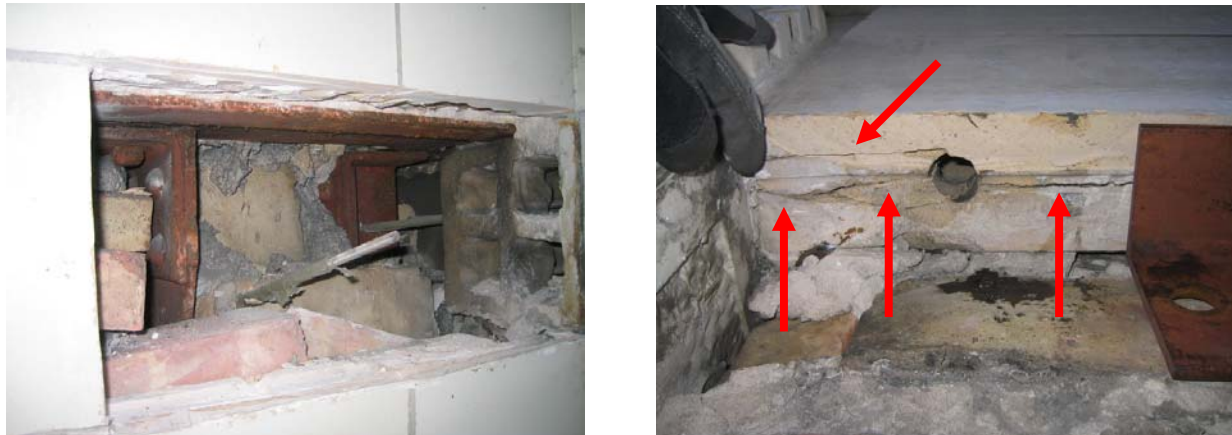
The cells of the ashlar units were found to be unfilled. The ashlars were anchored back to the structural steel columns or adjacent terra cotta units with bent square bars through holes in the top surface of the unit. Typically, the original steel lateral anchors were in serviceable condition with only minor surface corrosion. The building structure was comprised of built-up I-shaped steel columns and on this facade the web was parallel to the exterior wall. The space between the steel column and back face of the terra cotta was void at the top and intermittently filled with brick and mortar from mid-height to the floor level (Figure 2).

Figure 2: Representative examples of the conditions found in Case Study 1:
a) Previous repair anchor remaining after removal of terra cotta unit; b) Shear cracks through terra cotta unit behind exterior face (note: angle on right side of photograph was installed as a temporary support).

Since the large void areas existed behind the terra cotta, the previous repair attempts were ineffective. The threaded rod stabilization anchors were not installed into sound backup material. Instead, the anchors were installed through the face of the terra cotta units and hung freely in the void area. At some locations, there was evidence that the contractor who had installed the anchor had encountered steel while drilling the pilot hole for the anchor as indicated by the scratches in the column directly behind the repair anchor locations.

face shell of the terra cotta units ranged between 1 inch and 31.75 mm (1.25 in). The back of the face shell was spalled from drilling the anchor hole into the terra cotta unit. The depth of the spall was approximately 12.7 mm (0.5 in). Thus, the threaded rod likely engaged less than 6.35 mm (0.25 in) of the face shell. The previous repair therefore did not adequately engage the face shell of the ashlar unit or provide adequate embedment of the anchor into the substrate.

Based on these observations, the masonry contractor was directed to install plywood over units which were identified to be loose or vibrate when sounded. The plywood was lapped over adjacent ashlar units and secured with stainless steel threaded rods with epoxy, washers, and nuts into the cells of the adjacent units. This approach was used to prevent loose face shells from dislodging and falling by restraining the delaminated portion with the plywood enclosure. At the completion of our inspection, we advised the owner that a repair plan should be developed and implemented the following year. The repairs would include the removal and installation of new terra cotta ashlar units at all of the plywood locations.

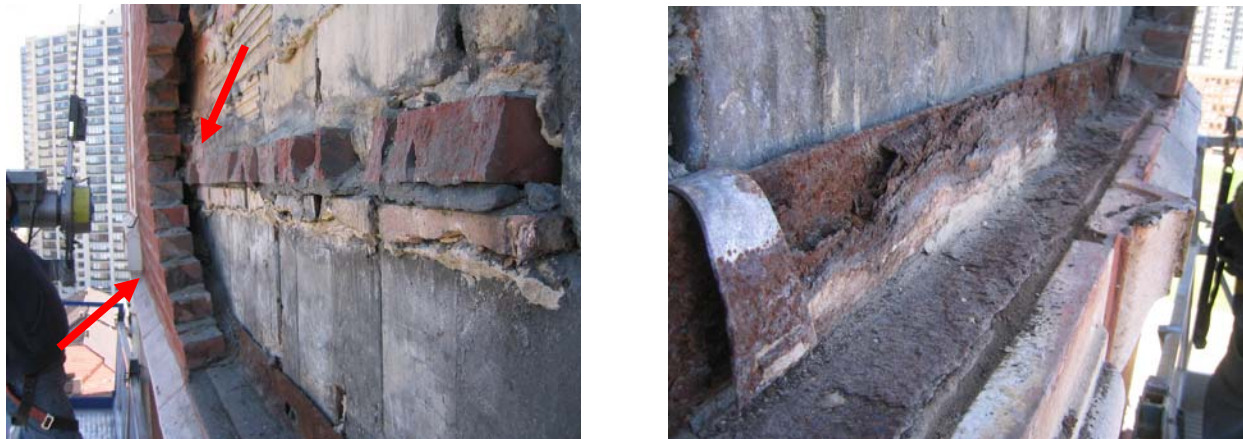
A limited survey of the collar joint at the inspection opening revealed that no brick ties existed between the field of the face brick and the backup wall. The majority of the brick headers were actually false headers, with true headers being installed randomly throughout the parapet wall. The true headers visible at the inspection opening were cracked at the collar joint interface and the outer wythe was displaced outward as much as 38 mm (1.5 in). A loose laid steel angle had originally been installed on top of the terra cotta banding course and was significantly corroded. Loss of section and corrosion scale accumulation of the angle had caused the parapet wall to be displaced upward, resulting in the observed cracking and displacement of the brickwork (Figure 3).

**Figure 3: Representative examples of conditions found in Case Study 2:
a) Cracked headers and displaced parapet wall; b) Significantly corroded angle.**

Based on our observations of the existing construction and the severity of the exterior wythe displacement, we recommended that the parapet wall cladding be removed from the terra cotta band up to and including the coping units. The backup walls remained and a wood-framed wall was installed in front of and anchored back to the concrete structure. Plywood sheathing was installed on the exterior of the framing and the joints and perimeter sealed to provide a water tight enclosure. Due to economic constraints, we recommended that the owners develop and implement a repair program for the building facade which would be performed in a phased approach over a number of years. The repair program will include reconstruction of the parapet walls removed during the inspection as well as repair and/or replacement of other areas of deterioration on the facade.

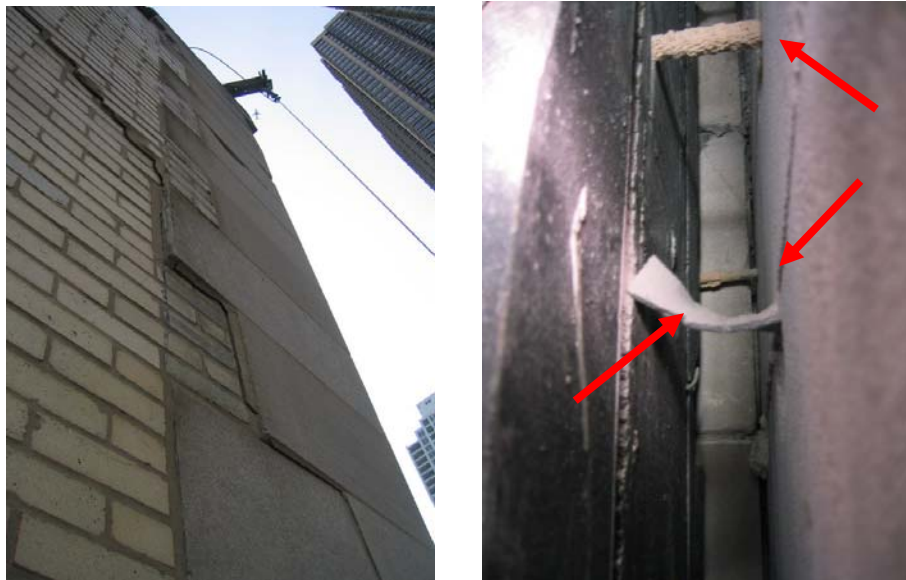
At the inspection opening, it appeared that the limestone units were originally laterally restrained by metal dovetail strap anchors set into vertical dovetail slots cast into the face of the concrete column. However, at numerous locations, corresponding to the displaced limestone panels, the limestone dovetail strap anchors were no longer engaged in the slots in the columns. The anchors had either been pulled out of the slot by the horizontal movement and associated forces within the wall, or they had not originally been installed into the slots. Thus, the limestone units at the top of the parapet wall were not adequately anchored to the backup (Figure 4). The brick portion of the wall was originally anchored to the masonry backup wall with smooth or corrugated metal brick ties. However, the ties were found to be randomly installed and several were severely corroded or had pulled out of the bed joint of either the backup or exterior wall from the forces resulting from the wall displacement.

Figure 4: Representative examples of conditions found in Case Study 3:
a) Displaced brick and limestone; b) Bent original dovetail anchor (left arrow) and new epoxy threaded rod stabilization anchors (right arrows).

In order to secure the limestone in place, the contractor was directed to install stainless steel threaded rods through the face of the units set into an epoxy filled hole in the concrete column. A washer and nut were installed on the end of the rod and installed snug to the face of the limestone to prevent further outward movement of the units. The brickwork was stabilized by installing a stainless steel retaining system consisting of a grid of stainless steel straps installed over stainless steel mesh. The straps and mesh are held in place with stainless steel threaded rods set in epoxy into the backup brickwork. The mesh and straps were installed snug to the face of the limestone with washers and nuts on the ends of the rods. The owner is currently in the process of developing and implementing a repair program which includes removing and rebuilding the displaced masonry walls.

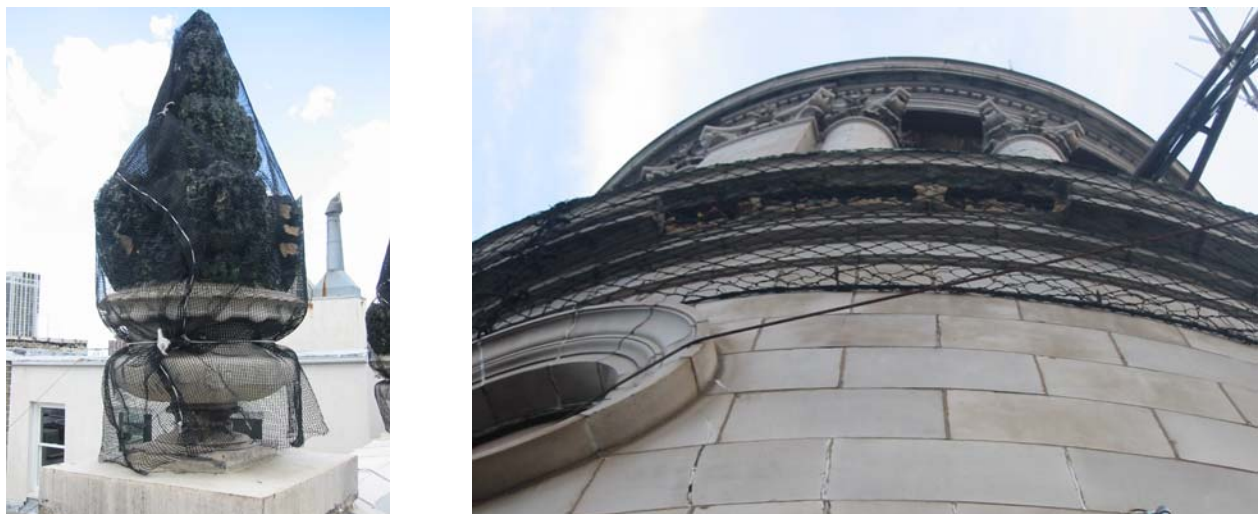
Figure 5: Representative examples of netting systems.
