## **SURVIVORS TALES: UNREINFORCED MASONRY AND THE 1886 CHARLESTON, SOUTH CAROLINA EARTHQUAKE**

**Steven C. Jaumé<sup>1</sup>, Krystle S. Miner<sup>2</sup> and Craig M. Bennett, Jr.<sup>3</sup>**

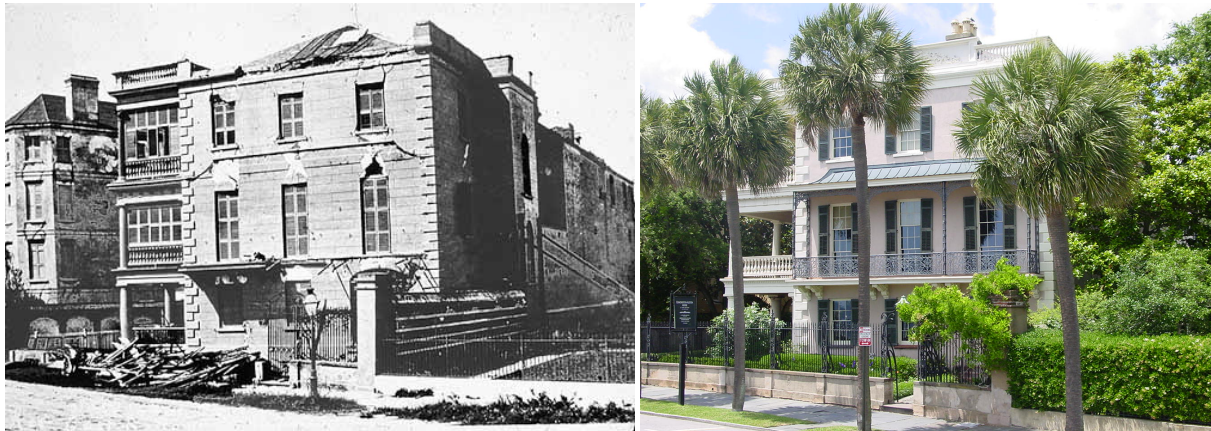
**Table 1: Example entry from 1886 Charleston earthquake insurance report for 21 East Battery; “Damages by Earthquake” are estimated repair costs in 1886 US dollars**

Material		Dimensions			Condition of Walls				Condition of chimneys or flues	Damages by Earthquake	What should be done to make it safe
Building	Roof	Ft. Long	Ft. Wide	Ft. High	North	South	East	West			
Brick	Tin	125	60	40	Must come down	Badly cracked	Must come down	Badly cracked	Must be taken down	5330	By entire renovation

**Figure 1: 21 East Battery, view from northeast: left) 1886 post-earthquake; right) in 2002.**

One aspect of damage to URM buildings observed both in historical and modern photographs is evidence of in-plane versus out-of-plane masonry wall failures. In-plane shear cracking (Figures 1 and 5) is often observed between windows and out-of-plane failure is seen in fallen gables and

walls separating from buildings (Figure 2). A preliminary review of the insurance report and corresponding photographs suggest phrases such as “badly cracked” and “severely cracked” for walls with many windows imply in-plane failure. Phrases such as “top of wall down” appear to indicate out-of-plane failure.

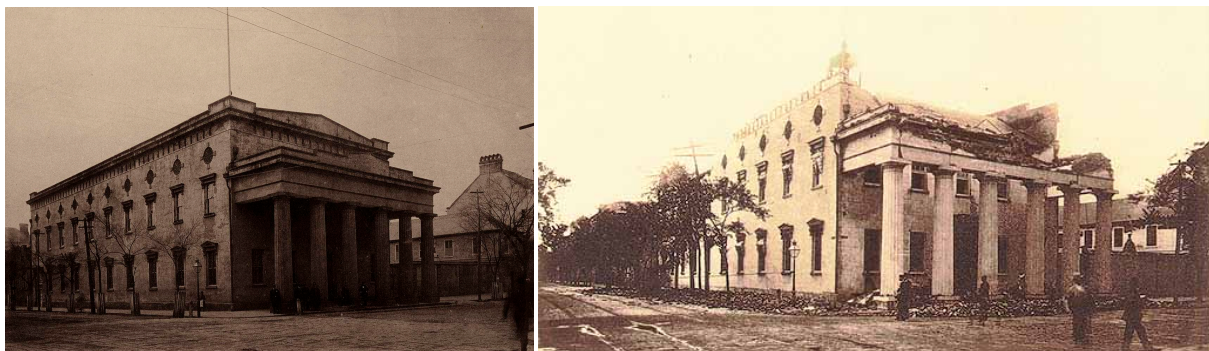
**Figure 2: Main police station, corner of Meeting and Broad Street: left) 1883 pre-earthquake; right) 1886 post-earthquake.**

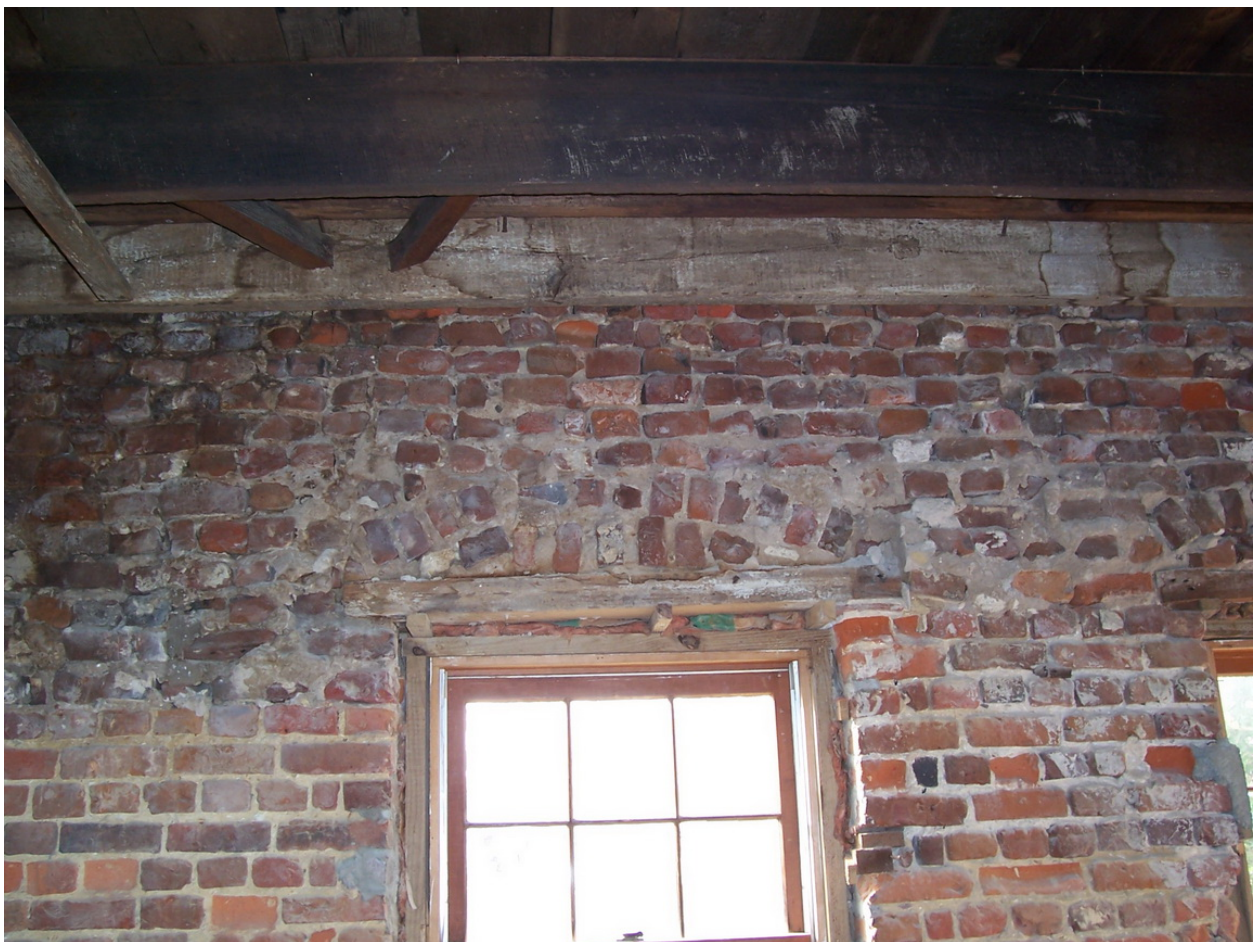
Finally, one must never forget the importance of being a good observer of the built environment. As one walks around the older parts of Charleston looking at pre-1886 masonry buildings, one finds subtle clues in almost every building of the earthquake damage and subsequent repair. Further studies by the third author during restoration work on many of these historic structures show that the level of 1886 damage is made obvious when interior finishes are removed, providing those working on the buildings with clear maps of failures (Figure 4).

**Figure 4: Interior view of the top (third) floor of an unreinforced masonry wall, originally built in 1785. Lower quality construction in the upper portion is the 1886, post-earthquake, reconstruction.**

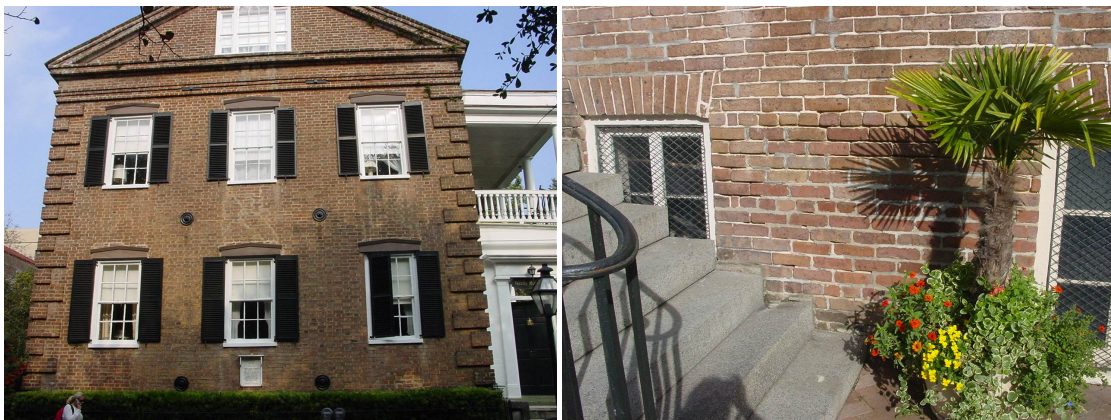
**Figure 5: Buildings on Glebe Street on the College of Charleston campus: left) 20 Glebe Street, showing typical post-event “earthquake bolt” (pattress plate) repair; right) close up of 12 Glebe Street showing mortar deterioration due to moisture migration through the wall.**

- b. Dizhur et al. [16] noted that poor quality mortar played a significant role in URM damage during the 2010 Darfield earthquake, with some mortar failing with finger compression. We have noted similar "finger compression failure" mortar in Charleston (Figure 5), particularly in the mortar used after the fire of 1837. Some of the mortar used in the repair after the 1886 earthquake had a Portland cement base and has held up better than some pre-1886 mortar.

Observation of 1886 post-earthquake photos, study of 1886 reports and present day knowledge of the structural damage to buildings built before 1886 all indicate that closely spaced pattress plates were tremendously effective in tying brick masonry walls to floor diaphragms, that is, in holding masonry buildings together during the 1886 earthquake. For this reason, in present day structural repairs and strengthening of historic masonry buildings, we generally favor them over stainless steel/epoxy/screen tube (resin) anchors. Their pullout cones are quite large, compared to the similar cones of resin anchors. Details of some modern pattress plate installations by the third author’s firm are shown in Figure 6.

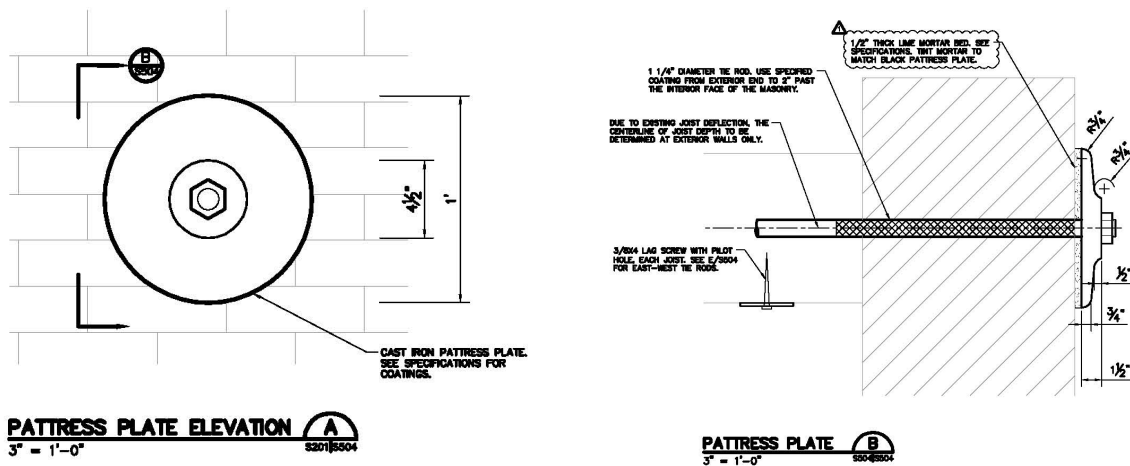
**Figure 6: Diagram of typical pattress plate and rod system in current use by third author.**
