SEISMIC VULNERABILITY ASSESMENT OF MASONRY APARTMENT BUILDINGS IN ACAPULCO CITY (MEXICO)

**Sulpicio Sánchez Tizapa¹, Roberto Arroyo Matus¹, Ahmed Mebarki², Nathalia Valencia³
and José Antonio Morales Galeana⁴**

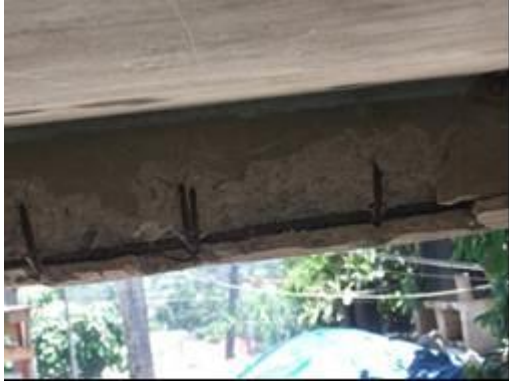
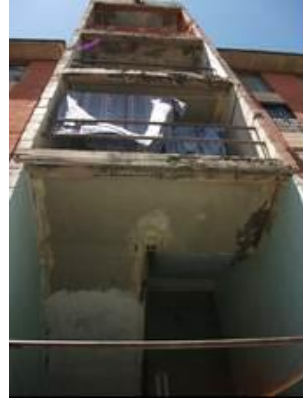
1. Environment causes. a) Salt weathering caused by the marine environment, which produces the cover concrete spalling and corrosion of reinforcing steel, b) Attacks of bacteria, which feeds lichens and algae; it can generate structural or non-structural damage, see Figure 3.
2. Human causes. a) Design and construction errors: Inadequate wiring for both plumbing and electrical installations. It is the origin of foundation settlement, moisture in walls, corrosion of reinforcing steel, and damage of painting finishes; b) Structural modifications, which modify the behavior of buildings, see Figure 4 and 5.

Figure 3: Current physical condition of buildings: a) and b) Cover concrete spalling and corrosion of reinforcing steel; c) Moisture in walls of upper stories; d) Shrubs growing on the roof

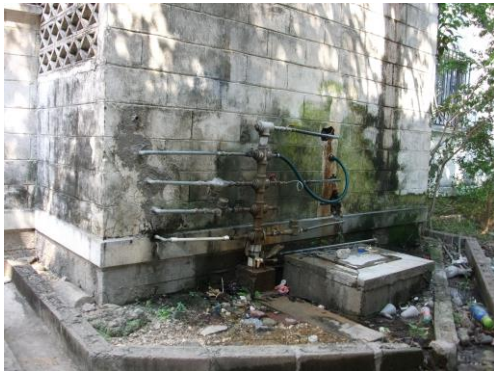
Figure 4: a) Bad plumbing systems producing moisture on walls; b) Inadequate electrical system installation

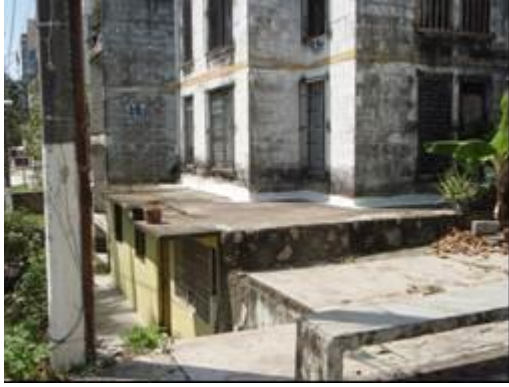
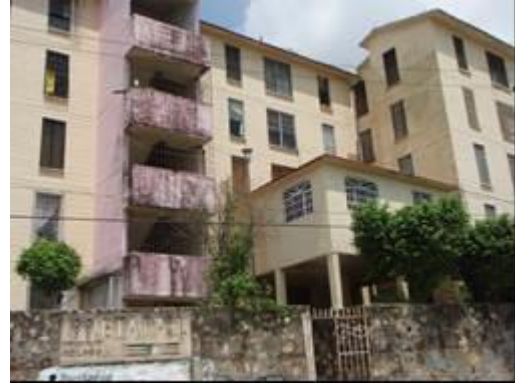
Figure 5: Structural alteration of original architectural system: a) and b) Additions in lower stories; c) and d) Additions in upper stories

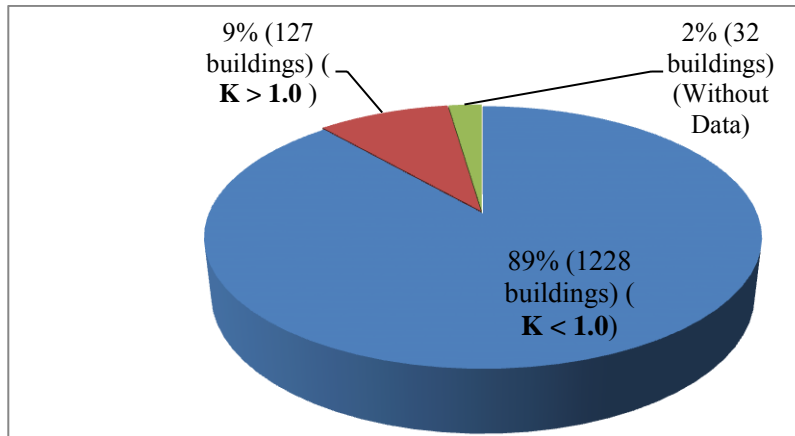
Figure 7: Seismic capacity index of buildings blocks

Table 8 contains the lowest values of the seismic capacity index calculated for the 41 identified structural typologies according to Equation 1. Figure 7 summarizes the seismic capacity index (K) of the apartment building blocks in Acapulco City.

Current physical conditions as well as the building blocks stock in Acapulco (Mexico) were evaluated in this study. Therein, 1,387 buildings were divided into 17 blocks and 41 different typologies were identified. Even if the methodology used to evaluate the seismic capacity of the buildings is simplified, it has allowed the identifying the seismic vulnerability of a huge stocks buildings. According to Figure 7, the seismic capacity index of 1,228 buildings (89%) is lower than one, which implies high vulnerability of these buildings by considering the current physical condition and the earthquake design spectra. It can be stated that only 127 buildings (9 %) comply the standardized specifications.

This situation could be justified because most of these buildings were constructed before the local code which was updated in 1994, when the values of seismic coefficients were raised in order to improve the seismic capacity of buildings. However, it is compulsory to establish an extensive structural retrofiting program in order to reduce the high seismic vulnerability of these buildings.
