RESTORATION OF HISTORIC BRICKWORK CASE STUDY: THE ROUND FOUNDRY, LEEDS, UK

G. J. Edgell¹

¹ Dr, Ceram, Stoke-on-Trent, Staffordshire, ST4 7LQ, UK, geoff.edgell@ceram.com

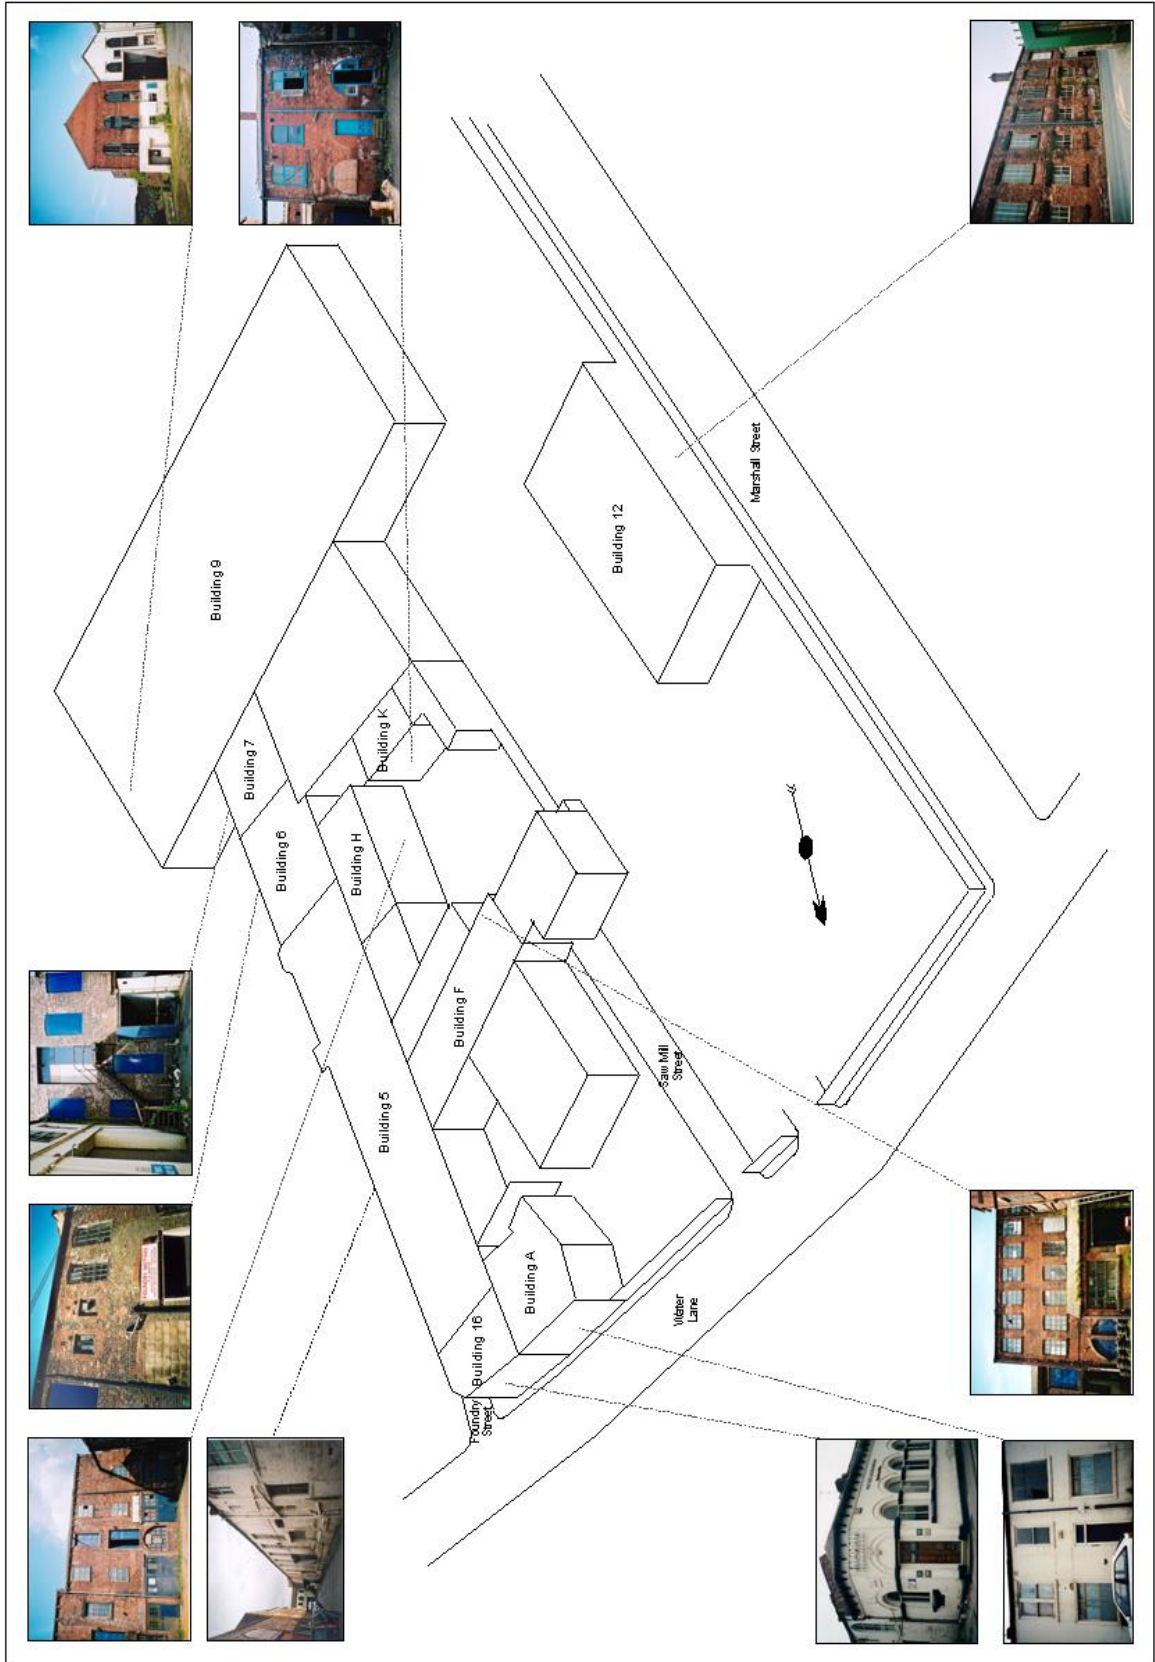
Figure 1: The Round Foundry

The front of the Fireproof Mill (building F on Figure 1) faces South into what was known as Saw Mill yard. The main part of the building is three storeys high (see insert on Figure 1) with a one storey lean-to extension. The extension of the building showed large patches of frost damaged bricks but also numerous individual bricks which has suffered frost damage. In total it was estimated that 25% of the bricks were damaged.

The brickwork in the South facing elevation, which would become exposed when the single storey extension was removed, was expected to have a reasonable working life. However there were other areas where there was quite extensive frost damage and either further testing was warranted or fairly extensive replacement was necessary. In view of the degree of damage in what is a very sheltered location the brickwork of the Western elevation it was recommended that it be replaced.

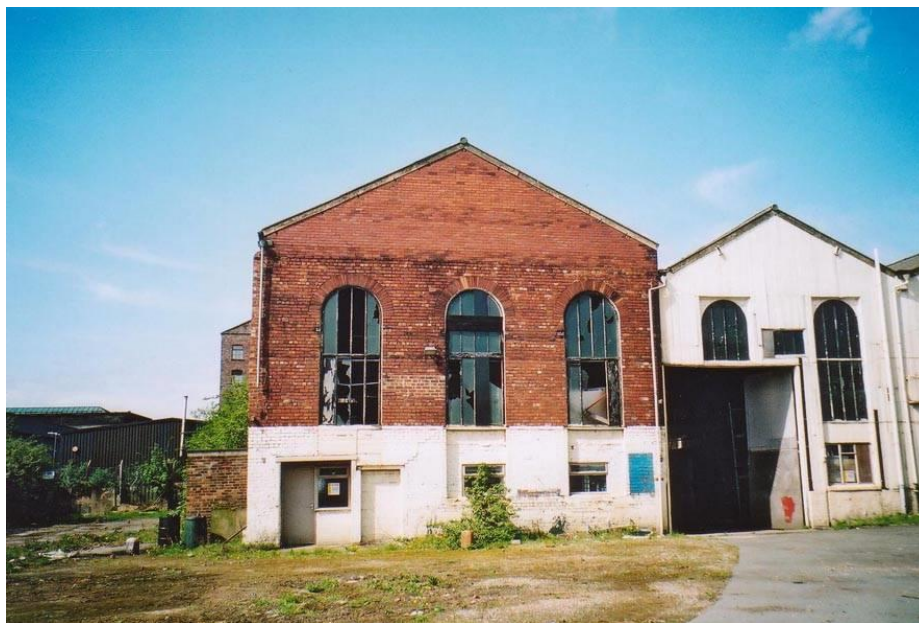
Figure 2: The Machine Shop

This was the building in which machines were assembled and consisted of the remains of three buildings. Attention was focussed on the Eastern elevation of the building as much of the rest of the cladding was to be replaced (see Figure 2). The brickwork plinth to the timber clad Northern part of the building was painted white, it was 370mm thick (1½ bricks) thick. The wall was generally in English Garden wall bond, with a course of headers in every fifth course. The brickwork was in good condition with no indication of frost failure and a hard grey mortar had been used. The window cills varied, in some cases being of bullnose specials and in others timber had been used.

The brickwork in the Southern most part of the Eastern elevation (1875-1877) was painted white up to the cill level. The top triangle was relatively new, and the remainder had been repaired in various places and is in need of further repair. The rebuilt top triangle of the wall looked to be in good condition, it was one brick thick and connected to the roof structure by six straps, probably of steel along each of the two verges. There was a diagonal crack to the Southern end.

The Eastern wall was 510mm (two bricks) thick at the base, reducing to 380mm (1½ bricks) at the height of the cills to the main windows (4.26m). The height at which the brick changed to those for the apex is 7.8m. The arch bricks were of special shape 310mm in length with a depth of 50mm at the arch soffit and 75mm at the other end. Above the window openings the mortar which was hard to a key test had eroded to a depth of about 10mm.

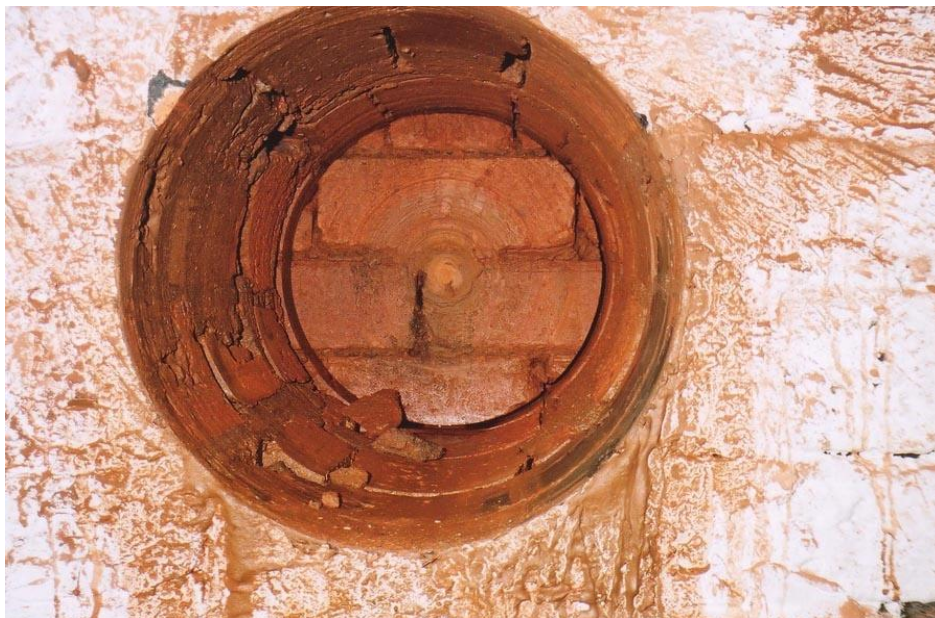
Figure 3: Core Site

In view of the desire to retain this façade sampling, which left damage to be reinstated, was kept to a minimum. However, in order to try to obtain a sample of brickwork for testing an attempt was made to remove a 300mm core from the internal face of the wall near to the Southern end. The removal of the core showed a number of things. The wall construction is of two parallel leaves each one brick thick. Although each wall appeared to be cross-bonded every sixth course there seemed to be no regular connection between the leaves. The core could not be removed intact as the mortar was very weak and friable and also because there are a significant number of places where the mortar was missing. These gaps in the joints were clearly visible from the cored wall, see (see Figure 3) and were evident as water used to lubricate the core drill was emerging from joints remote from the drilling position. The mortar mix was 1: 0.1: 11.5, which confirmed that the reason for the poor performance was lack of binder. Two bricks were removed from the Eastern façade. In order to obtain representative samples of what is an important part of the cladding without being too intrusive, and in view of the fact that this building was known to be part of an earlier larger building. It was considered that the brickwork of the Southern boundary wall was of the same type as machine shop and greater numbers of bricks were sampled from that wall. The boundary wall was probably the Southernmost wall of the original larger building. Although the water absorptions in the bricks from the boundary wall were highly variable, it seems most likely that the inner leaf of the Eastern wall, the Southern boundary wall and what remains of the old North wall is of one brick type. The outer leaf of the Eastern wall was of a different, denser, larger brick type. For the purpose of future structural consideration this difference is probably unimportant.

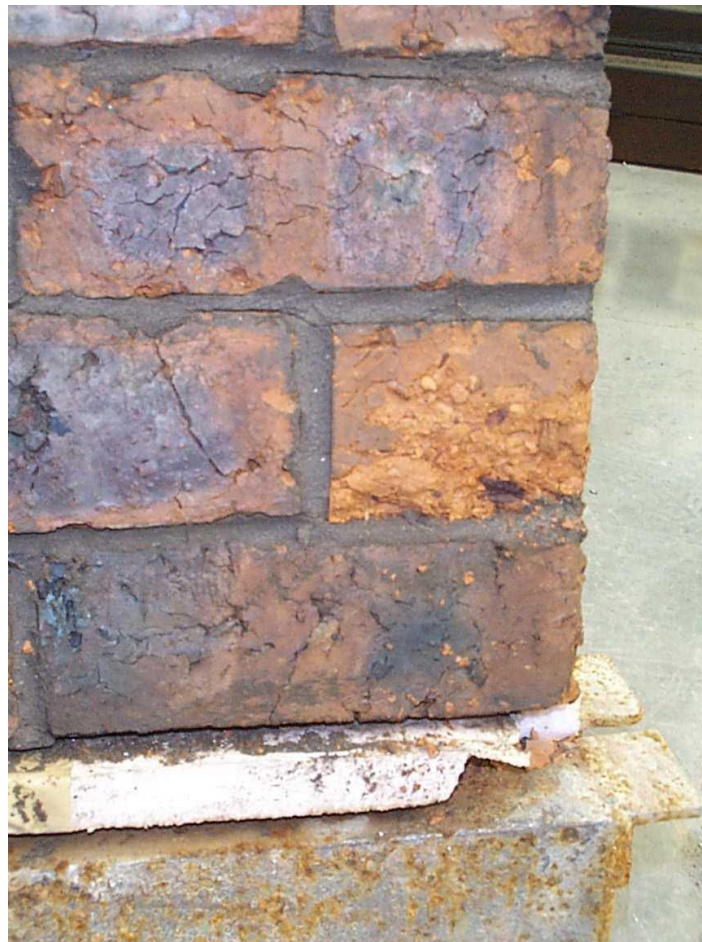
Figure 4: Frost Failure

In view of the massive nature of the wall, which had clearly been built to withstand the load from another storey, now removed, attention was focussed on the likely durability of the façade rather than compressive strength. However from the cubes cut from the interior bricks which come from the core it seemed strength of about 10MPa was reasonable [10-15]. This would suggest, bearing in mind the poor nature of the mortar, a brickwork strength of no more than 2MPa. The two bricks sampled from the Eastern façade of the building and the eleven taken from the boundary wall, were tested for their frost resistance. They did survive 78 cycles before failure occurred by delamination of one of the two façade bricks, one of the eleven boundary wall bricks and no further damage occurred to other bricks during the remainder of the 100 cycles (see Figure 4). Consequently the bricks although of quite low strength were of reasonable durability, however once failure occurred it did develop quickly.

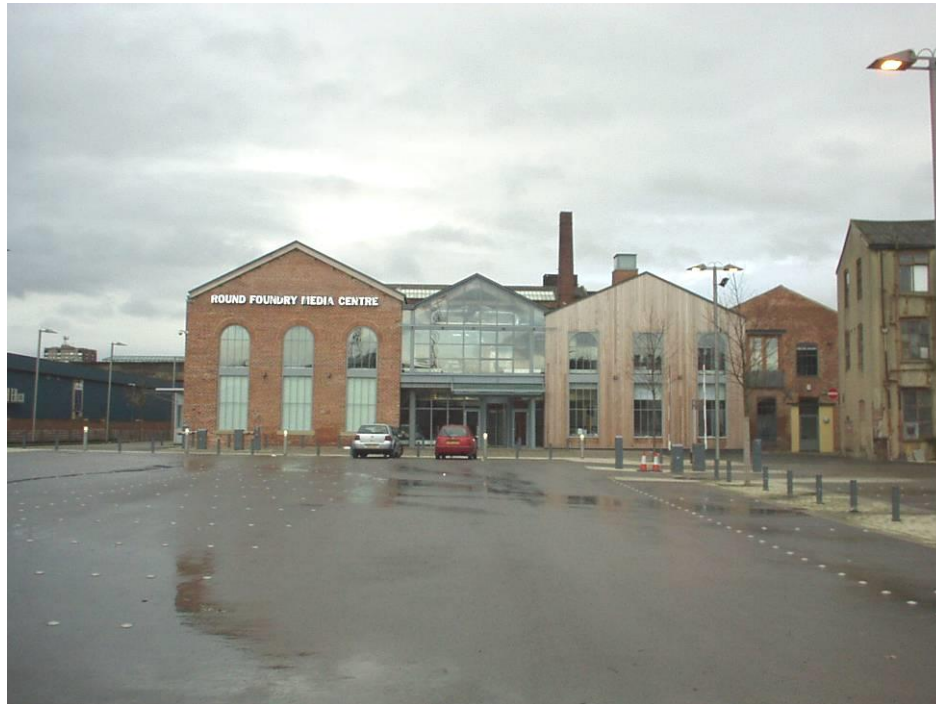
Figure 5: Round Foundry Media Centre

Since the work on site it is understood further consideration was given to the brickwork elevation. Although the bricks appeared to be some of the more durable from the site the mortar within the body of the wall was poor and there were numerous gaps. The fairly poor standard of construction in terms of joint filling, the poor mortar and the fact that quite extensive repairs would be required to make the corner safe, to stitch across the cracks means that repairs would be extensive. Taken together with the fairly unsightly painted band at the bottom part of the wall suggested that replacement was the best option. This was what was done and the wall was replaced forming a façade for what is now The Round Foundry Media Centre (see Figure 5) which was built in the same style as the original.
