13TH CANADIAN MASONRY SYMPOSIUM
HALIFAX, CANADA
JUNE 4TH – JUNE 7TH 2017

RESTORATION OF HERITAGE BRICK CLOCK TOWER

Hughes, Kevin¹

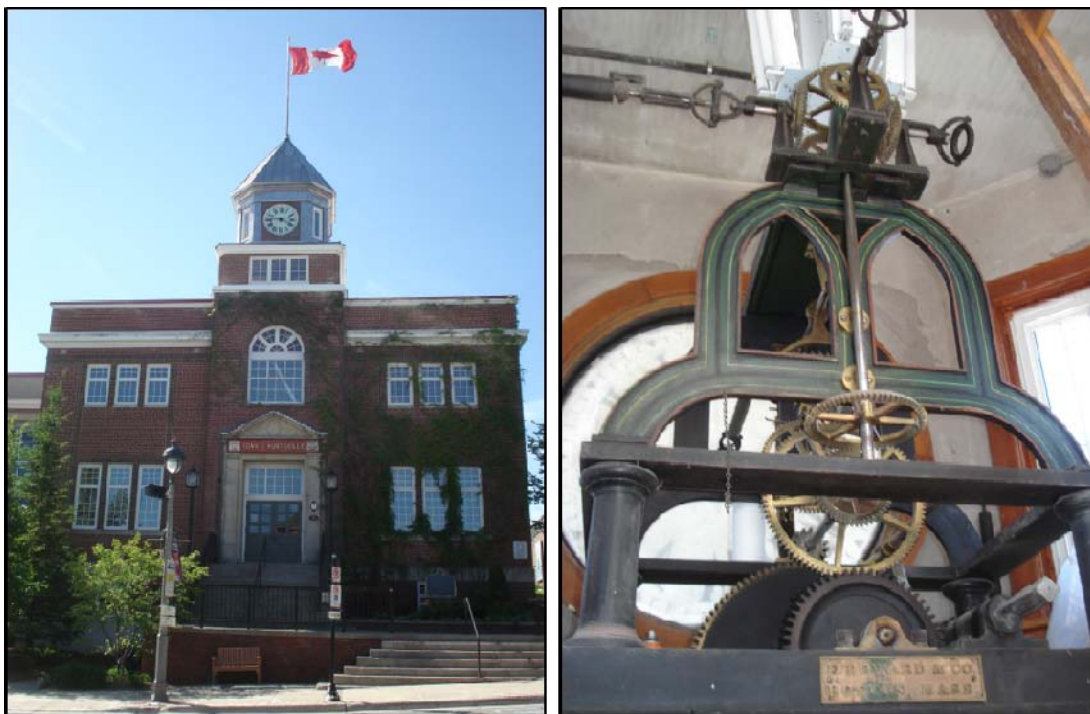
Figure 1: Huntsville Town Hall (left), Clock Mechanism (right)

The town of Huntsville originally retained a structural engineering consultant in September 2011 to prepare a repair scope of work to address the damaged wood floor framing supporting the clock tower motor and gear mechanism (refer to Figure 1). Tacoma was not involved in the project at this time. The repair work was intended to address the main source of water infiltration which was originally thought to be the flat roof on which the eight-sided tower structure was supported. The original scope of repair work included: reinforcement of upper tower floor joists, replacement of windows in lower level, replacement of lintels above windows in the lower level, and waterproofing of flat podium level of the clock tower structure. Heritage Restoration Inc. from Toronto,

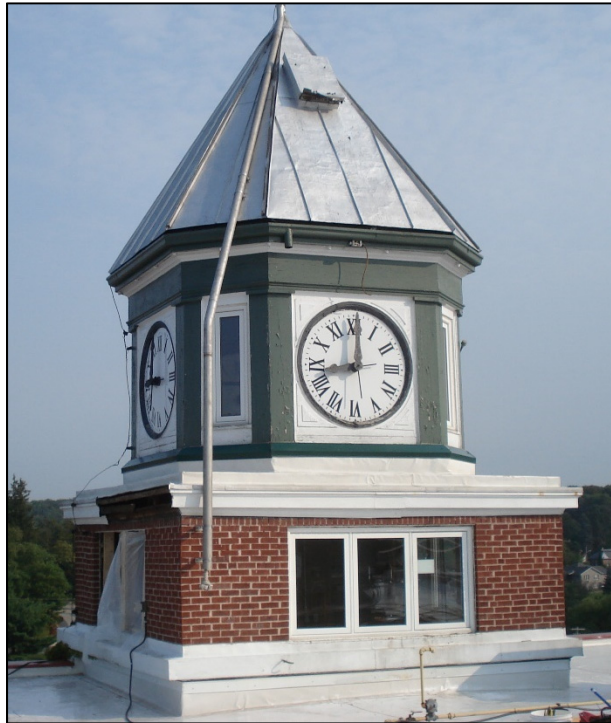
Figure 2: Existing Condition of the Clock Tower (August 19, 2013)

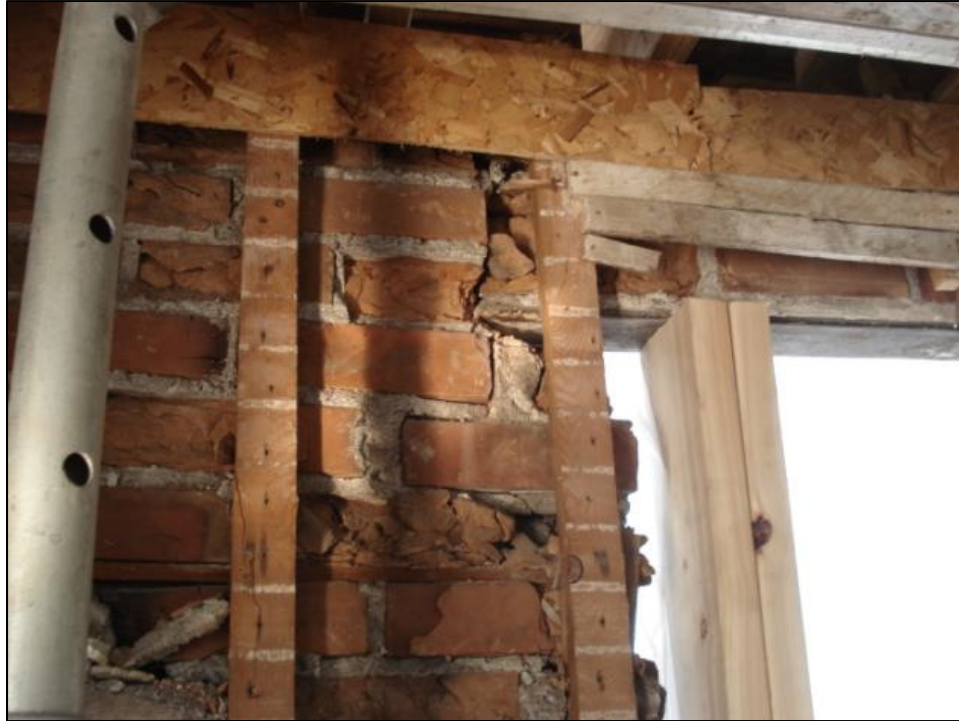
Construction of the original repair scope started in the Spring of 2013. The clock mechanism was removed and the floor framing below the clock mechanism was reinforced. Construction halted when the contractor removed the interior plaster wall sheathing in order to remove one of the old windows. Significant deterioration of the multi-wythe masonry wall construction was noted (refer to Figure 3). The General Contractor asked the Engineer of Record if Tacoma could be brought in to review the condition of the brick walls, given our knowledge of heritage masonry buildings. The Engineer of Record did not object. Tacoma first attended the site on August 19, 2013 to review the condition of the brick walls. The deterioration of the inner-wythe was severe. Mortar loss and spalling was extensive in the area exposed. The softer inner-wythe of the brick wall was in very poor condition and the structural integrity of the wall was in question. Tacoma recommended that the remaining interior finishes be removed from the lower level to facilitate a more complete assessment of the masonry conditions. Since the repair work to the floor framing had been completed, it was decided that Tacoma would take over as Engineer of Record for the project. The restoration efforts were put on hold until a detailed assessment of the brick could be completed. Shoring of the tower floor framing was to remain in place until a revised repair scope could be established.

Figure 3: Severe Brick Deterioration (August 19, 2013)

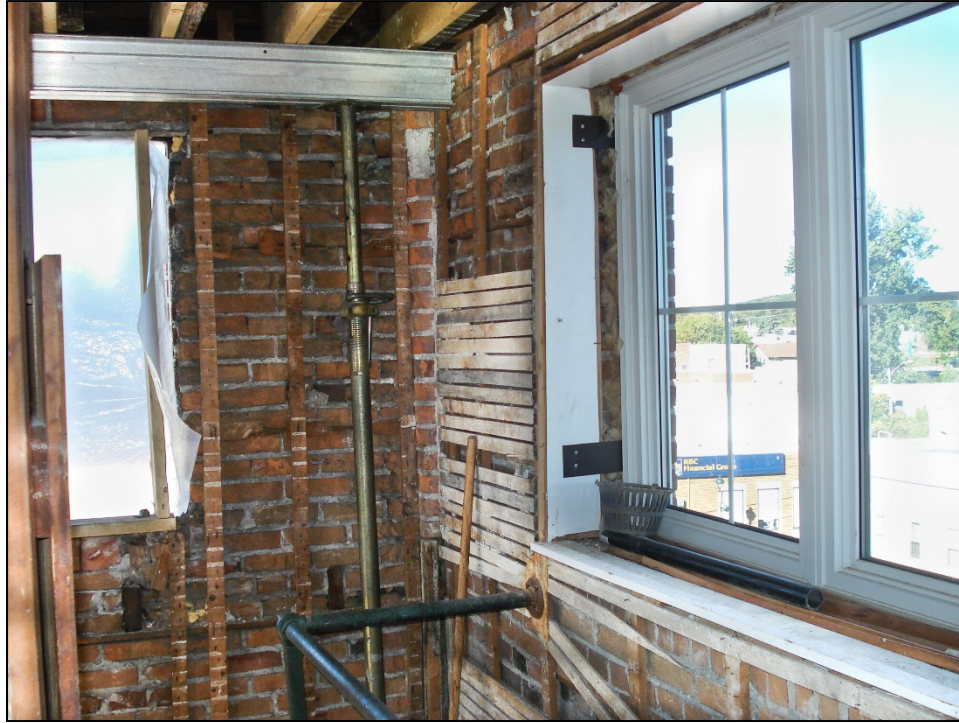
Since the initial site visit Tacoma had been in regular contact with the Town of Huntsville and the General Contractor about the proposed addition of structural brick repair to the project. Tacoma was back on site on September 17, 2013 to complete a detailed assessment of the brick walls. The deterioration noted previously was found to be prevalent throughout the exposed structure. The damage to the brick masonry was most severe at the two load bearing walls (refer to Figure 4). The interior wythe of the two-wythe wall was no longer significantly contributing to the structural integrity of the walls. Damage was noted to be most extensive at the top of the masonry wall and the condition improved nearer to the main roof of the building. It was decided that the condition of the brick masonry walls posed a life safety risk and the repair of the brick walls was required to be completed immediately. The structural repair of the brick masonry was added to the scope of the project at this time.

Figure 4: Brick Deterioration (September 17, 2013)

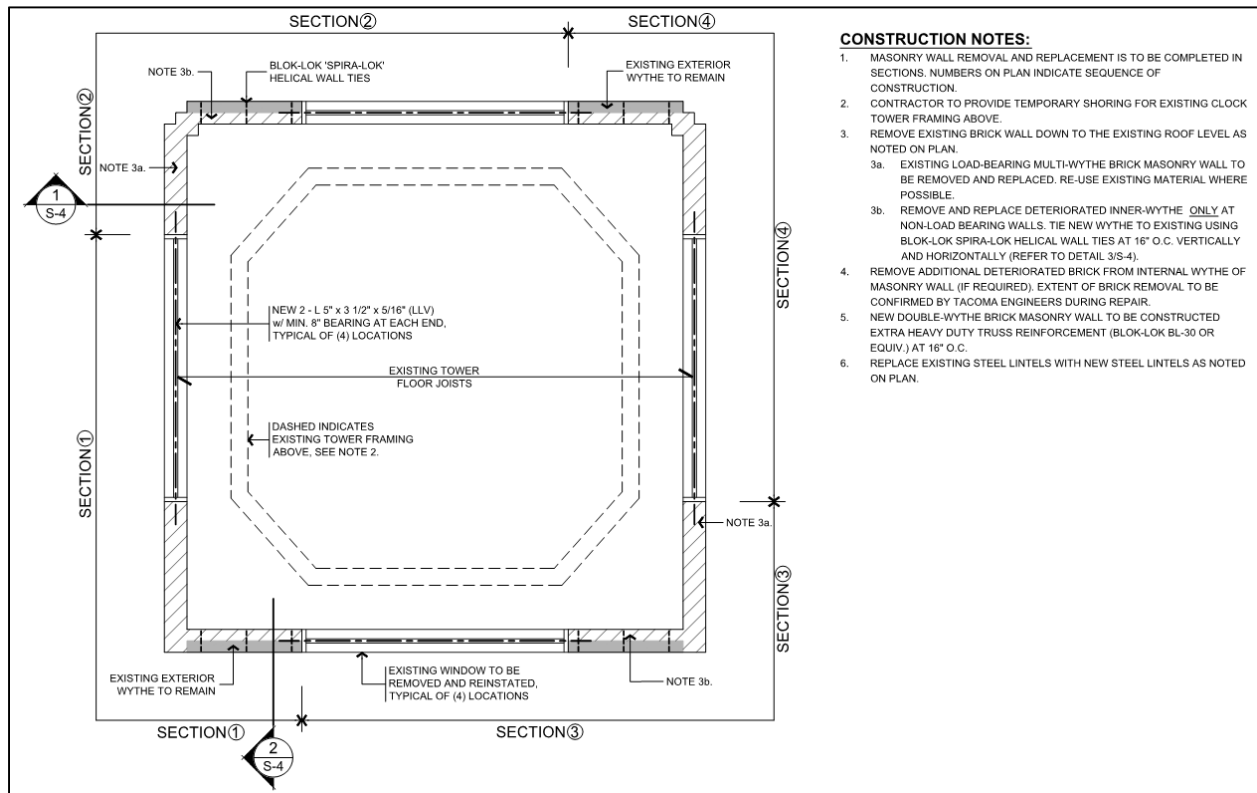
Figure 5: Original Scope of Brick Repair Work (September 23, 2013)

It was decided that the existing brick used in the exterior wythe was still in good condition and that it could be cleaned and re-used in the reconstruction of the brick walls. The contractor was then able to find a suitable brick to match the size, material properties, and style of the exterior wythe. This approach of blending the existing brick from the exterior wythe and the new brick was approved by the Municipal Heritage Committee.

The sequence of construction was challenging. It was decided that the best way to proceed was to work on one side and one corner of the building at a time while leaving the rest of the structure intact. A series of interior wood stud walls were constructed within the lower level of the tower

that transferred the weight of the tower above to the lower tower floor. The shoring walls were sheathed with plywood to provide additional lateral rigidity to the building during construction.

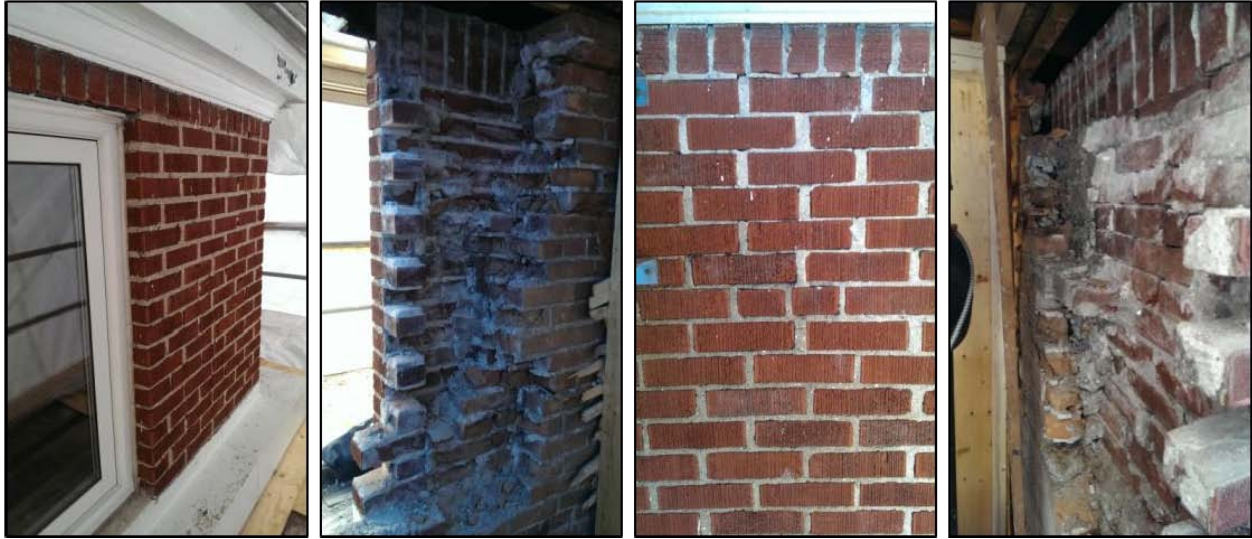
To complete the repair to brick masonry as noted in Figure 5, scaffolding was constructed around the tower. The scaffolding allowed for a more detailed review of the exterior masonry wall facing the street (north side of the building). Our construction review on November 7, 2013 uncovered that the exterior brick and mortar joints on the north wall were in similarly poor condition to the two load-bearing walls. Another unique finding on this date was that two of the four walls were noted to have a full extra course of brick within the walls. The variation in mortar joint thickness around the tower can be seen in Figure 6.

Figure 6: Condition of Masonry Wall as Observed on November 7, 2013

The anomalies uncovered on November 7, 2013 and the advanced state of deterioration on the north side of the building prompted a change to the repair approach. The scope of brick repair work was modified to include the full removal and replacement of the multi-wythe brick masonry on all four sides of the tower. Drawings were revised and re-issued for construction on November 8, 2013. Refer to Figure 7 for the revised scope of repair work. The weather was now cold enough that the cold-weather masonry construction practices were required to be followed.

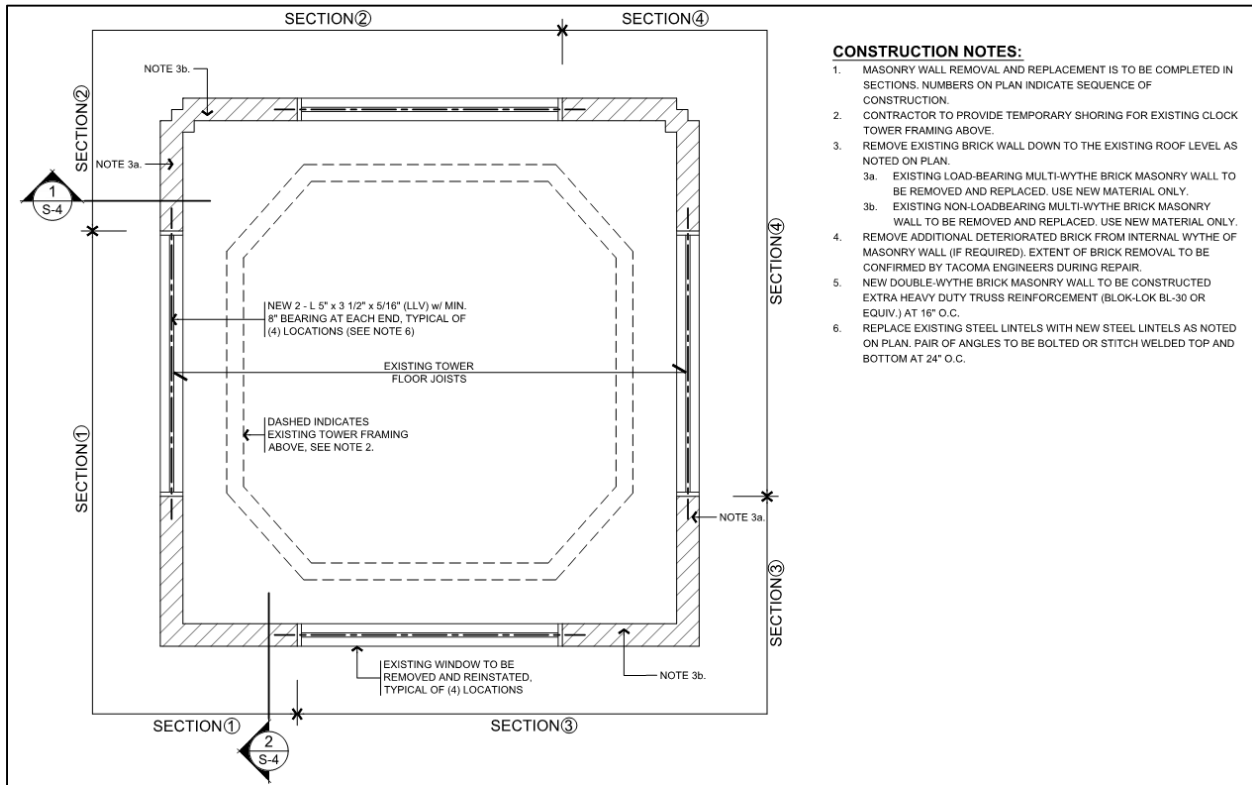
Figure 7: Revised Scope of Brick Repair Work (November 8, 2013)

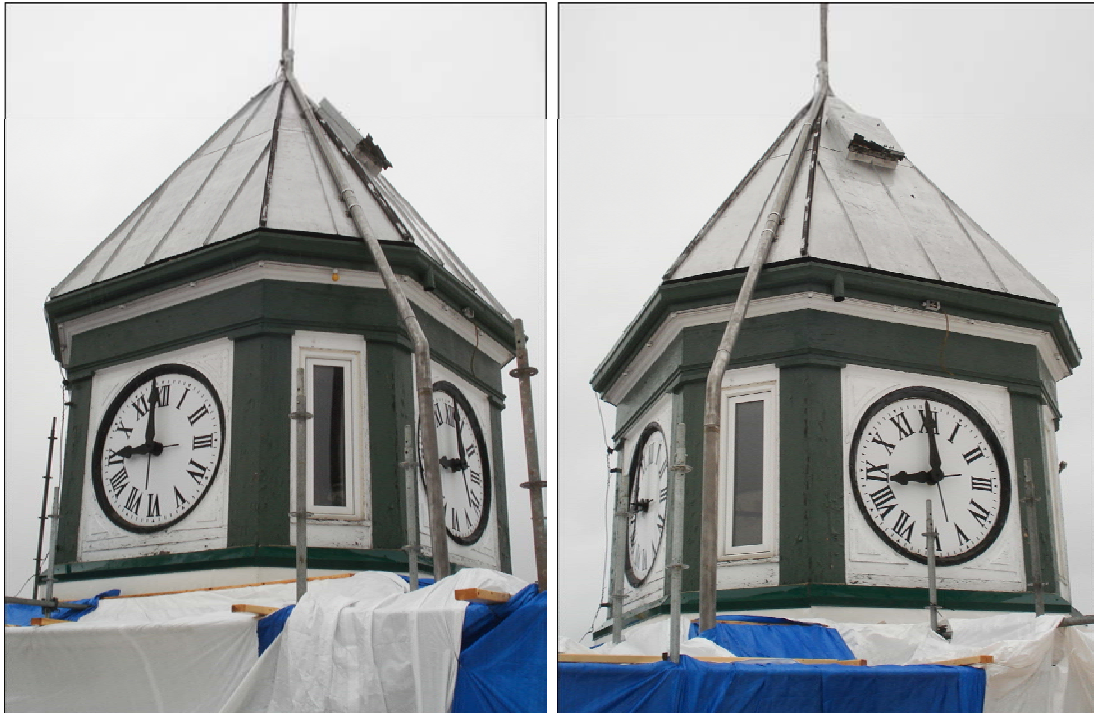
The masonry contractor completing the brick replacement asked Tacoma to attend the site on November 18, 2013 to review additional sources of active water infiltration. It was raining during the construction review. Significant water infiltration from the tower roof was noted. A review of the flashing and roof drainage system during the rain event highlighted the flaws of the existing

systems. The gutter at the eave of the tower roof was inadequately sized, the downspout was not connected, the flashing between the wood panels of the eight-sided tower walls and the flat podium roof was ineffective, and the roof hatch was poorly sealed (refer to Figure 8).

Figure 8: Tower During Construction (November 18, 2013)

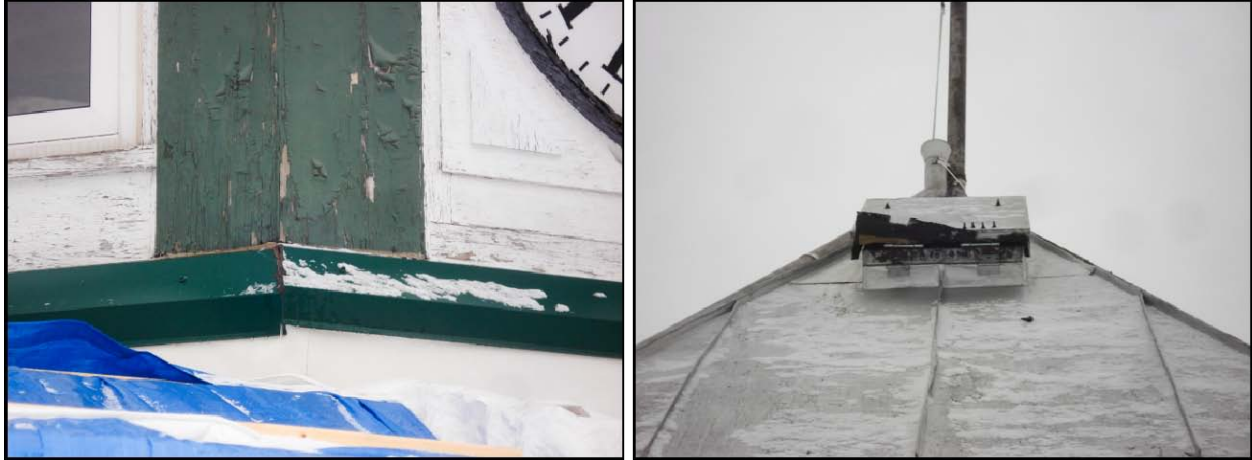
On November 27, 2013 Tacoma met with the Town of Huntsville and Heritage Restoration Inc. to discuss water infiltration issues. The deterioration of the clock tower roofing, access hatch, flashing and wood wall siding were all noted to be in poor condition and deemed inadequate to effectively prevent water infiltration (refer to Figure 9). Up until this point the additional scope of repair work had been approved on an emergency basis as the uncovered structural damage was deemed to be a life safety risk. Tacoma discussed the importance of addressing the cause of the observed structural damage and about how the active water infiltration from the upper tower structure had largely contributed to the damage to the wood floor framing and the brick masonry. The Town of Huntsville asked Tacoma and Heritage Restoration Inc. for a recommendation to address the issues of water infiltration while maintaining the heritage features of the clock tower façade.

Figure 9: Sources of Water Infiltration

It was recommended that in addition to the structural repair to brick masonry walls, a comprehensive waterproofing system be provided for the clock tower structure. It was crucial to the Town of Huntsville and the Municipal Heritage Committee that any modifications to the clock tower replicate the detail of the existing. The proposed modifications to the scope included: removal of existing rotted material and replacement/ consolidation as required, install new waterproofing membrane over the exterior surface, repair of exterior wood sheathing of clock tower, re-cladding with copper and lead-coated copper to match existing profiles, replace standing seam steel roofing with lead-coated copper standing seam, and add a code compliant lightning protection system. The proposed system would be essentially maintenance-free (no painting, etc.). The additional expense required to complete the waterproofing work was estimated to increase the total cost of construction from \$107,000 to \$230,000.

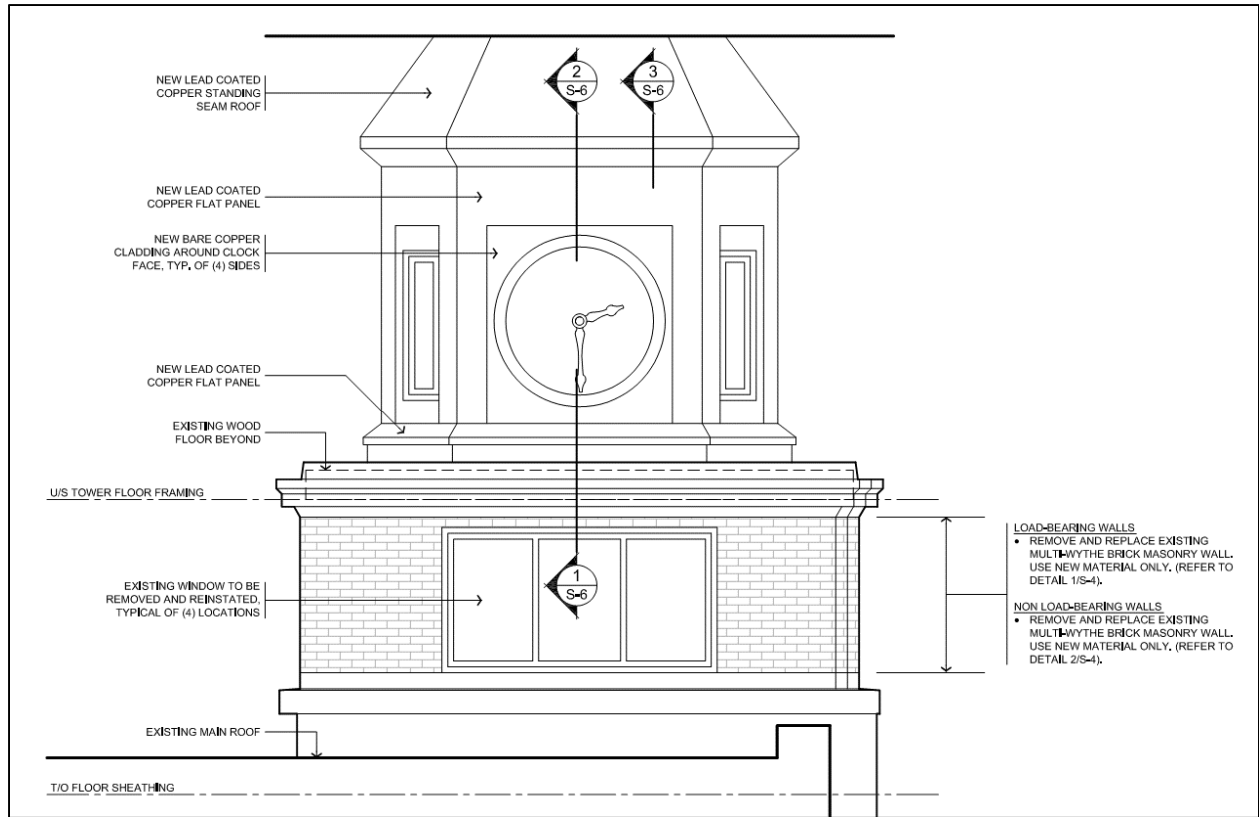
Figure 10: New Lead Coated Copper Siding and Roofing

The Town of Huntsville decided that they wanted to proceed with the comprehensive waterproofing of the tower structure. The revised scope is shown in Figure 10. The Municipal Heritage Committee agreed that the use of copper and lead-coated copper would be a more durable exterior finish than the existing wood sheathing and would be better for the overall sustainability of the building. The copper and lead-coated copper were to be hand crafted to match the exact profile of the existing clock faces and wood cladding (refer to Figure 11). New eave gutters and downspouts were added as part of the waterproofing work.

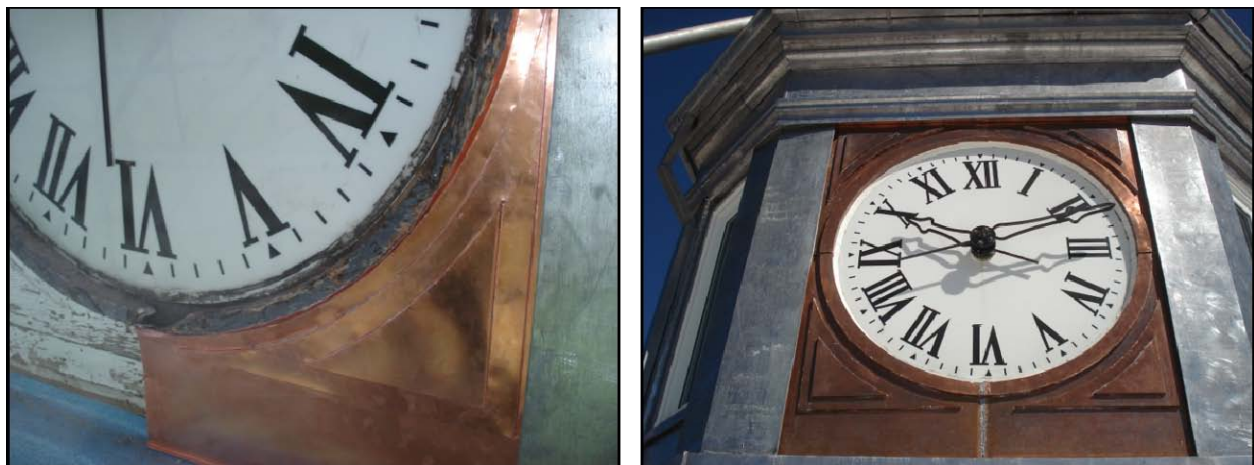
Figure 11: Copper Re-Cladding Underway (left), Tower Re-Cladding Complete (right)

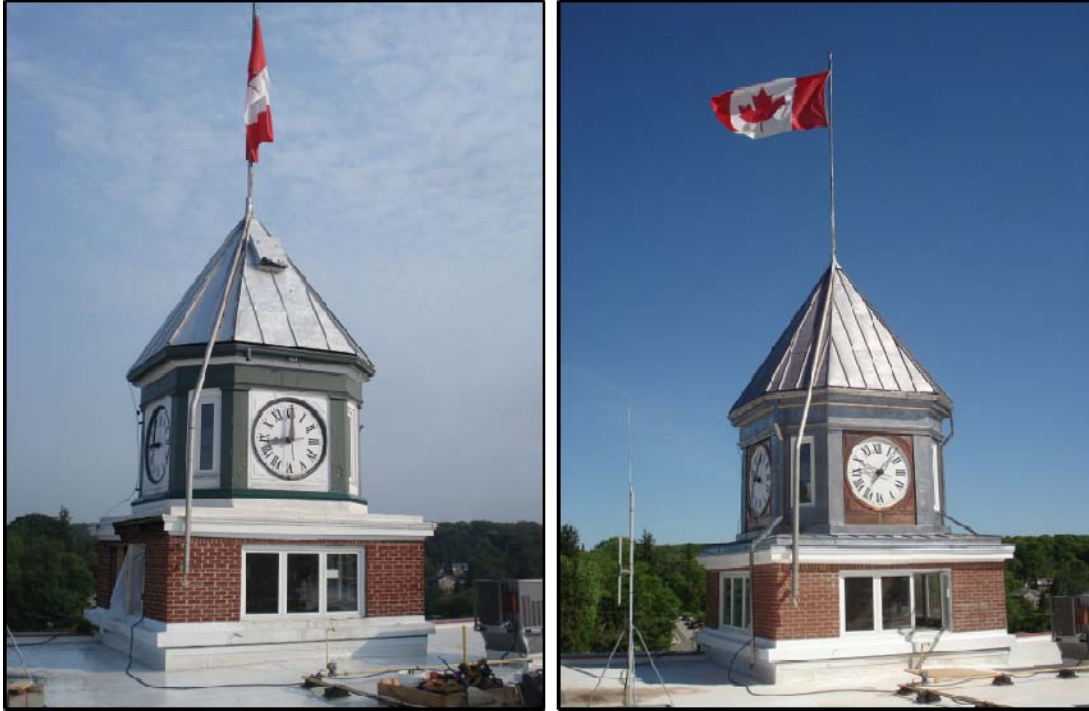
Figure 12: Original (left), Restored (right)

The total construction time was approximately one year. The final construction cost was approximately \$230,000. The total repair work included: reinforcement of the floor framing, reconstruction of multi-wythe brick tower walls, repair and replacement of rotten wood sheathing, installation of waterproof membrane, the addition of new copper and lead-coated copper cladding, replacement of steel standing-seam roof, flashing and gutters with lead coated copper, and installation of a lightning protection system. The end result was a beautifully restored clock tower that matched the detail and profile of the original tower structure.
