13TH CANADIAN MASONRY SYMPOSIUM
HALIFAX, CANADA
JUNE 4TH – JUNE 7TH 2017

**PERFORMANCE OF REINFORCED CONCRETE FRAMES WITH UNREINFORCED
MASONRY INFILL DURING THE 2016 ECUADOR EARTHQUAKE**

Schultz, Arturo E.¹

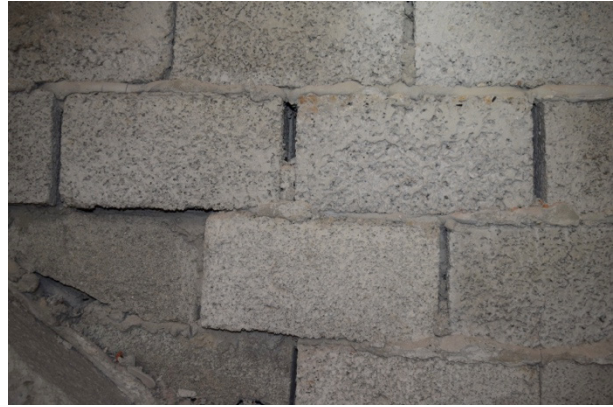
Figure 3: Open head joints

Construction practices were observed that can be detrimental to the performance of RC frames with URM infill. For example, it was noted that head joints in masonry infill and partitions were often left empty or filled only partially (Figure 3). Because the finishing practice is to use thick layers of plaster, as much as 5 or 6mm, the joints would be hidden from view once construction was completed. However, the ability of these URM panels to transfer stresses from lateral loading would be diminished due to the strong discontinuities offered by the open head joints.

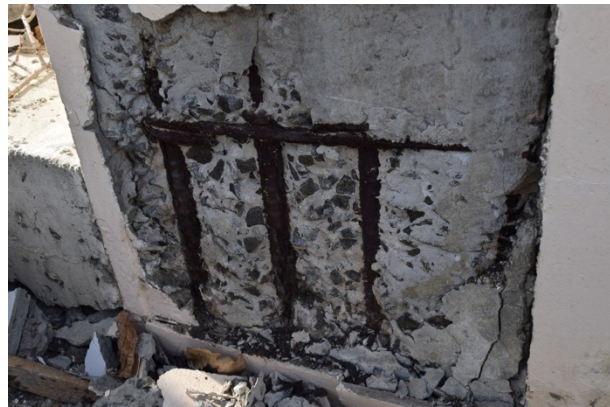
There is concern in coastal Ecuador regarding concrete quality in existing buildings because of past practice of using unwashed beach sand for the concrete mix. While petrographic analysis is needed to ascertain the composition of hardened concrete, a “rule of thumb” is used locally that focuses on the appearance of concrete along cracked surfaces: Sand gradation that appears visually uniform is taken as an indication of beach sand given its narrow particle size distribution. Thus, it is not surprising that many instances of corroded reinforcement in concrete members were observed (Figure 2). Another practice worth noting is the use of smooth bar or wire for transverse reinforcement.

Figure 2: Corroded reinforcing bars

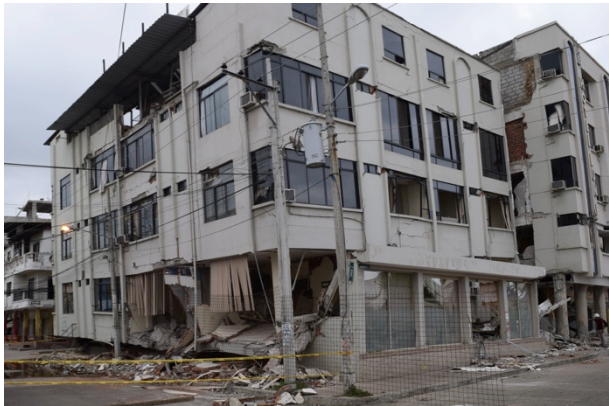
Problems related to soft (low stiffness) and/or weak (low strength) stories were observed, including the formation of story mechanisms and the eventual collapse of these stories. This problem was usually noted in first stories (Figure 4a), but in some cases it was noted for intermediate stories (Figure 4b).

a) First story

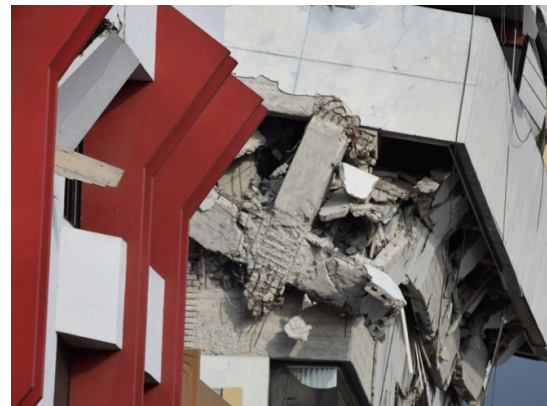
b) Intermediate story

In some of the larger buildings surveyed by the EERI team, the use of spandrels led to member sizing in which the beams were stronger than the columns which in some cases led to column hinging and a story mechanism (Figure 4b). In smaller buildings, especially those with colonnades, some columns were observed to have failed in compression (Figure 8). The combined effects of overturning and vertical acceleration, in combination with gravity loads, exceeded column capacity, and the omission of infill panels eliminated any alternate load paths.

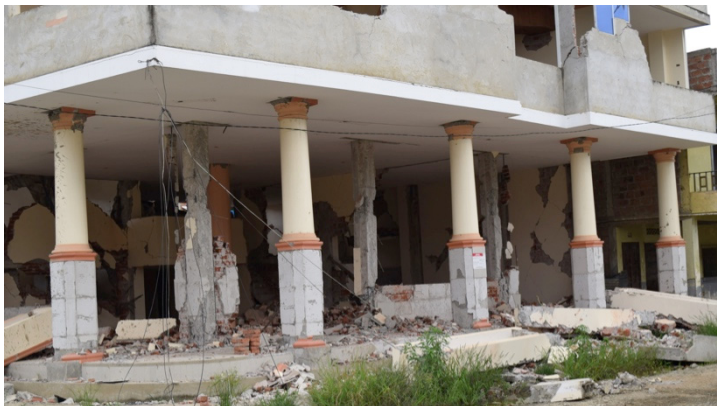
a) Open first story

large window and/or door openings, or by eliminating infills and partitions one or two façades facing the street. These practices result in reduced lateral and torsional stiffness and strength for the first story (Figure 5a). In some buildings, not only were the infills discontinued in the first story, but the columns along the building perimeter as well (Figure 5b). In such cases, the transfer of column axial forces from overturning were also interrupted in the first story.

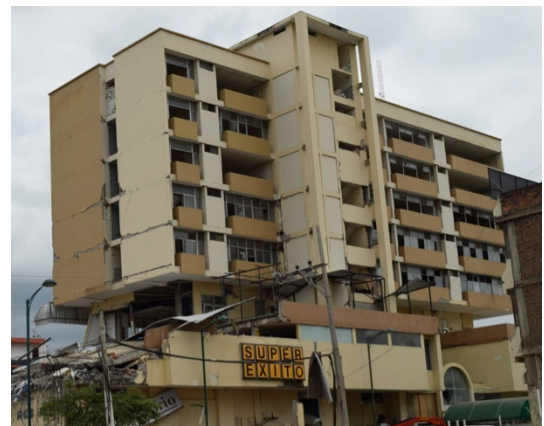
b) Discontinued RC infill frame

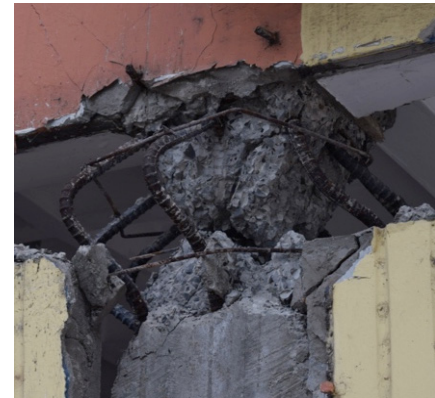
Short columns failing in shear were observed frequently in damaged or collapsed buildings (Figure 6). These occur typically when masonry infills are discontinued near the top of a story in order to create window openings, and the short length of column that is not supported by the infill is required to resist large shear force reversals. The shear force magnitudes, especially if the column is not well confined with transverse reinforcement, produce large shear cracks and crushing of the concrete core, after which the longitudinal bars buckle. The use of small-diameter column ties placed at a large spacing further exacerbated the damage to the columns.

Figure 6: Short column

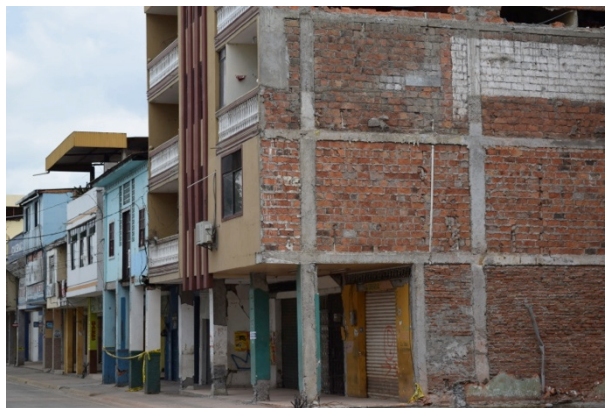
Traditional building architecture in Ecuador utilized colonnades along the street to maximize floor space in stories above the first (Figure 7a). This practice reduces the strength and stiffness of the frames along the colonnade by eliminating the infills along the street façade. However, later architectural developments did away with the colonnade altogether creating large cantilever overhangs along the street, and in the case of corner buildings the overhangs are present along intersecting façades (Figure 7b). The cantilever overhangs worsen the torsional irregularity of first stories, and the infill frames and partitions above the overhangs were identified as a common location of damage requiring shoring following the 2016 earthquake.

a) Traditional colonnade

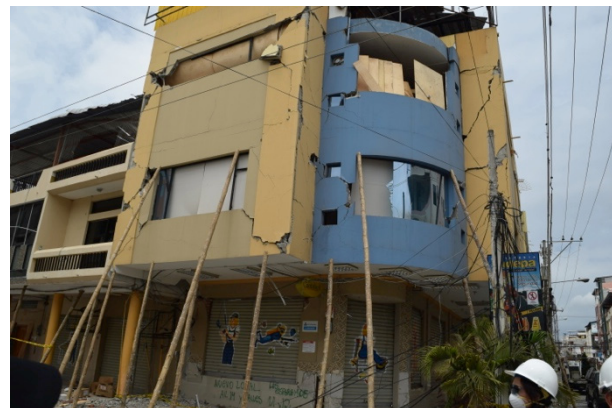
b) Cantilever overhang

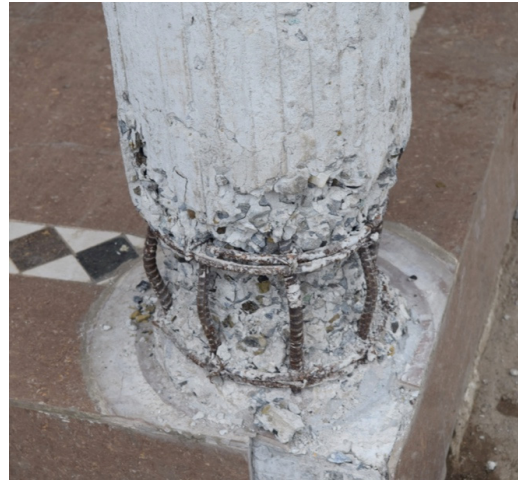
Figure 8: Column compression failure

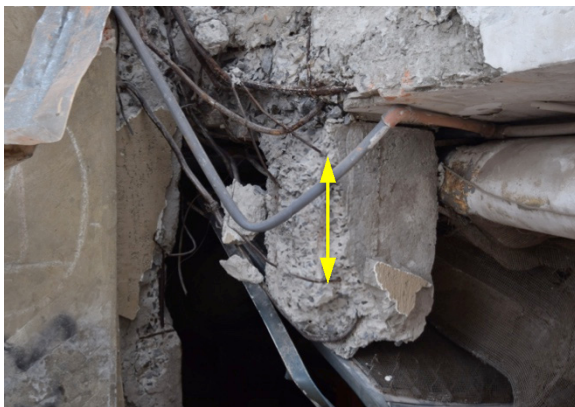
Numerous instances of inadequate reinforcement details for RC frame members were noted. These included excessive tie spacing in columns, which limited the amount of confinement of the column core and restraint against bar buckling (Figure 9a). In other cases excessive stirrup spacing in beams were observed, leading to limited shear strength (Figure 9b). Ties in columns (Figure 10a) and stirrups in beams were often observed to have with 90-degree bends, which increased the likelihood that the ties would open under seismic loading. Transverse reinforcement was also observed to have been made from bars that are too small (Figure 9a). In some cases beam-column joints were noted to have been provided insufficient or no reinforcement (Figure 10b), which resulted in joint failures.

a) Column

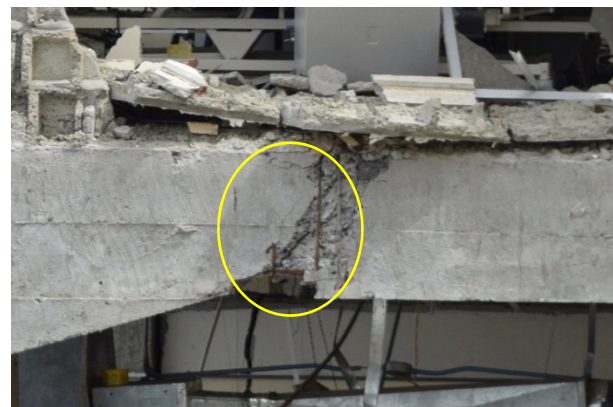
b) Beam

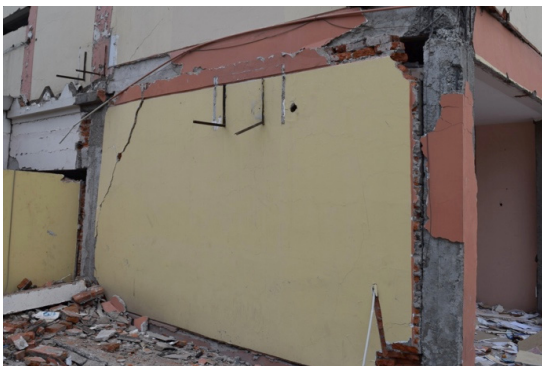
If the URM infill panel works as intended, it will develop cracks that increase progressively in width (δ_c , δ_x and δ_y in Figure 11) and number as the panel undergoes increasing cyclic drift demands. Depending upon aspect ratio, sliding along the perimeter may initially crack the panel and separate it from RC frame (Figure 12a). If not restrained from out-of-plane motion, transverse loading may initiate out-of-plane displacement relative to the frame (Figure 12a) that can eventually lead to collapse. A well-restrained URM infill will develop inclined cracks if the diagonal tension strength of the URM masonry is exceeded (Figure 12b). Under repeated cycles of load, cracked surfaces will slide generating strength degradation from abrasion and increased crack widths.

a) Cracking around infill panel perimeter

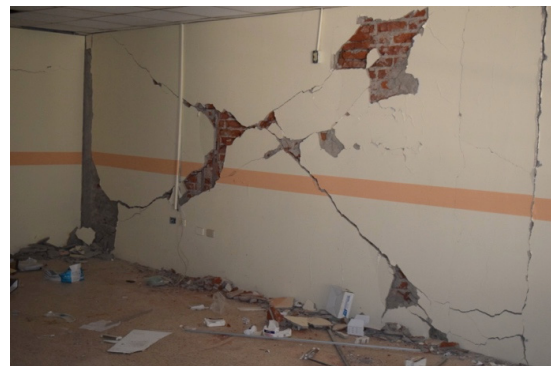
b) Bidirectional diagonal cracking

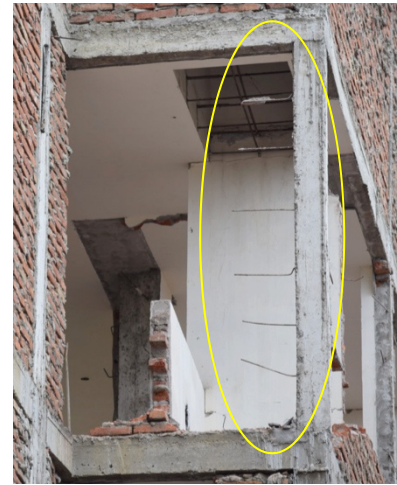
After many cycles, the cracked panel fragments, and these pieces can collapse out of plane. The transition from ‘expected’ to ‘undesirable’ behavior can be very quick, and infills at this stage can be totally destroyed (Figure 13). Similar observations have been made regarding an RC infill frame specimen tested under simulated earthquake motion in a shake-table [9].

In an attempt to restrain URM infill panels from out-of-plane collapse, anchors in the form of reinforcing bars embedded in the bounding columns were observed in some of the surveyed buildings (Figure 13). The anchors were invariably embedded in the horizontal mortar (bed) joints of the masonry, regardless of the type of unit (i.e., solid clay brick, hollow clay tile or hollow concrete block). In many instances the panel anchors were ineffective in preventing out-of-plane collapse of the infill panels (Figure 13). Either the anchor length was insufficient, or the mortar strength was too low, or both.

Figure 13: Panel anchors

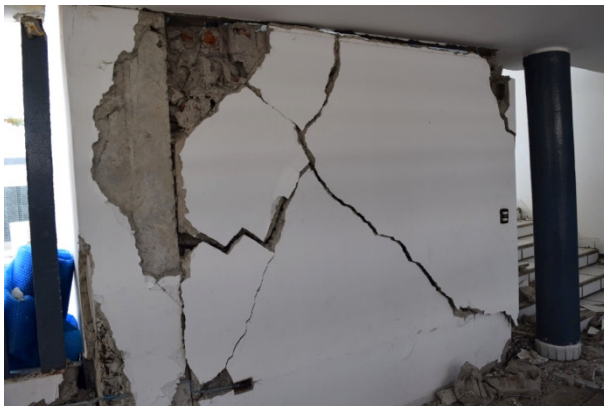
The columns bounding a URM infill panel on both sides offer paths for bearing and shear stresses from direct contact, and they provide confinement to the URM panel. If the columns are stiff enough, the confinement keeps diagonal cracks in the URM infill panel from opening as much as they would otherwise open in an unbounded panel. Thus, they enhance the ability of the infill panel to maintain its horizontal shear strength under cyclic loading. If the bounding column on one side of an infill panel, or on both sides, is removed, the ability of the panel to retain lateral strength and stiffness is diminished (Figure 14a). By introducing a door or window opening on one side of a panel bounded by a frame column on another side, the same detrimental effect was observed (Figure 14b).

a) Termination without a frame column

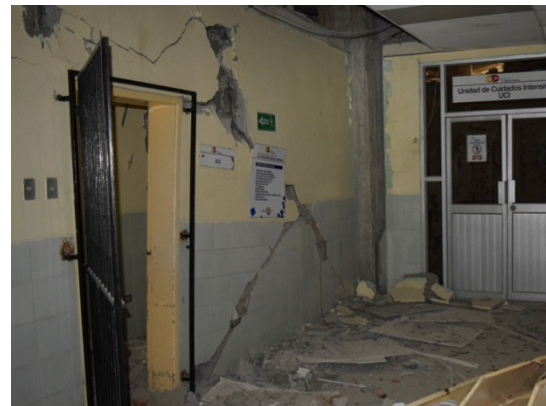
b) Interruption by door opening

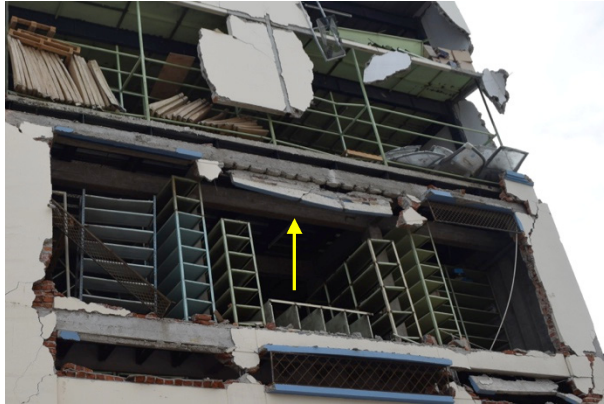
Infill panels should not be offset from frames for the same reasons offered in the preceding section. If they are, then the necessary contact for shear and bearing stress transfer vanishes, and the panels are reduced to isolated URM elements. In cases for which the frames were offset by large dimensions from the exterior infill panels, collapse of the infill panels was observed (Figure 15a). Even when the offset was only at one end of the infill panel, panel collapse was also noted (Figure 15b). Needless to say, details are needed to prevent out-of-plane collapse of the panels.

a) Offset frame

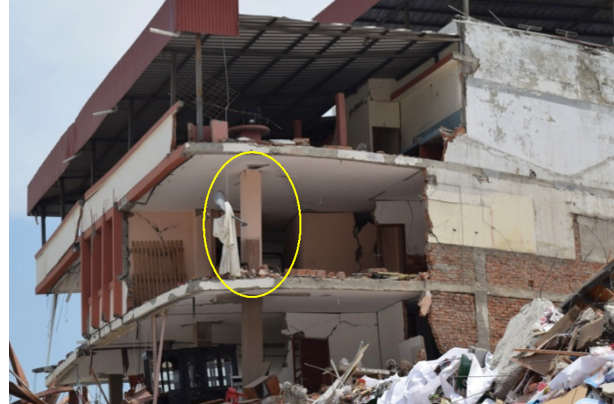
b) Offset column

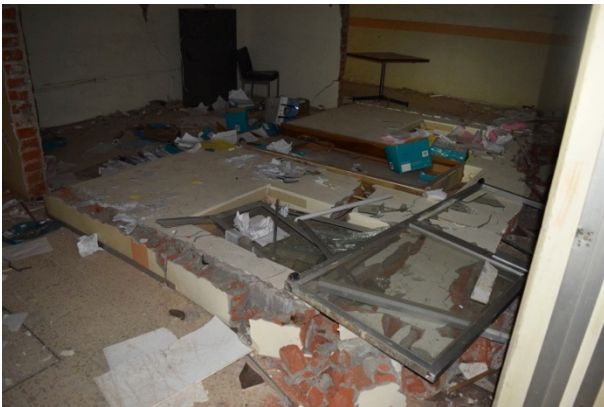
URM interior partitions behaved in a similar manner as the unbounded infill panels. As far as resistance mechanisms are concerned, these elements are essentially identical. Without restraining details to prevent out-of-plane collapse, interior URM partitions suffered frequent instances of collapse (Figure 16a). Exterior URM panels were often part of a continuous masonry skin that provided restraint to the more heavily stressed regions. Nonetheless, damage to these elements was widespread (Figure 16b).

a) Collapsed interior URM partition

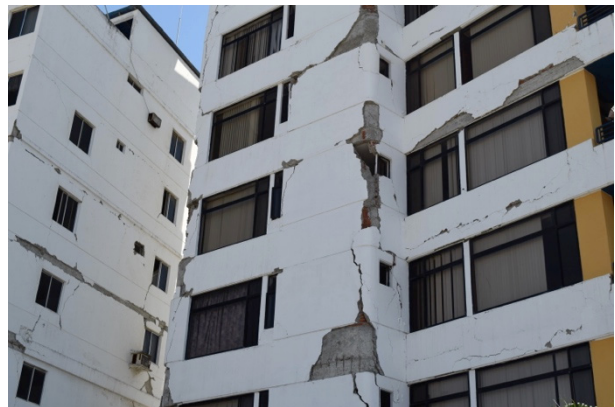
b) Damaged exterior URM panels
