## IN-FIELD SHEAR BOND STRENGTH TESTING OF ADHERED MASONRY VENEER

Dillon, Patrick B.<sup>1</sup> and Dalrymple, Gerald A.<sup>2</sup>

This paper presents a case study from an investigation in which in-field shear bond strength testing of AMV was performed for both investigation of an AMV failure and pre-construction quality control. The investigation employed a test methodology similar to that recently published in ASTM C1823. The field testing identified several insights regarding AMV installation and performance and highlights the importance of performing shear bond testing of AMV installations.

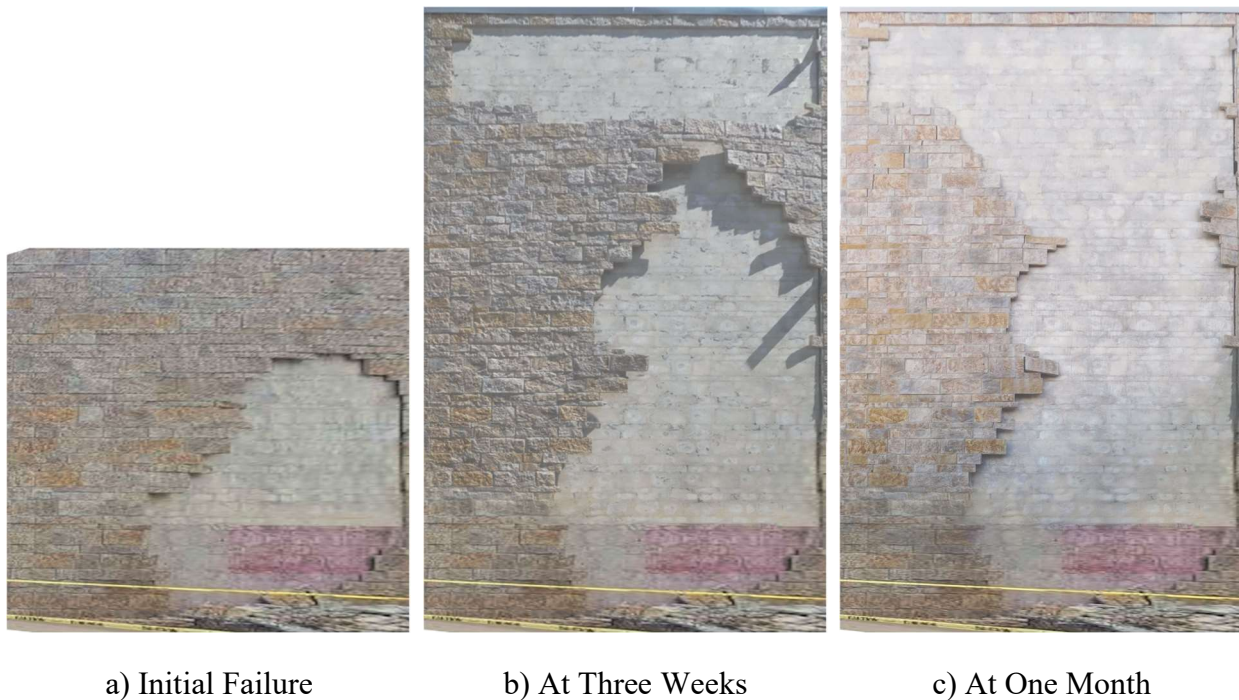
**Figure 1: Veneer Failure Progression**

The project was located at a large theater structure in the southern United States. The exterior walls of the structure were constructed of reinforced concrete tilt-up panels. A complete remodel of the building was performed in the early 2010s during which the exterior paint was to be removed from the panels and replaced with an adhered manufactured stone veneer (AMSV) assembly. During the renovation, AMSV was installed on a total wall surface area of approximately 1,510 m<sup>2</sup> (16,200 ft<sup>2</sup>). The AMSV units varied in size from approximately 150 cm<sup>2</sup> (24 in<sup>2</sup>) to 1860 cm<sup>2</sup> (288 in<sup>2</sup>). Approximately seven years after installation of the AMSV, portions of the veneer at one of the panels began to separate from the substrate and progressively collapse over the period of a month (Figure 1). Luckily, no persons were harmed during the veneer failure.

A forensic investigation was performed at the building to evaluate the cause of the failure and assess the risk for additional failures. The initial stage in the investigation was to remove the remaining AMV units at the failed panel to mitigate the risk of falling units and observe the conditions of the units and backup. At the time of the removal, only a few sections of the veneer remained on the panel, including a large section that had separated from the substrate except for

at the corner (Figure 1c). As the removal proceeded, many of the units were removed by hand or with simple hand tools. Often, units would separate from the backup as adjacent units were removed or would come off in small groups. Overall, it appeared that the units were generally better bonded to each other by the joint mortar than they were to the backup.

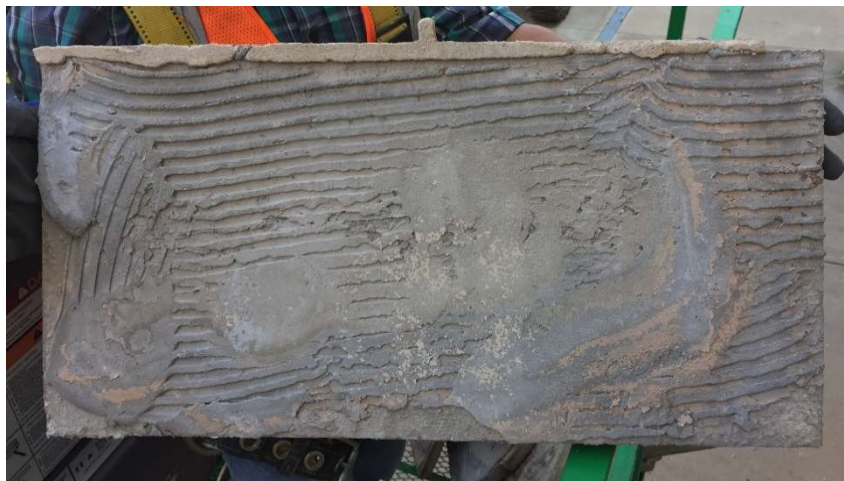
**Figure 2: Comb Pattern and Voids at Setting Bed Mortar**

The units removed during the initial stage of the investigation generally separated from the backup with the setting bed mortar still adhered to the backs of the units, indicating an adhesive failure at the substrate. A distinct comb pattern was visible in the setting bed mortar at all of the units (Figure 2), indicating that the units had been installed using a thin-set installation method but with insufficient pressure during setting for the mortar to spread and fill all of the voids. Significant voided areas were present on many of the units, particularly the larger units (Figure 2).

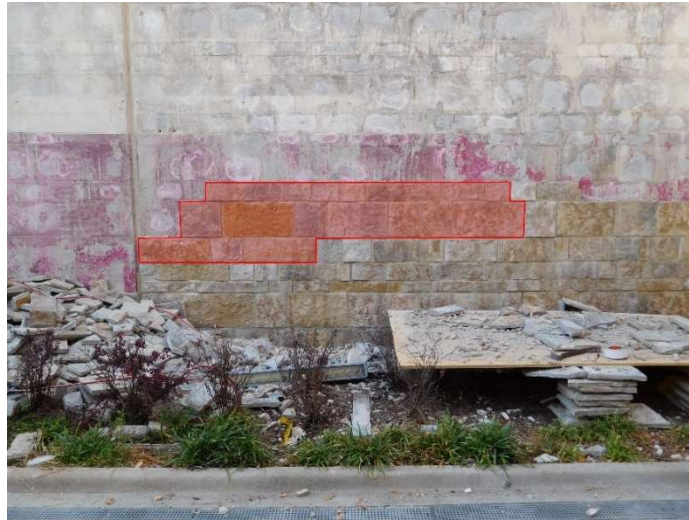
**Figure 3: Area of Veneer that Fell as a Unit**

The removal of well-bonded units typically left some setting mortar bonded to the face of the backup and some of the well-bonded units came off in pieces. The poorly bonded or debonded units left little to no setting mortar bonded to the backup and generally came off intact and sometimes came off with adjacent units. Near ground level, a 17-square-foot section (Figure 3) separated and fell to the ground as one unit was being removed from the wall by hand.

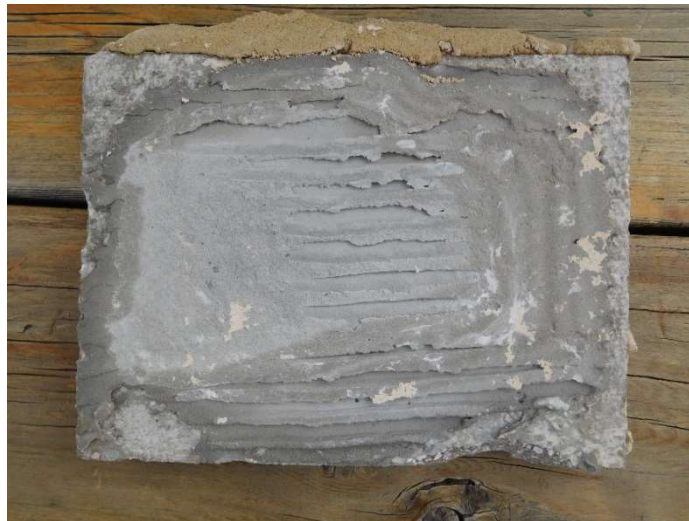
**Figure 4: Mortar Setting Bed Near Top of Second Panel**

The setting mortar on the units from the second panel generally showed the same notched trowel comb pattern as that observed at the failed panel, but the total voided area was generally less on

units that came from the top portion of the panel (Figure 4). At the upper portion of the panel, much of the panel surface was still covered with remnants of setting mortar, indicating a combination of adhesive failure at the substrate and cohesive failure of the mortar. The condition of the setting mortar and observed failure modes became similar to those at the failed panel as the work progressed down the face of the wall.

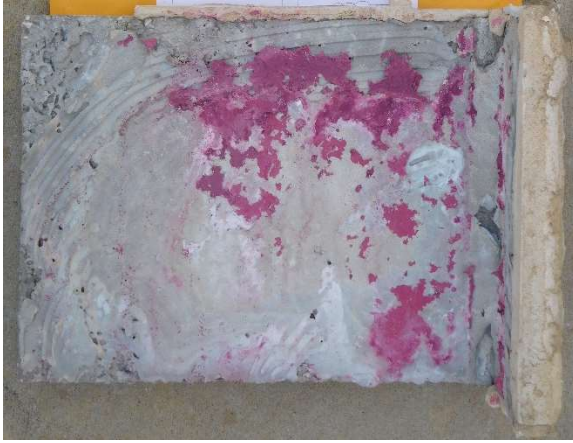
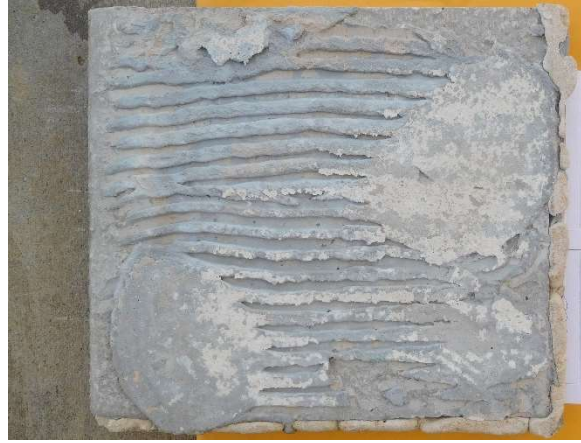
**Figure 5: Paint Coatings Adhered to Back Side of Units**

At both panels, the remnants of two different colored paint coatings were observed on the tilt-up concrete surface and adhered to the setting mortar on the back faces of many of the units (Figure 5). The coating from grade to about six feet above grade appeared to be shade of violet and above six feet the coating appeared to be a shade of white. The shades and patterns appeared to match those shown in the pre-renovation photographs of the building exterior (Figure 6). The coating near the top of the wall appeared to be in better condition and was better bonded to the concrete

backup whereas the coating near the base of the wall was flaking off at many locations and would often come off with the unit.

(a) Violet-Colored Paint

(b) White-Colored Paint

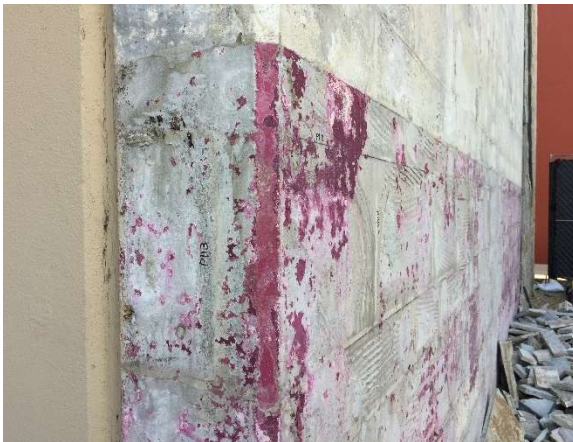
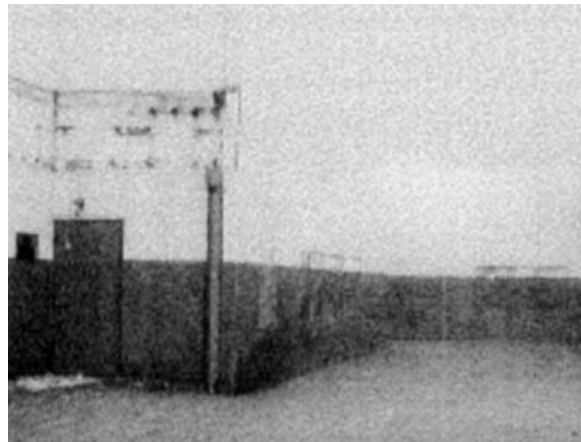
**Figure 6: Comparison of Paint Color Pattern with Pre-Installation Photo**

(a) Paint Remaining on Backup after Demolition

(b) Paint Pattern Prior to Veneer Installation

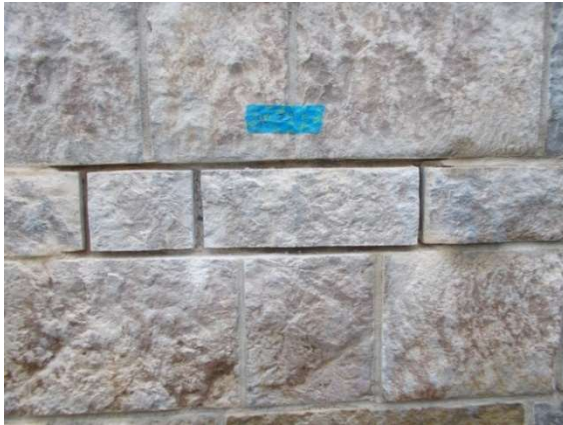
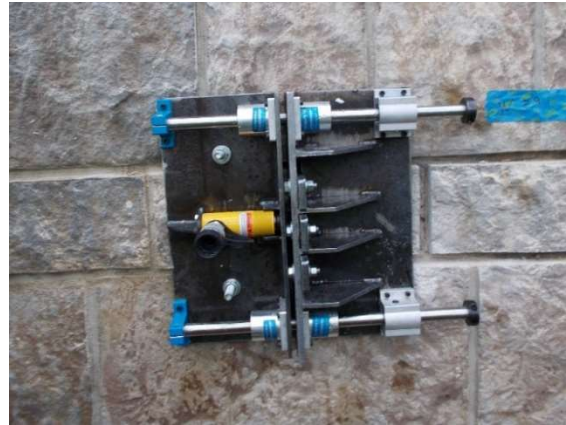
**Figure 7: Photographs of Text Specimen Preparation**

After preparation, the shear testing apparatus was mounted to the wall surface with proprietary concrete anchors (Figure 7b). The testing apparatus was leveled, and the loading plate was set at the contact level of the stone to bonding mortar. The loading plate was advanced until contact was made with the stone bearing surface. Load was applied to the test sample using a hydraulic ram powered via a hand pump. The failure load was recorded, and direct shear bond strength was calculated based on the gross stone specimen bond surface area.

(a) Joints Removed Around Specimen

(b) Apparatus Mounted to Wall

These test results fell significantly below the prescriptive code-required minimum shear bond strength of 345 kPa (50 psi) for AMV systems. The field investigation revealed that the principal cause of the veneer failure was improper preparation of the substrate surfaces. Large, voided areas in the setting beds were also a significant contributing factor in the veneer bond failure. The field testing of the AMSV panels showed that the average shear bond strength of the veneer units was significantly lower than the code-prescribed minimum values. Based on these results, it was recommended that the existing AMSV units be completely removed and replaced, the precast concrete panel surface prepared, and the AMSV replaced.

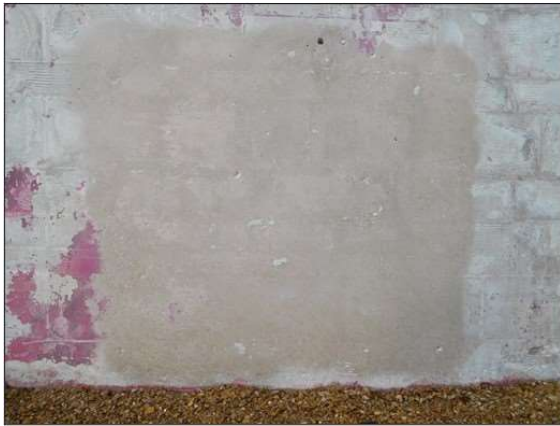
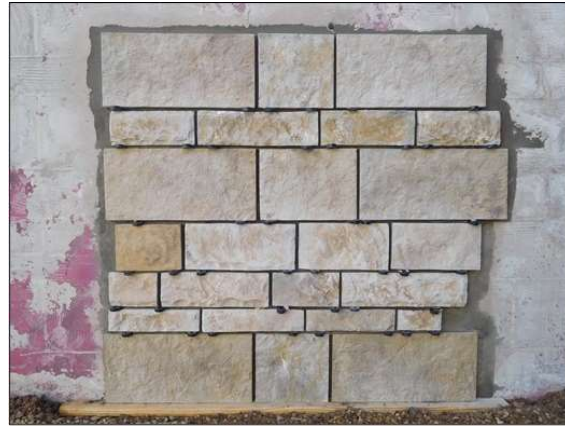
**Figure 8: Photographs of In-Place Mockup Panel**

A protocol was developed for installation of a replacement veneer. Included within the protocol were requirements for substrate preparation and unit installation based on industry recommendations and requirements for quality assurance using in-field shear bond strength testing. A mockup panel was constructed at one of the previously demolished veneer panels to evaluate the effectiveness of sandblasting as a means of substrate preparation. The sandblasting produced a surface profile on the face of the tilt-up panel that corresponded to ICRI CSP 3 [7]. The sandblasting was able to remove the majority of the remaining coating from the wall surface, but some small, isolated areas of coating remained. Observations were performed during the AMSV unit installation to verify that the installation protocol was being followed, namely that the units were being fully buttered and pressed into intimate contact with the backup.

(a) Substrate Preparation

(b) Installed Mockup Panel
