REPAIR OF FAULTS IN MASONRY BUILDING ENVELOPES

Gerald R. Genge¹

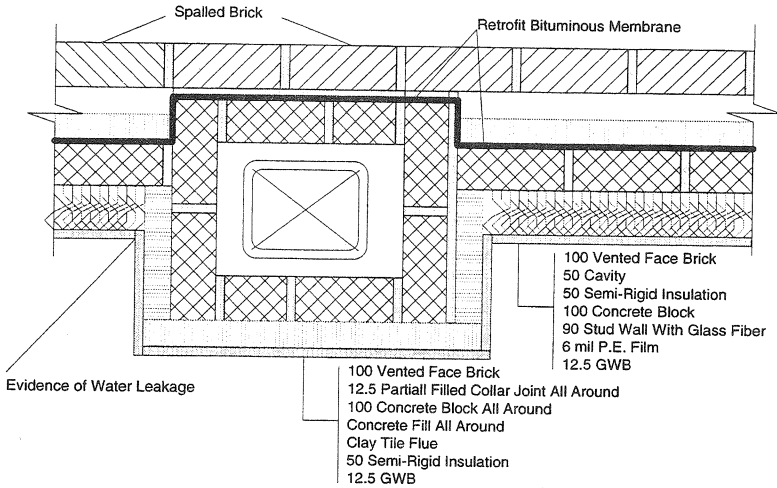
Fig. 3: Case 1 Wall Plan Section.

This case involves the replacement of damaged brick and the addition of a bituminous air barrier on the wall to prevent air and water leakage. In this case the building is a residential condominium that is 15 years old and has minimal cash reserves. The exterior wall cross-section is shown in Fig. 3. The figure shows a plan view of a chimney that is part of the exterior wall. The main wall is a cavity system with insulation in the cavity, block masonry back-up and face brick. The chimney differs somewhat in that the wall is solid masonry with insulation inboard of the flue. Thus the chimney is outside the insulated section of the wall. Apart from spalling of the brick face, exploratory work found the sealants around adjacent windows are cracked, flashings are poorly terminated and brick joints require repointing. The collar joint at the chimney is only partially filled and the joints in the back-up block are typically poorly filled.

The bituminous air barrier will, no doubt, act as waterproofing and prevent any exterior water from entering the living space but, a new problem has been introduced. The wall now has a vapour retarder (bituminous membrane) on the cold side of the insulation in both the main wall section and the chimney section. Thermal gradient calculations through the main wall section would indicate that average interior relative humidity levels would result in condensation in the block at exterior temperatures of 0°C or less. The moisture from this condensation can affect the bond of the air barrier membrane allowing exterior water to enter once again and making the removal and replacement of the exterior brick, at \$600 to \$700/m², rather futile. More significantly though, the chimney wall section has a vapour retarder outside the portion of the wall that is subject to frequent freezing and thawing conditions. Condensation on the tile from flue gases would contribute considerable moisture to the chimney behind the air barrier. This places the chimney construction at considerable risk. The damage may even not be visible until it has reached an advanced state or the chimney has collapsed.

In this case the fault lay in the workmanship of the original flashing and chimney grouting construction and in a lack of maintenance of the exterior brick joints. The original wall design was, in fact, adequate even though it did not call for an air barrier membrane. The addition of the air barrier in this case was a change to the design of the wall and an attempt to address the only fault option that did not contribute to the distress.

A more appropriate solution to the water penetration problem that would be more in line with the financial situation of the owner, would have involved reduction of water ingress through repointing of the brick, replacement of the cracked sealants and redirection of the water that did penetrate the cavity by reconstructing the poorly built flashings. Air leakage, if a problem at all, could be controlled through the use of interior sealants and modifications to the gypsum wall board to provide continuity. At the chimney, the leaks could have been controlled through the use of flashings, by repointing and by completely filling the collar joint with a low pressure grout application. These efforts would have

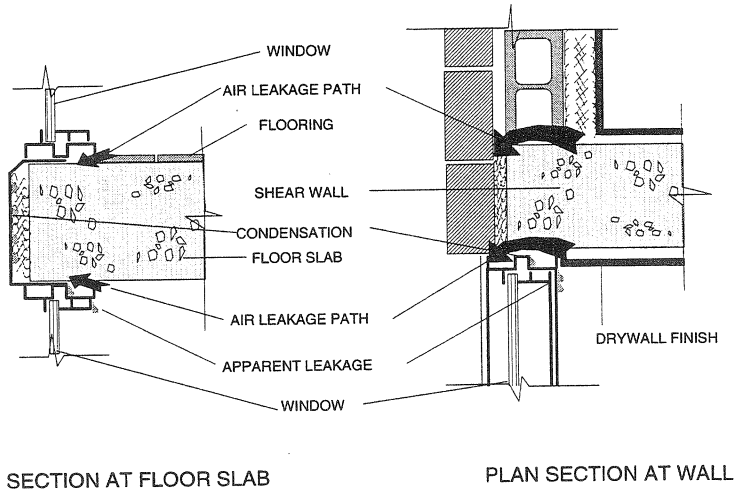
Fig. 4 Condensation at Floor Slab Covers.

This substantial cost to the Owners resulted in little change to the moisture problem. The reason that the problem was not resolved was that the initial fault in the design was misdiagnosed. The water that the unit owners saw was actually condensation that collected on the inside face of the metal slab cover that formed part of the curtain wall system (see Fig. 4). The condensation soaked the slab edge insulation, dripped into the head and jambs of the window frame and drained down the inside of the wall, wetting the interiors.

The damage caused by the condensation water leaking back into the units was not unlike that caused by leaking of rain; however, water tests performed on the windows could not cause the same type of leaks that the owners observed. The true problem was identified only after considering the thermal bridge caused by the concrete floors and shear walls and the absence of a good air seal at the areas where walls and windows abutted concrete. Moisture carried by the exfiltrating interior air condensed during cooler evenings on the metal covers or collected as frost in the winter that occasionally melted when the dark metal was warmed by the sun. The result was periodic wetting of the interior floors and wall finishes.

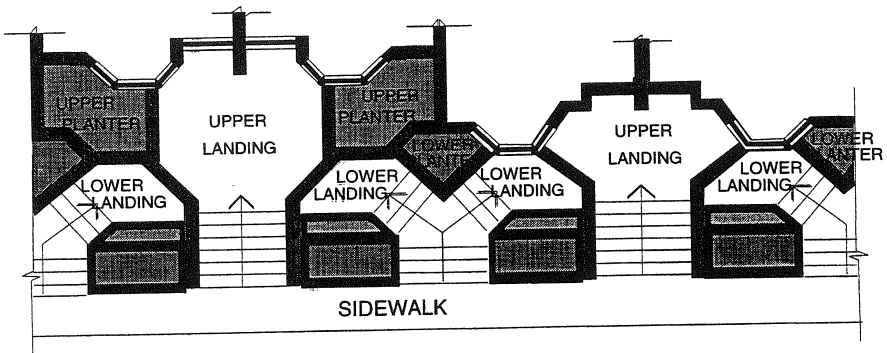
Fig. 6: Masonry Landing Layout

The upper units are of two types; one type has large brick planters, the other no planters. The lower units also have brick planters. The stairs to the upper landings had masonry walls supporting a short combination guard and handrail. The design of the walls employed a rowlock course on the top of the wall. After five to seven years, the occupants of the lower units complained of water leaks. The exterior faces of the stair and planter walls was spalling and the owners were concerned that the deterioration was affecting their property value and they were looking for a cost effecting repair. In the Spring, the upper units also complained of leaks.

Investigation of the existing conditions and the design revealed that the rowlock course resulted in leaks into the double wythe wall which, in turn, resulted in water leaks into the lower units and spalled the brick. In addition, the waterproofing of the planter was brittle and had been invaded by roots from shrubs in the planters and the drainage of the planters was inadequate. In the Spring, the melting of the snow and ice in the planters overflowed the waterproofing in the planters and leaked into the units.

The other townhouse block wished to retain the aesthetics offered by the masonry entrances and preferred to retain the planters. After some assessment of the extent of the deterioration and the nature of the leaks GRG Building Consultants determined that the landings did not leak; however, there was a risk of leaking through the landing-to-slab joint where the landings were poorly drained. The leaks in the upper units resulted from the inadequate drainage of the upper planters and the poor condition of the planter waterproofing. The masonry walls were generally sound but required extensive isolated brick replacement. Brick was in particularly poor condition on the inside faces of the stair walls adjacent to the stair treads, likely due to the use of deicing salts. The brick originally used is no longer available so replacement would have to be made using reclaimed brick.

The repairs the second block adopted included the rewaterproofing of the upper and lower planters using a modified bitumen, torch-applied membrane, addition of a "chimney drain" to the planters. The rowlock course was removed from the walls and planters and a precast concrete cap was placed on top of the existing walls. The rowlock course was reclaimed for use as repair brick for spalled areas. The stair walls were removed to the stair level, a new concrete curb was poured to act as a stair stringer and new precast concrete caps were installed. In order to regain the appearance of masonry at the stairs, new 300 x 300 brick columns were added to the top and bottom of the stairs. Precast concrete caps were added to the columns. The masonry columns served not only as architectural features but also provide support for the new handrails and guards.
