**Brick Veneer/Steel Stud Walls  
- A Repair Solution -**

H. Keller<sup>(1)</sup>, P.Eng. and T.W.J. Trestain<sup>(2)</sup>, P.Eng.

The paper describes the investigation and subsequent repair work carried out on the brick veneer/steel stud masonry walls of a highrise apartment building in Calgary, Alberta. The paper deals with the original design details, with workmanship deficiencies and with the selected repairs.

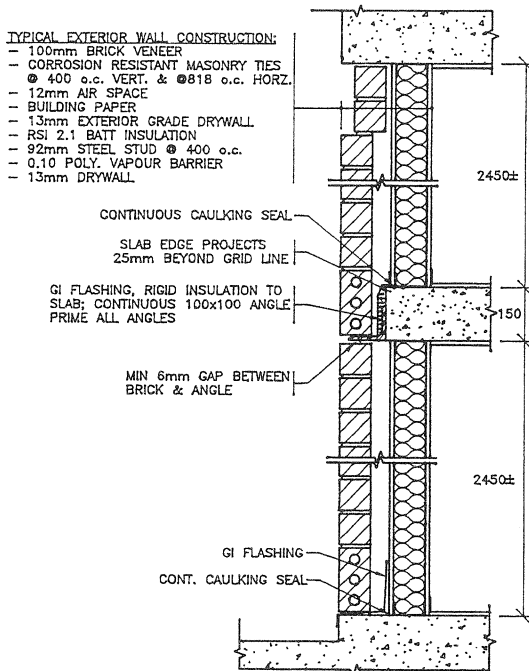
**Fig. 1 Original Design Details of BV/SS Wall**

The building was constructed in 1981. The design of the BV/SS wall was governed by the 1977 Alberta Building Code. The details and specifications for the BV/SS wall system were shown in the architectural drawings, see Fig. 1.

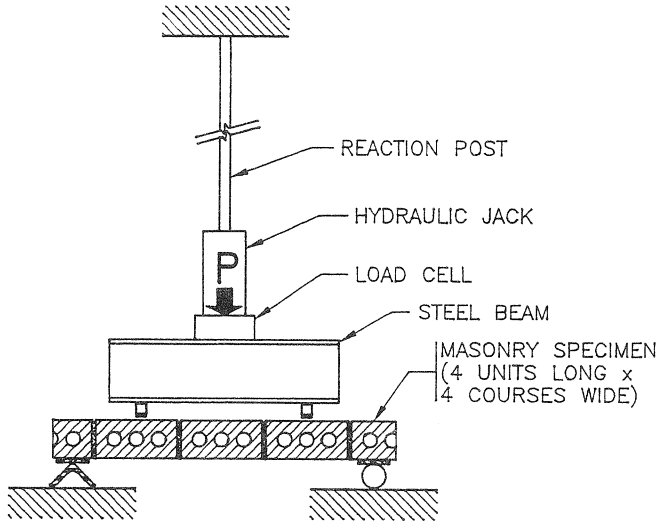
**Fig. 2 Test Apparatus**

To determine the spacing of the steel columns, the flexural capacity of the brick veneer parallel to the bed joint needed to be verified. To answer this question, masonry specimens were removed from random locations on the building and tested in flexure using ASTM E518 and Drysdale et al, 1994 as a guide. A typical test setup is shown diagrammatically in Fig. 2. Eight specimens were tested with the tooled joint in tension and two specimens were tested in reverse. The test results are summarized in Table 1.
