**A CASE STUDY IN THE ASSESSMENT  
AND REPAIR OF FREEZE-THAW DAMAGE TO TTW BRICK WALLS**

**ABSTRACT**

This paper describes the assessment of masonry deterioration and the repair program at three essentially identical buildings with walls constructed of TTW brick. Each building has six storeys with a combination of flat and sloped roofs. Extensive brick deterioration and leakage into the buildings were the driving forces behind this work.

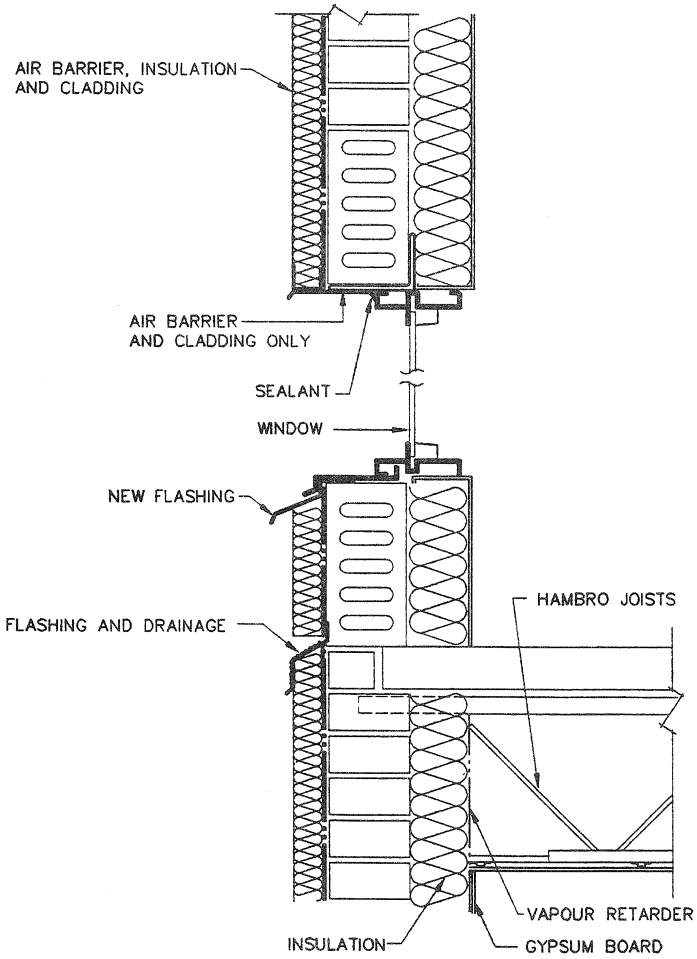
Fig.1 Wall Section (with Retrofit Cladding)

The buildings were constructed between 1979 and 1980. The exterior TTW brick walls are load bearing (see Fig.1). There is a layer of parging on the back face of the brick. The interior of the wall comprises batt insulation, a polyethylene vapour retarder and drywall fastened to steel studs. The insulation was intended to be held away from the parging by strings strung between the studs. These were not effective, so the insulation was in contact with the parging. There are sloped roofs at the tops of some of the walls (Fig.2) and flat roofs with brick parapets elsewhere.

A trowel-on, cementitious, air barrier material with a low vapour resistance was installed over the faces of the bricks on the walls to be clad (Fig.5). This replaced the air barrier function of the generally detached parging. Calculations verified that condensation from vapour diffusion would not form at the inside face of the new air barrier. Sufficient insulation was provided on the exterior side of the air barrier material to move the dew point outside the air barrier layer.

A free draining insulation was applied to the exterior face of the air barrier, and covered with a rain-screen design metal cladding.

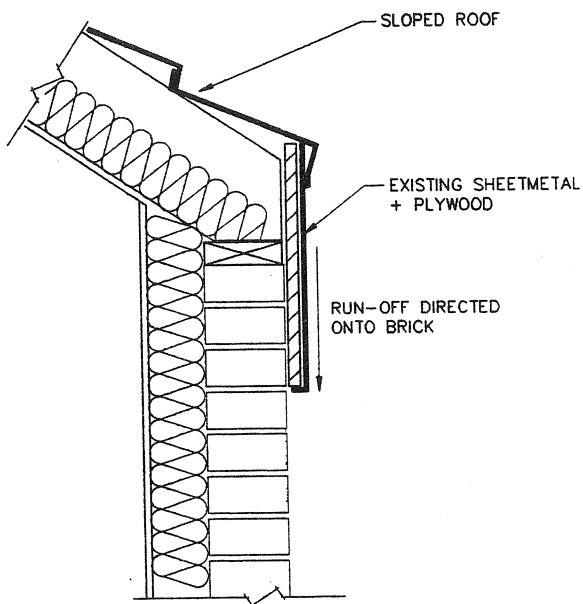
Fig.2 Sloped Roof Junction with Brick Wall

The vast majority of the damage occurring was related to water running off the sloped roofs onto the bricks. The sloped roofs had no eavestrough, and no overhang. Water flowing down the roofs was directed straight onto the brick. Dark staining of the brickwork related to moisture absorption could be observed below each of the sloped roofs during a rain or thaw. The exterior brick damage generally correlated with these run-off zones.

Flashings were installed along the edges of the sloped roofs to prevent water from blowing off the sides of the sloped roofs onto the dry walls.

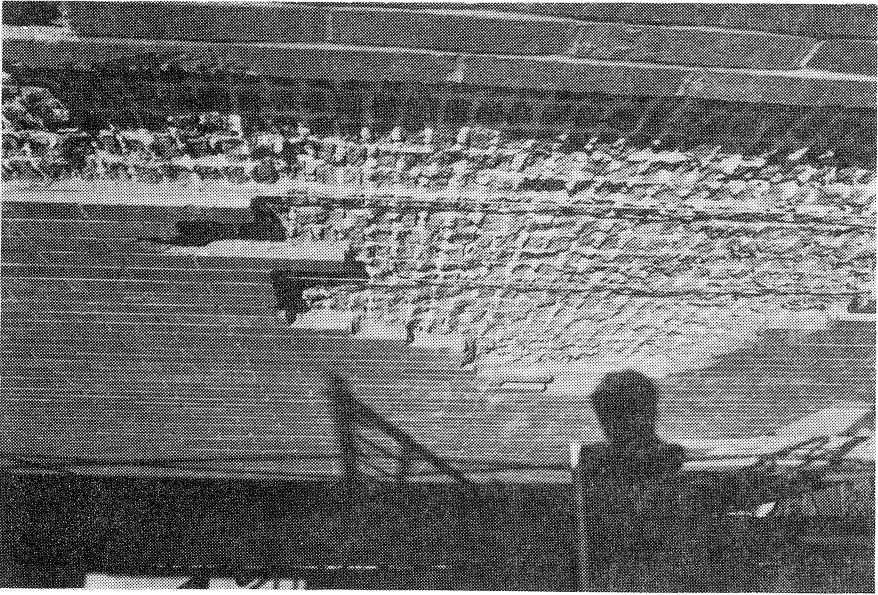
Fig.3 Bricks Removal where Fractured to Depth of Cores

The spalling on the exterior faces of the bricks had two forms: a surface spalling of thin layers of brick, and deeper cracking of the bricks at the depth of the cores (Fig.3). The surface spalling was visible from the ground, and had attracted attention to the damage, but during the repairs it became apparent that the deeper spalling through the cores was actually more extensive and structurally significant. This deeper damage to the bricks could only be detected by sounding the bricks.

The cracking of the bricks at the depth of the cores appeared to be related to freezing of bulk liquid water filling the cores. Water likely reached the cores by soaking through the brick, and also at locations where brick ties were placed close to the outside surface of the mortar joints, resulting in voids in the mortar joints through which water flowed to the cores.

Prior to installing the cladding, the integrity of the load bearing masonry walls was restored. Where there was extensive spalling to the depth of the brick cores, the load bearing capacity of the wall was significantly reduced. In large areas of deep spalling, vertical panels of brick were removed with the wall shored on the interior, and new "columns" of brick were installed (Fig.4). These brick columns were designed to take over the vertical load-carrying function of the adjacent sections of wall. Adjacent to the new columns, the spalled faces were removed, and the bricks patched with a polymer modified mortar.
