**PERFORMANCE MONITORING OF A
BRICK VENEER/STEEL STUD WALL SYSTEM**

ABSTRACT

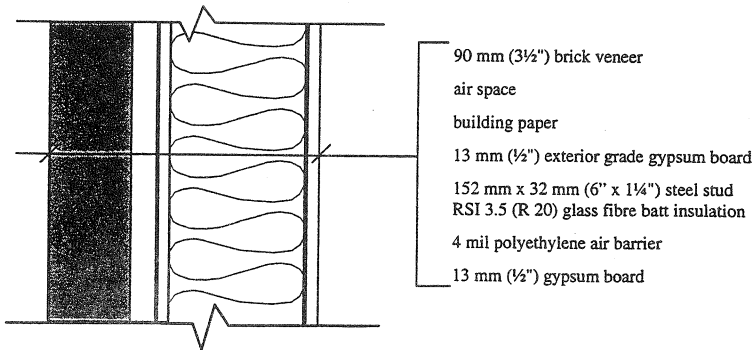
Structurally, the steel stud backup wall was well designed. In fact, most features of the backup wall are considered to be in accordance with "best practices", as outlined in the CMHC publication "Exterior Wall Construction in High-Rise Buildings, Brick Veneer on Concrete Masonry or Steel Stud Wall Systems" (Drysdale and Suter, 1991). Features of the backup wall include 20 gauge steel studs (the above publication recommends 18 gauge studs for increased durability during construction), double top tracks, lateral bridging between studs, and a deflection limit of $L/720$. Unfortunately, some building science recommendations of the CMHC document were not implemented, including the installation of a fully sealed and rigid air barrier to minimize air leakage, the provision of exterior insulation to reduce thermal bridging, and compartmentalization of the cavity to improve pressure equalization of the wall system. The drawings did call for the 4 mil polyethylene vapour barrier to be sealed, but the drawings did not specifically identify the air barrier. A wall section with materials and thicknesses is shown in Fig. 1.

Fig. 1 Cross Section of Test Wall.

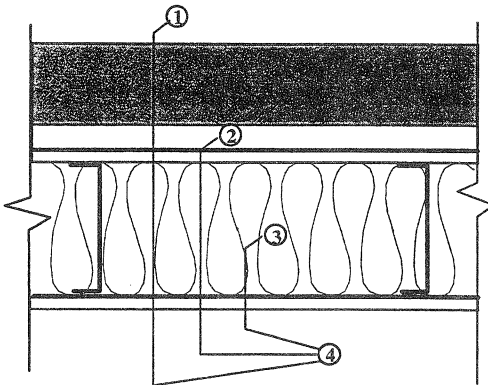
During the monitoring program, the air pressures at the exterior, in the air space, in the stud space and of the interior air were measured and were denoted P1, P2, P3, and P4, respectively, as shown in Fig. 2.

Fig. 2. Location of Pressure Taps.
