**Moisture Conditions Across Stone Masonry Walls
- A Case Study -**

ABSTRACT

The paper deals with the results of a 12-month monitoring program of massive sandstone masonry walls in a heritage structure in Ottawa. Measurements included temperature, moisture, relative humidity and pressure across the exterior wall system and windows. The purpose of this monitoring program was to determine the source of moisture in the stone masonry walls. The results clearly established that moisture in the walls is primarily from exterior sources (i.e. rain and snow) but that air exfiltration in localized areas is also a contributory factor. The information obtained from this monitoring program has been considered in the design of the restoration program which will be underway shortly.

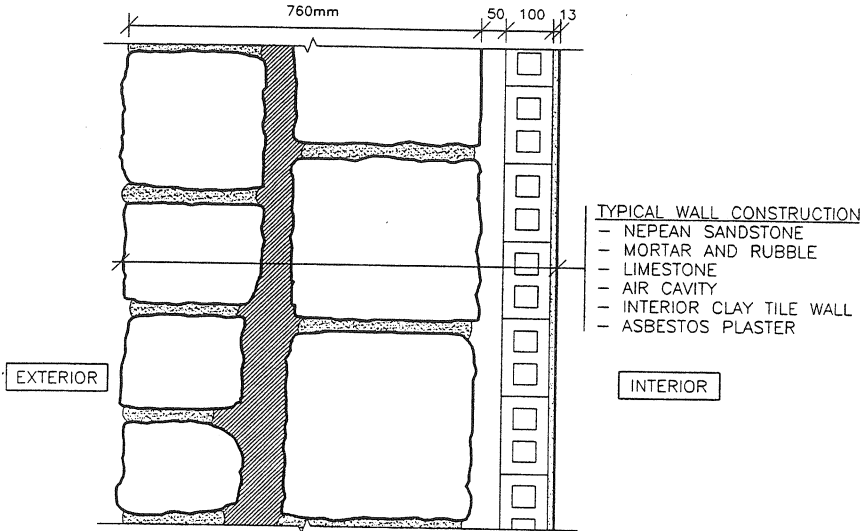
Fig. 2 Typical Wall Section

thickness of limestone. An interior clay tile wall covered with asbestos plaster provides the air barrier. The walls are not insulated. Fig. 2 shows a typical section through the exterior masonry walls.

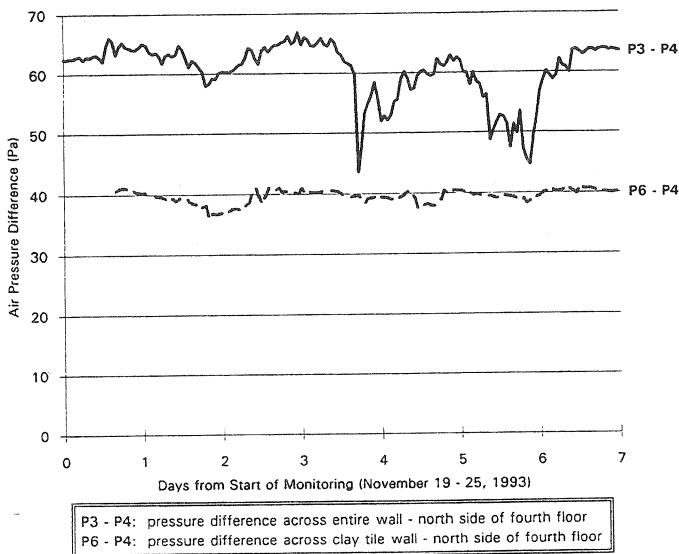
Fig. 5 Fourth Floor Air Pressure Differences

Pressure differences across the walls were measured to evaluate the potential for air leakage. The pressure difference across the entire wall assembly at the fourth floor ranged between 45 and 65 Pa (0.007 to 0.009 psi). The pressure difference across the clay tile wall was more uniformly at about 40 Pa (0.006 psi). Fig. 5

illustrates the pressure differences during November 1993. The large difference between the two curves and their dissimilar shapes indicates that air leaks across the clay tile wall and that the air cavity is not open to the exterior. The key finding regarding pressure differences is that moist interior air exfiltrates past the air barrier system into the stone masonry walls.

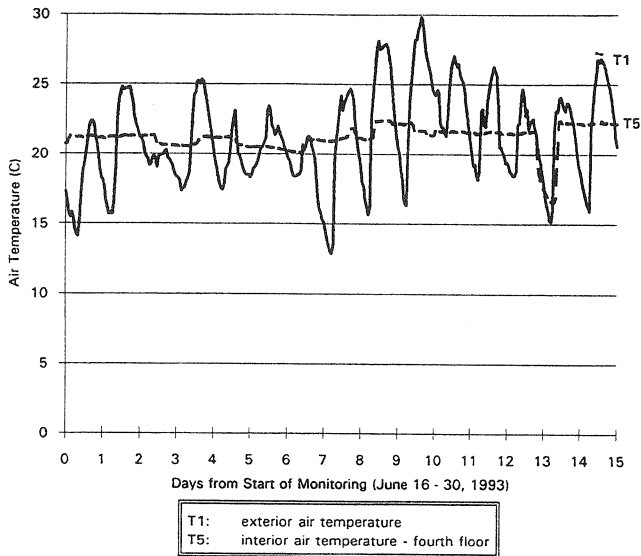
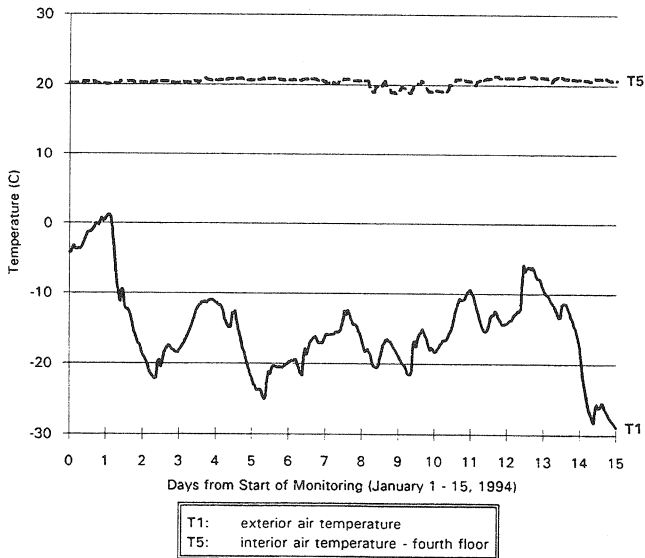
The interior and exterior air temperatures during June 1993 and January 1994 are shown in Figs. 6 and 7. As seen, the interior air temperature is relatively stable at about 21°C (70°F). The temperature profiles through the masonry walls for extreme summer and winter conditions are shown in Fig. 8. The data review showed that the exterior face of the sandstone masonry experienced about 83

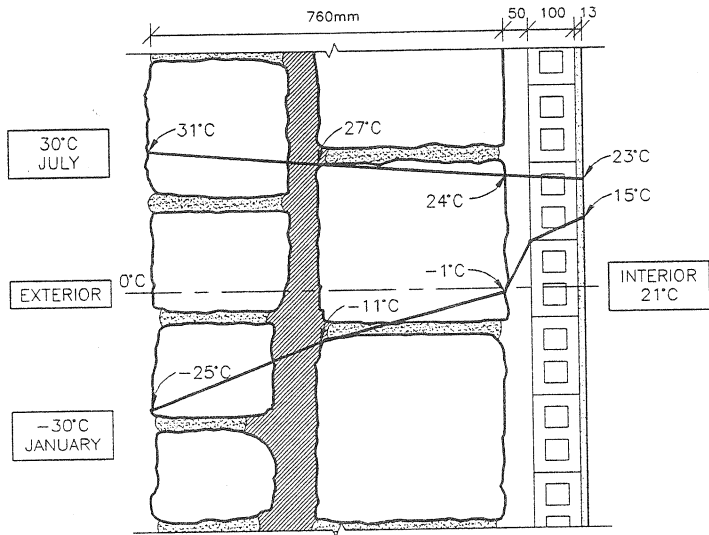
Fig. 8 Temperature Profile Through Masonry Wall Under Extreme Summer and Winter Conditions

freeze/thaw cycles during the winter of 1993/94. Weather data indicates that there are typically about 80 freeze/thaw cycles to be expected in this region during the winter. Therefore, the number of freeze/thaw cycles during 1993/94 was normal, even though the winter of 1993/94 was extremely cold, with long periods of low temperatures. In contrast to the exterior face of the wall, the interior face of the sandstone masonry went through only two freeze/thaw cycles, since it was frozen from December 1993 until March 1994.

Additional recommendations, to be implemented in conjunction with interior renovations at some later date, include the replacement of the mechanical systems to ensure more stable and lower humidity levels inside the museum. It was also recommended that the walls not be insulated as this would subject the entire wall section to more freeze/thaw cycles each winter.

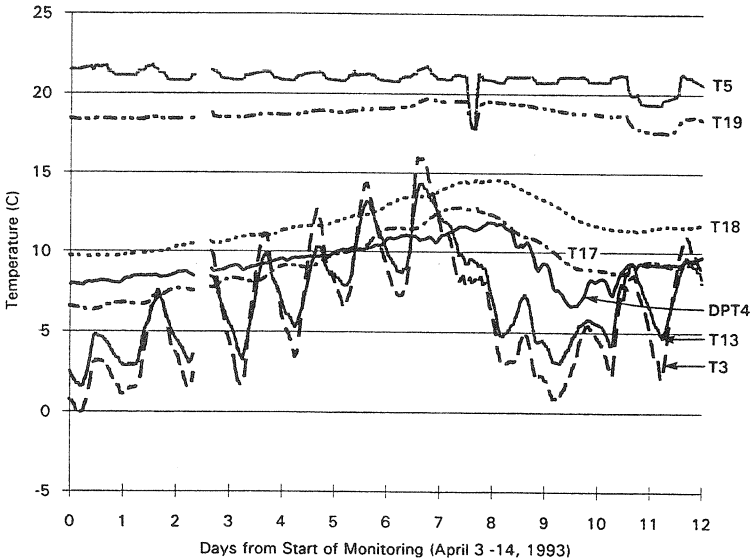
Fig. 9 Temperature Profile Through Stone Masonry Wall in April, North Side

The temperature profiles through the masonry wall and the dew point temperature for April 1993 and January 1994 are shown for the north side in Figs. 9 and 10, respectively. During spring weather, (Fig. 9), the dew point initially was in the limestone and then it moved into the sandstone. There were several temperature spikes which caused the dew point to move outside the masonry wall for short periods of time. As seen in Fig. 10, the stone masonry wall was frozen through its entire thickness most of the time in January; T18 was at or below 0°C (32°F). The dew point of the cavity air was located at the interior face of the limestone; T18 and DPT4 were at approximately the same temperature. Overall, the incidence of condensation within the masonry walls is as follows:

- condensation occurs in the limestone at air temperatures below about 5°C (41°F)
- condensation occurs in the sandstone at air temperatures between about 5°C and 15°C (41°F and 59°F)
- no condensation occurs in the wall at air temperatures above about 15°C (59°F)

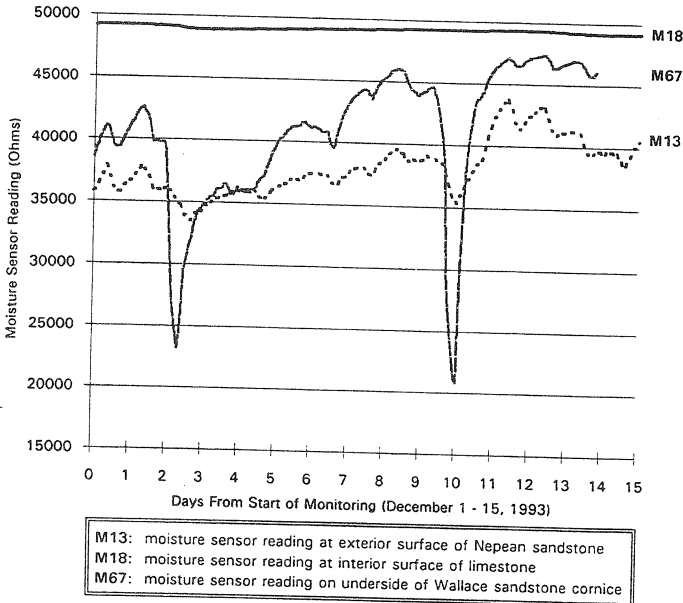
Fig. 11 Moisture Conditions in Stone Masonry Wall during Winter Weather, South Side

Fig. 11 illustrates the moisture in the masonry wall on the south side during December 1993. It is interesting to see that the interior face of the limestone remains dry during this measuring period whereas the exterior sandstone face is often "wet" and the band course is generally "damp". On two days, when rain hit the wall, the band course gets "very wet". After the second rainfall (on Day 10), a drop in temperature then caused the moisture to freeze in the sandstone which resulted in a false reading of "damp" or "dry".

- Precipitation is the main source of moisture in the stone masonry walls. Fluctuations in the moisture readings can be directly attributed to weather conditions. Increased wetting occurs only during precipitation against the walls.
- Exfiltration of moist interior air is a minor contributing factor to the moisture in the stone masonry walls.
- The band courses experience much more severe wetting than the main walls.

To reduce the potential for future deterioration of the exterior sandstone masonry, all band courses and buttresses will be covered with lead-coated copper flashings.
