PERFORMANCE OF MASONRY IN HIGH HUMIDITY ENVIRONMENTS

David L. Scott¹

ABSTRACT

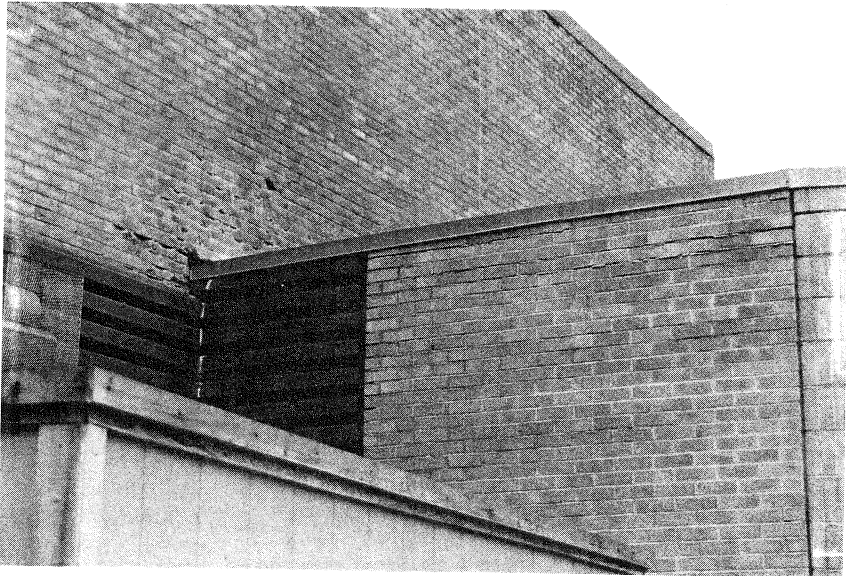
Masonry damage is evident around the perimeter of the pool and administration building. Both brick and mortar systems are extremely wet over large areas during periods of cold weather. Photo's 1 and 2 show typical patterns of deterioration including loss of mortar brick spalling and brick displacement.

Photo 1 - Brick Spalling Junction of Whirlpool with Main Roof

Our site investigation included a thermographic scan and test openings to establish the condition of the masonry. The thermographic scan showed patterns indicative of air leakage and warm air entrapment at junctions. These patterns, most intense on the south elevation, corresponded with locations on the exterior where brick spalling and moisture staining was most evident. Photo 3 shows the air leakage at the roof/wall junction and Photo 4 shows air leakage at the junction of the whirlpool and main pool. This location corresponds with the damage shown in Photo 1.

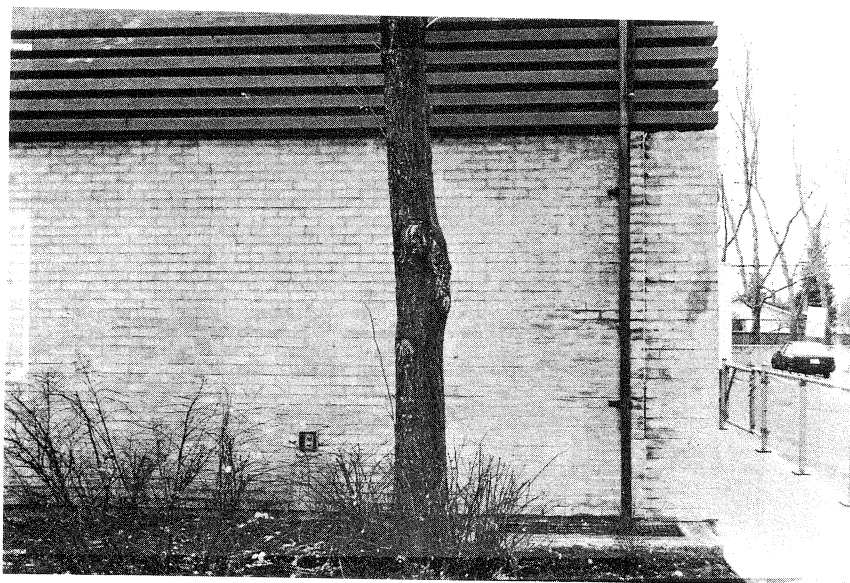
Photo 2 - Saturated Brick on Administration Wing

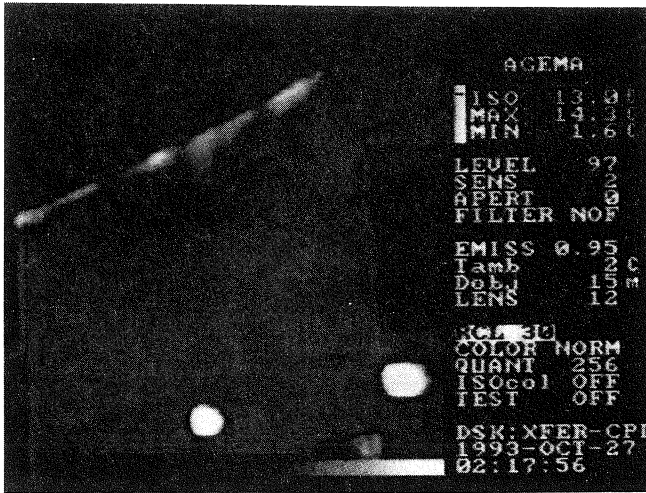
Photo 3 - Air Leakage at Roof/Wall Junction

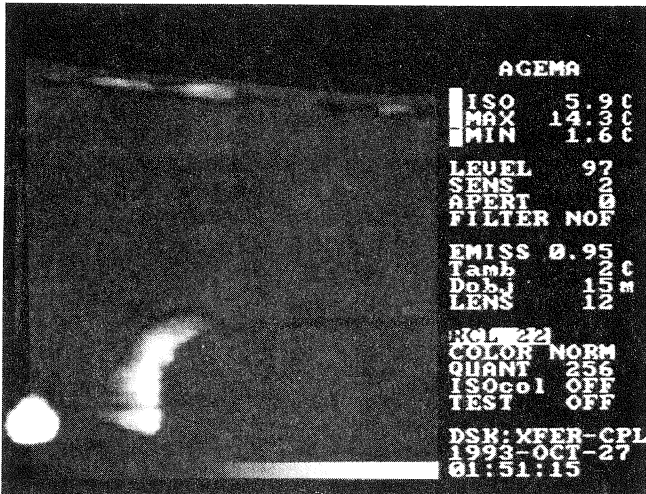
Photo 4 - Air Leakage at Junction of Whirlpool and Main Pool

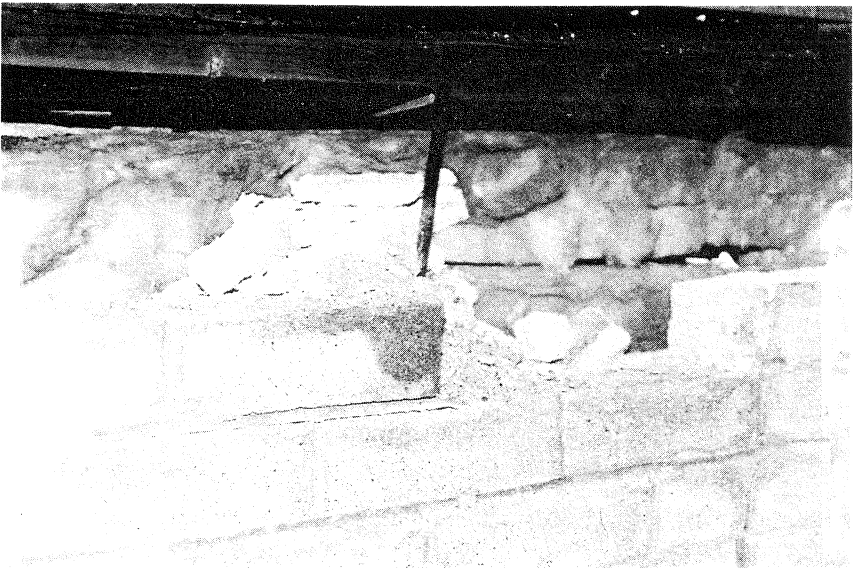
A test opening was conducted from the exterior at the roof/wall junction to establish the current condition of wall components. The concrete face brick at this location was displaced near the parapet with little bond left at mortar joints.

The wood blocking at the parapet was saturated and masonry anchors for the blocking were showing significant corrosion. The glass fibre insulation was streaked with dust indicating substantial air movement. (Photo 5)

Photo 5 - Saturated Materials, Corroded Anchorage and Dust Streaked Insulation at Parapet.

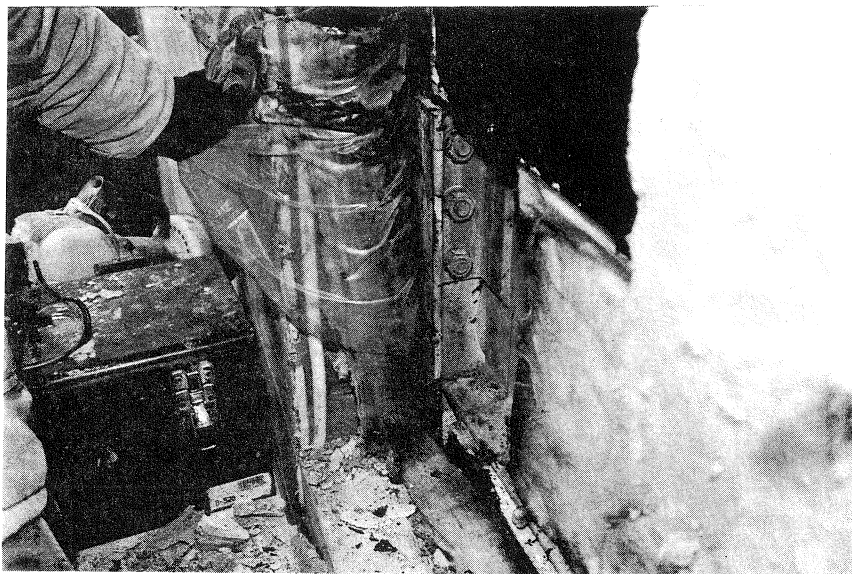
Brick removal revealed the trowel on asphalt mastic vapour barrier on the exterior of the block infill. At steel structural columns, spandrel beams and open web steel joist bearing points polyethylene had been used to bridge across from block infill to adjacent block. (Photo 6)

Photo 6 - Polyethylene Boots over Structural Steel/Block Interfaces

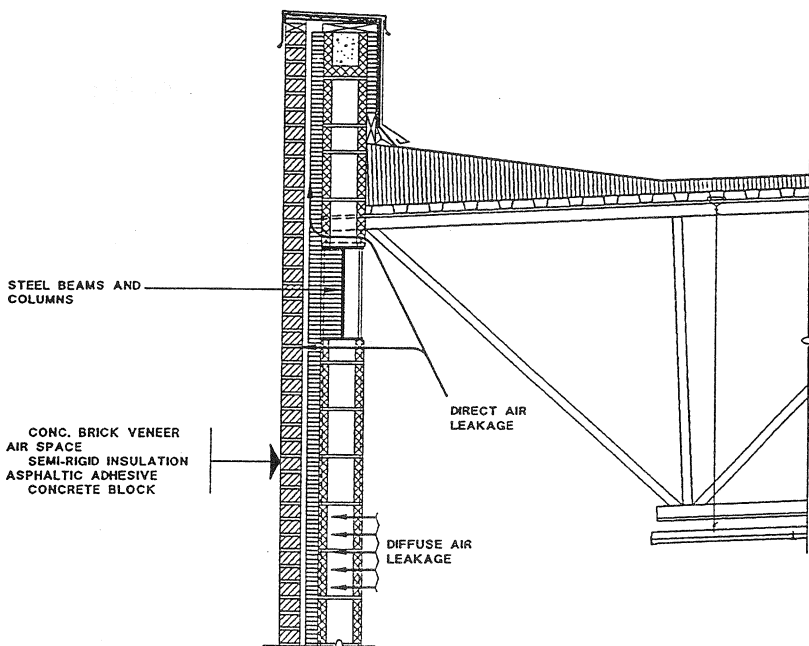
The brick wetness and deterioration on this building are consistent with continuous air leakage over a long period of time. The air leakage has resulted from a positive pressure difference across the building envelope generated by wind, mechanical systems and stack effect combined with building envelope design details that are prone to air leakage. Air leakage paths from interior to exterior include:

- The junction of blockwork and steel spandrel beams at the perimeter of the pool building. (Figure 1)
- The connection of the whirlpool and main pool building.
- The porous acoustic block on the upper portion of the main pool wall.

The architectural details and site investigations reveal an asphaltic vapour barrier has been applied to the exterior of the block walls. At penetrations for structure and services the continuity of this vapour barrier is maintained with polyethylene sheets. These two materials in combination are not however capable of withstanding the pressure difference necessary to act as an air barrier. Re-detailing is necessary to reinstate the air barrier within the wall assembly.

Figure 1 - Locations of Air Leakage

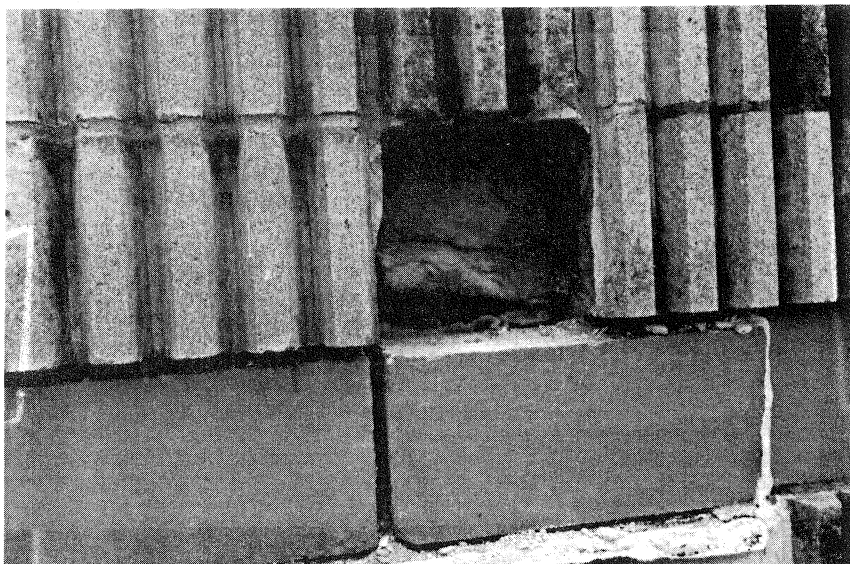
The exterior concrete block cladding on this structure is experiencing significant displacement near corners and parapets where mortar is in very poor condition. (Photo 7)

Photo 7 - Mortar Missing, Concrete Block Displaced near Parapet

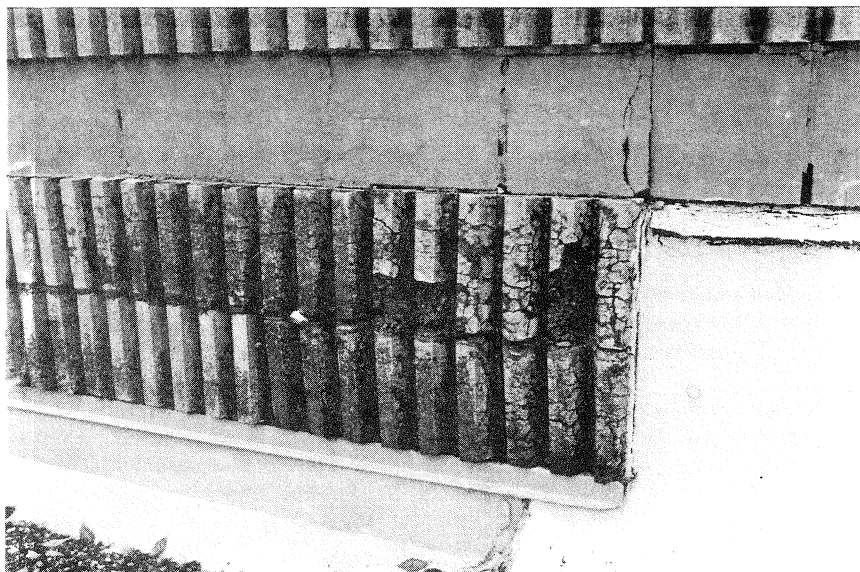
The block is visibly wet, fractured and approaching an unstable condition in some areas.
(Photo 8)

Photo 8 - Badly Fractured Concrete Block Cladding

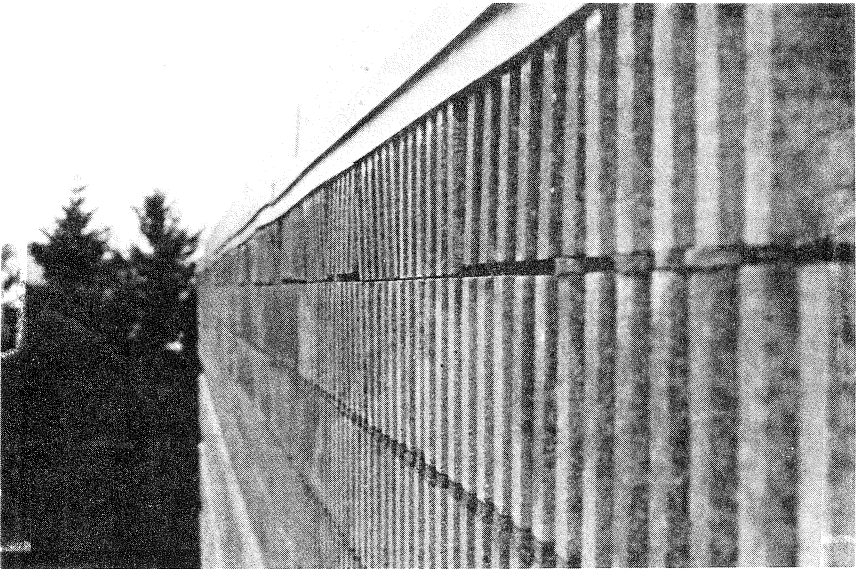
Several test openings revealed serious masonry damage associated with air leakage paths. At the upper pool roof/wall junction mortar was found to be wet and friable. In some locations upper courses had settled to contact the course below. (Photo 9)

Photo 9 - Deteriorated Mortar Leaves Blockwork Unstable

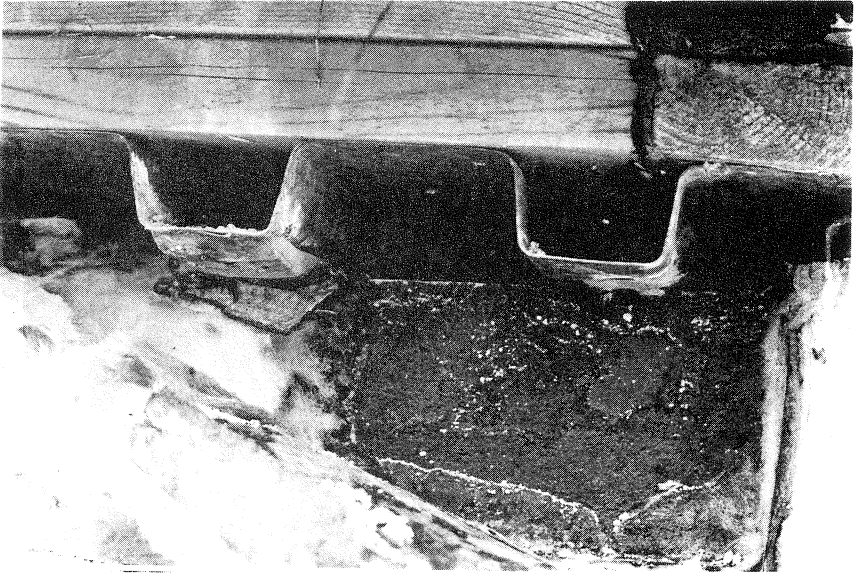
Neoprene flute closures were observed in the lower flutes of the metal roof deck but in line with the inner face of the 250 mm (10 inch) block. A mastic type sealing strip was placed along the flute above the inner surface of the north wall. Despite these, warm air could be felt leaking from the wall to deck interface. (Photo 10) Glass fibre insulation was wet.

Photo 10 - No Closures were Provided in Troughs or Fluted Deck

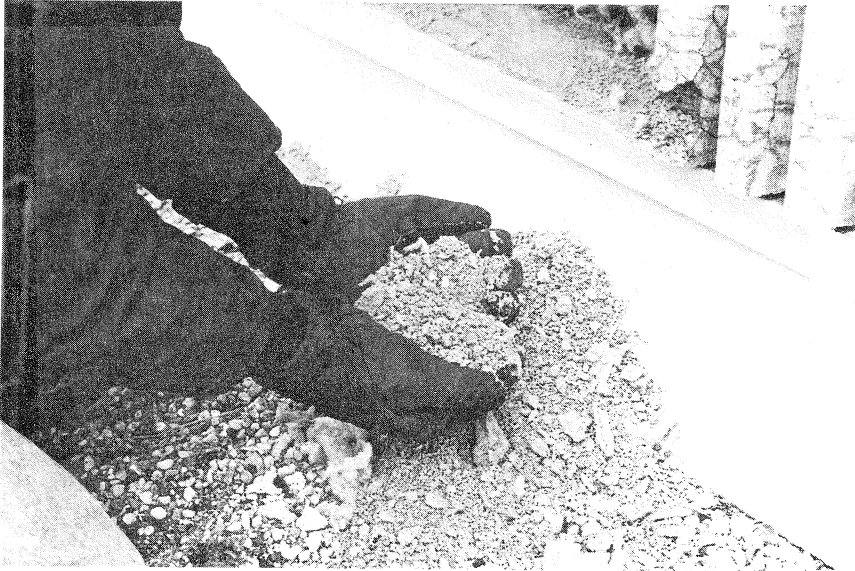
A second test opening was conducted at the intersection of the upper roof wall with the lower administration area roof. At this location, mortar had no consolidation, and concrete block was fragmented. (Photo 11)

Photo 11 - Serious Concrete Block Deterioration

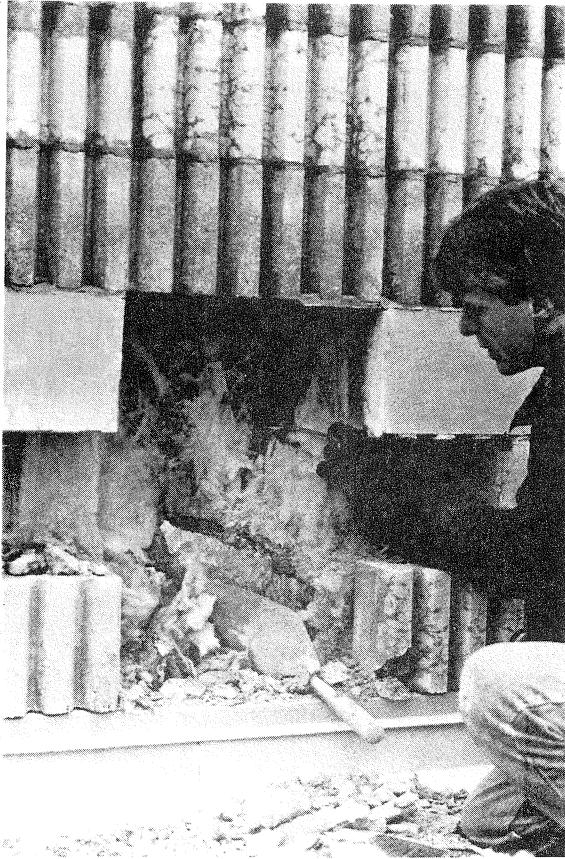
Photo 12 - Air Leakage from Top of Flashing

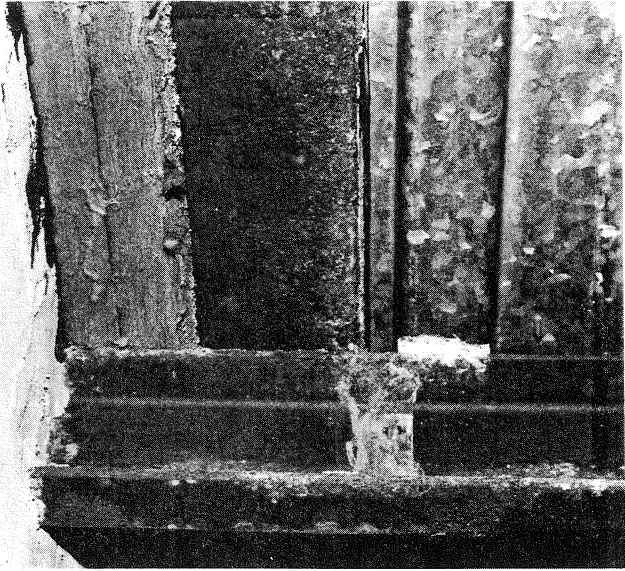
When the construction was reviewed from within the ceiling space of the administration area below, insulation was found to connect the ceiling space within the wall cavity above. (Photo 13)

Photo 13 - Wall/Lower Roof Intersection Showing Lack of Air Seal at Junction

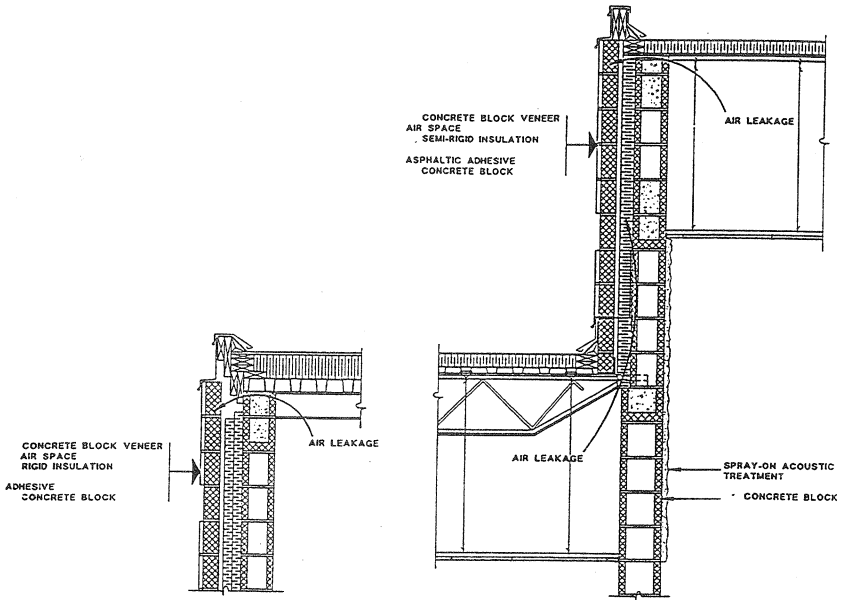
Figure 2

Block and mortar damage observed in this building can be attributed to air leakage, condensation collection and subsequent freeze/thaw damage. The deterioration is so great that structural failure of the facade is very likely. Certain design features intended to protect the envelope from high humidities were actually included in the original design (such as mastic type vapour barriers, and metal deck closures) but they have proven ineffective. The degree of air leakage at the roof/wall interfaces was significant at all test opening locations and appears to be the primary source of moist air in the cavity. Diffuse air leakage and vapour transmission through the block interior walls and an incomplete mastic type air/vapour barrier is a secondary but possibly significant source of moisture. (Figure 2)
