Jasper, Alberta  
May 31 - June 3, 1998

## FACADE RESTORATION OF AN 1889 BROWNSTONE

David T. Biggs, P.E.  
Ryan-Biggs Associates, P.C.  
Troy, New York 12180, USA

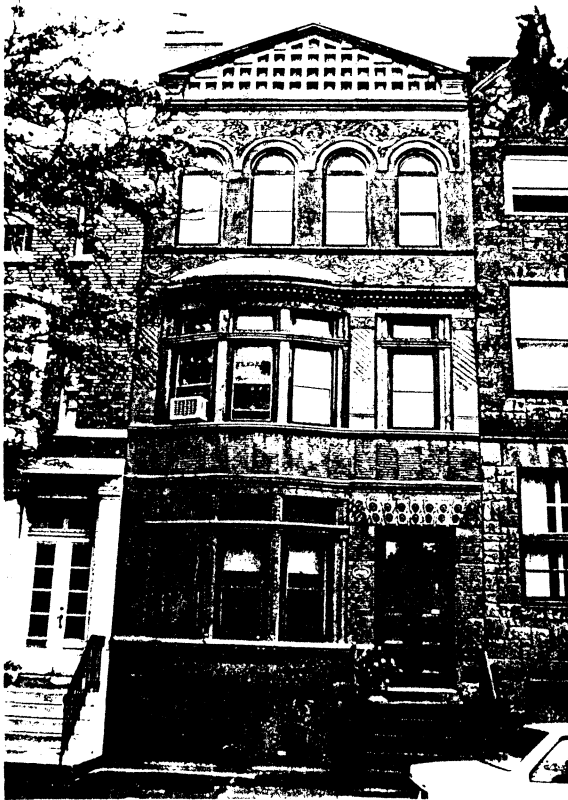
The brownstone for this residence is unique in that it is one of a few in North America where the carved scrollwork is evident over the entire facade. See Photograph 1 of the facade. No two stone panels are identical.

Photograph 1 - Building elevation

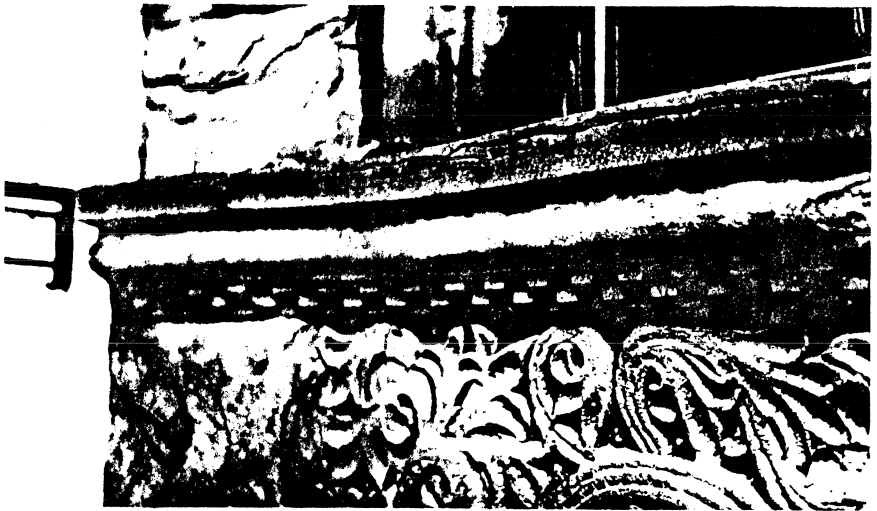
1. Facade delaminations from the backup. The thickness of the brownstone is generally 100 mm to 175 mm. The backup of the load bearing wall is 2 wythes of brick (200 mm thick). The delaminations of the stone were most evident at window jambs (Photograph 2) and below sills (Photographs 2 & 3).
2. Internal stone delaminations. Horizontal surfaces, primarily sills, were spalled and internally delaminated.
3. Weathering. Carved features were worn.

The sills were placed with the stone horizontally bedded. Mortar leaks around window frames and sills allowed moisture penetration from water and snow. Freeze-thaw from the absorbed moisture caused the stone to delaminate internally or spall.

Photograph 3 - Deteriorated sill & scrollwork

Individual stones were patched by removing all spalls and deterioration. A bonding agent was used to adhere the patching material. Isolated patches which were more than 75 mm deep were also pinned to the stone using stainless steel pins epoxied to the brownstone. As with the delaminated stones, ornate features were carved into the patches. Weathered or worn stones were chiseled down to sound material and similarly built up.

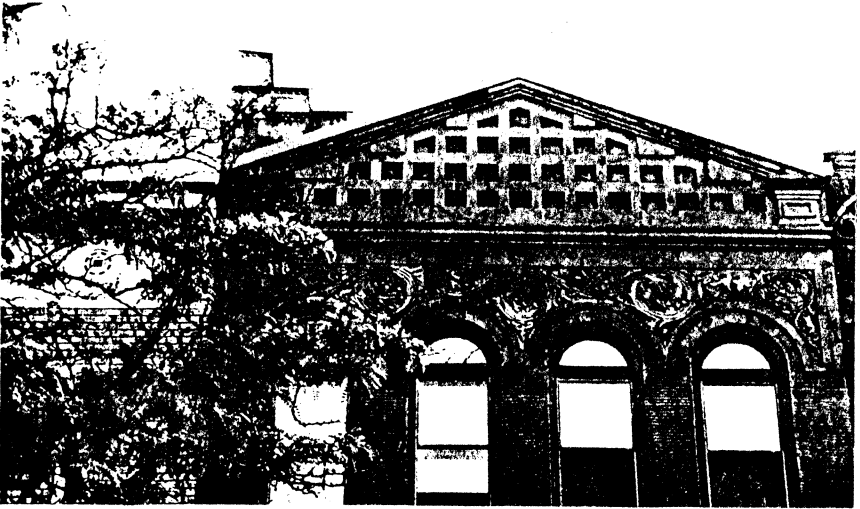
Photograph 4 - Restoration completed at roof level

Approximately 60 percent of the facade was restored. Once all the repairs were completed, a consolidant was applied to the entire surface to provide added protection to the original sandstone. The patches were also coated to prevent a spotty discoloration of the wall. Photographs 4, 5, & 6 show the results of the restoration. The scrollwork was replicated in all the patches.

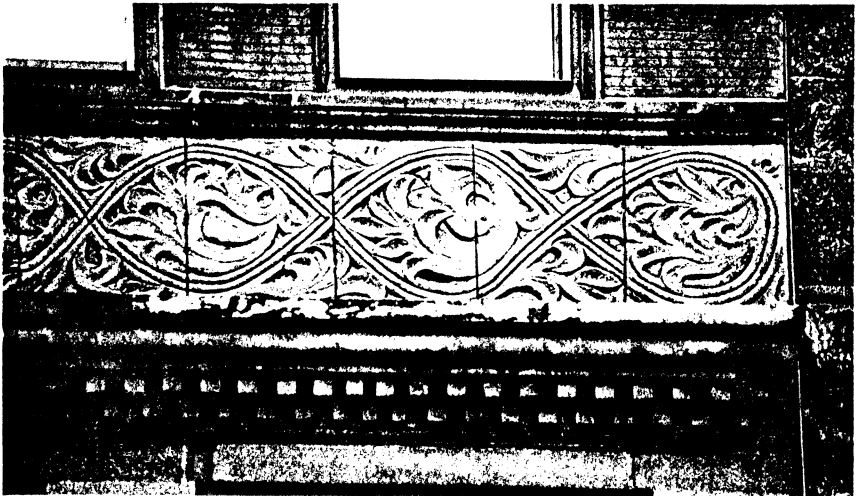
Photograph 5 - Restoration of scrollwork and details

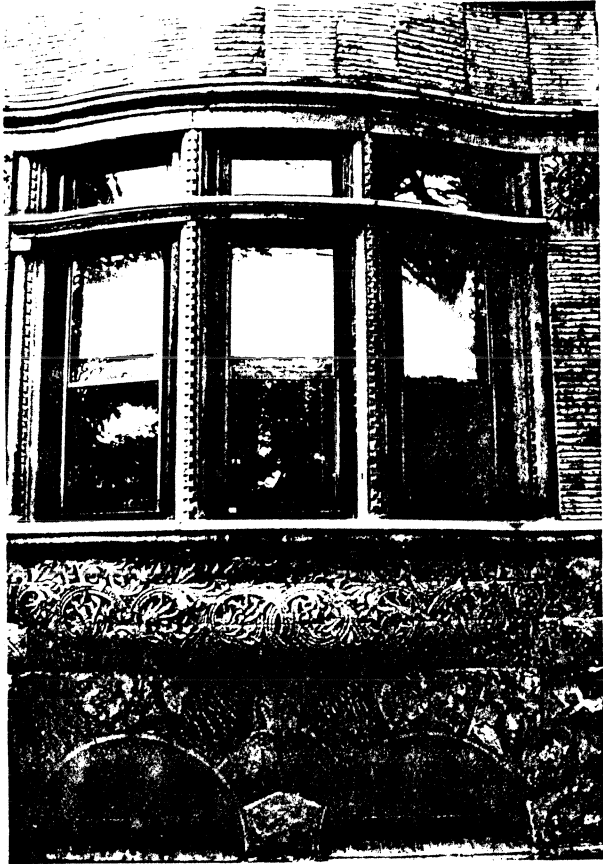
Photograph 6 - Restoration completed at lower level
