**Jasper, Alberta
May 31 - June 3, 1998**

TERRA COTTA RESTORATION - A CASE STUDY

David T. Biggs, P.E.
Ryan-Biggs Associates, P.C.
Troy, New York 12180, USA

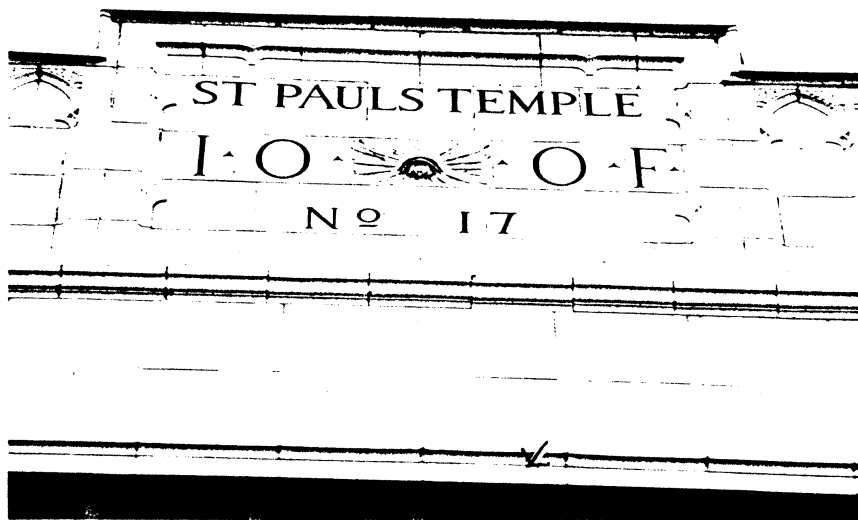
Photograph 3 - Repair completed at head of window (arrow)

One of the most difficult aspects was installing the flashing, because the steel was not fully exposed. A self-adhering membrane was used so moisture could not get under the flashing at discontinuous ends. This was a compromise due to cost restrictions; it would have been preferable to remove all the terra cotta at window heads and install flashing. Photograph 3 shows the work completed corresponding to Photograph 2.

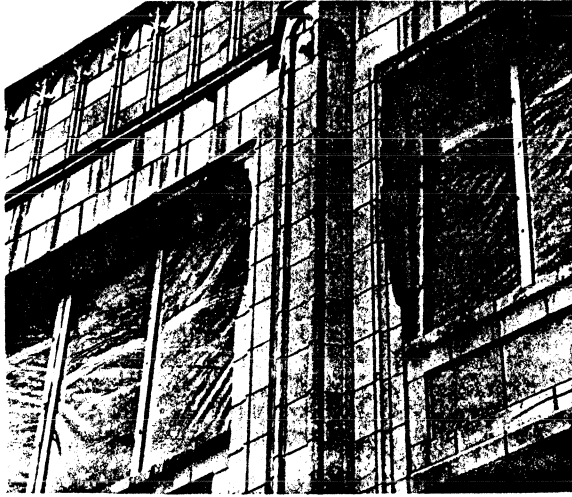
Photograph 4 - Broken terra cotta removed

Photograph 4 shows work at the jambs. New anchors were installed to the brick back-up. Photograph 5 shows the completed work corresponding to Photograph 4.

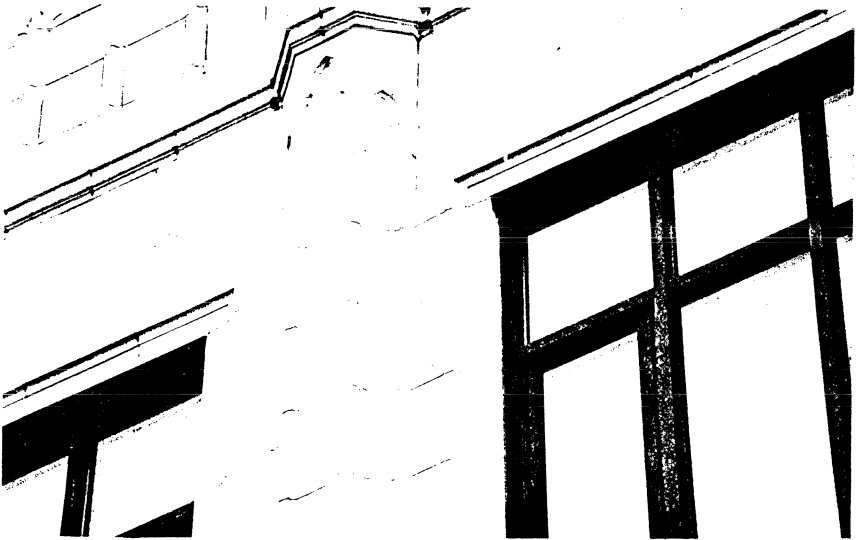
Photograph 5 - Completed jamb repairs

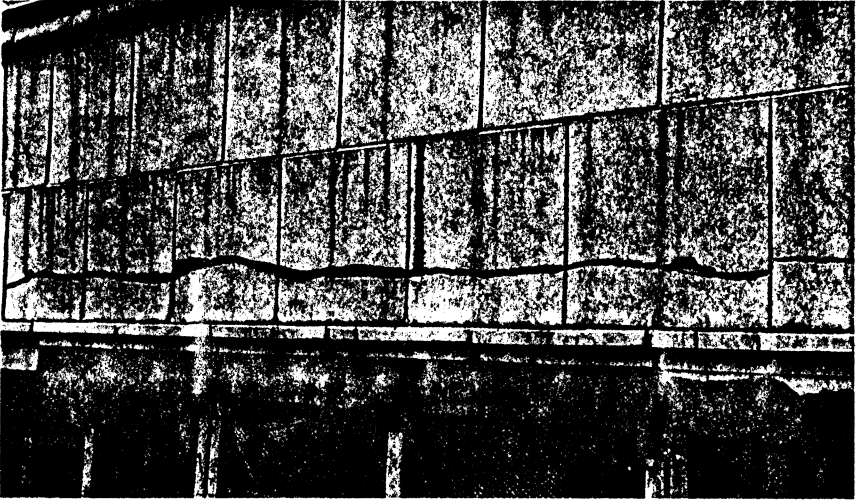
Photograph 6 - Routed crack

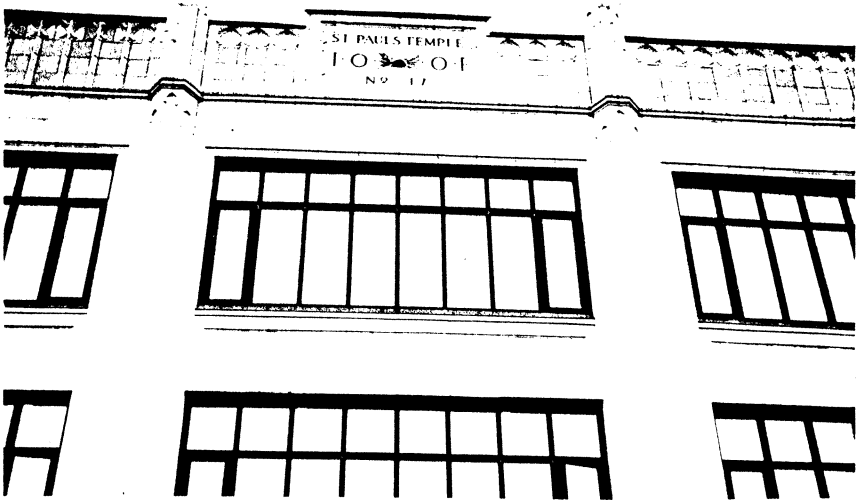
Photograph 7 - Repaired terra cotta

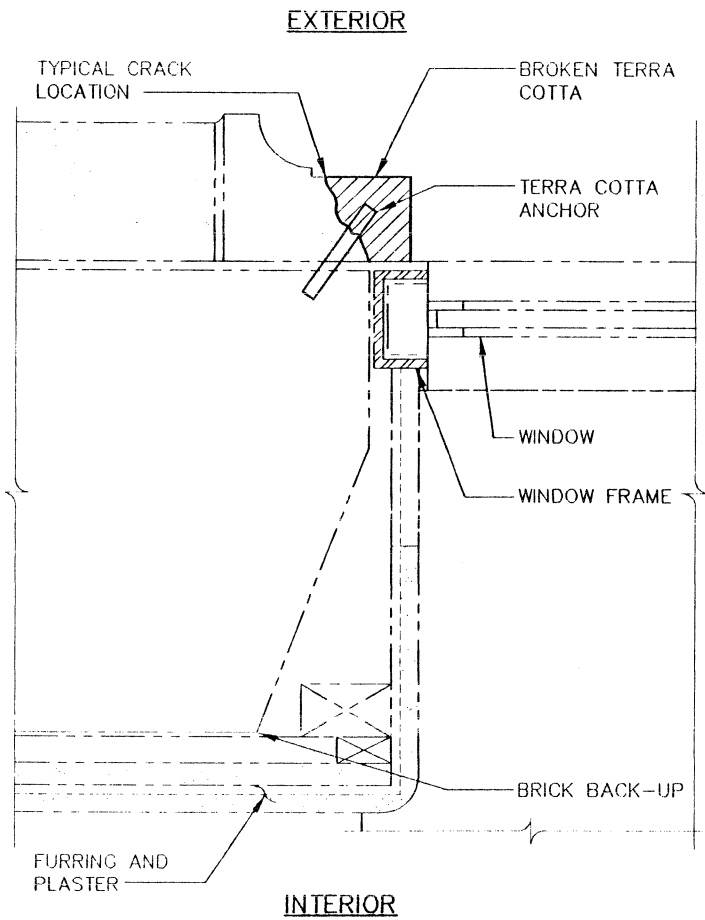
Fig. 1 - WINDOW JAMB

Based upon this report, the Board authorized a full investigation. These efforts centered on the terra cotta cracking, and included interior and exterior removals. The interior removals were made through the plaster finish at the head and jambs of the windows. The jamb removal at the third floor revealed a steel column encased in brick. Corroded anchors from the brick to the exterior terra cotta were observed (see Fig. 1). The brick was in good condition. The window frame was embedded in the brick.

Using a man-lift, the jambs of the window were inspected. Cracks in the terra cotta were parallel with the jambs, approximately 100 mm from windows. These cracks generally began at the head of a window and extended down the jamb of the window. The crack width was approximately 15 mm. There was no cracking between floors.

Adjacent to the interior removal on the third floor, a large piece of cracked terra cotta was removed from the exterior. The terra cotta was approximately 125 mm thick. Underneath the terra cotta was the anchor observed from the interior; it was corroded. In addition, the embedded window frame was also corroded.

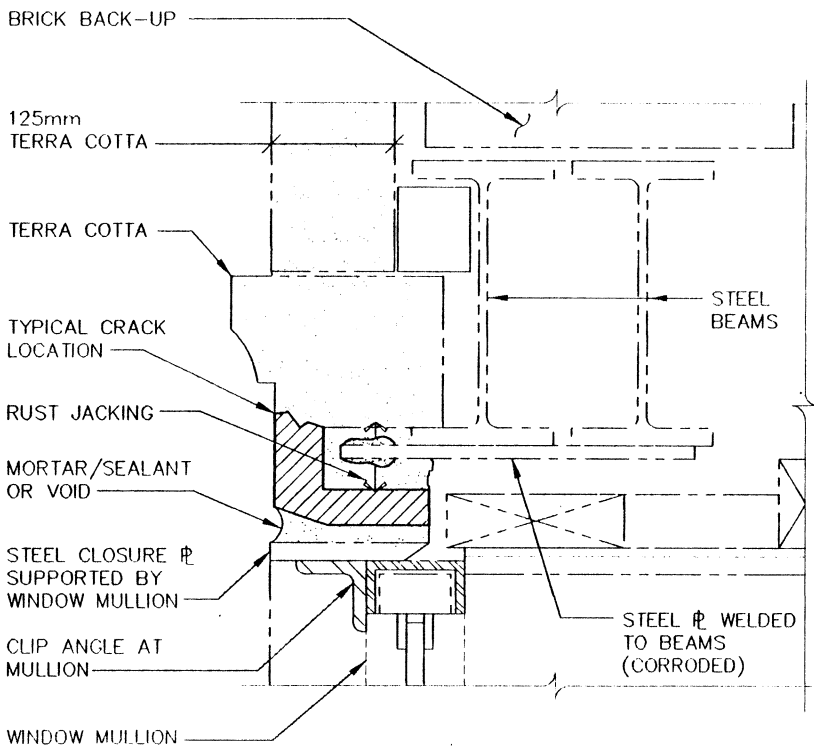
Fig. 2 - WINDOW HEAD

The interior removals at the window head uncovered a steel beam with a cover plate which was heavily corroded (see Fig. 2). The beam supported brick above. The corrosion had rust-jacked the plate from the bottom of the flange of the beam. How the exterior terra cotta was supported was not evident from these interior removals.

From the exterior, a plate was observed at the underside of the terra cotta. It was fastened to the window mullions and appeared to support the facade (see Fig. 2).

A length of broken terra cotta was removed. Photograph 2 shows the broken terra cotta before it was removed. Fig. 2 shows the cross-section of wall and how the terra cotta was notched around a steel plate which supported the facade. The lower exterior plate was used as a closure.
