Jasper, Alberta  
May 31 - June 3, 1998

**THE CHALLENGE AND THE COSTS OF  
RESTORING THE HISTORIC STONE MASONRY WALLS OF  
THE VICTORIA MEMORIAL MUSEUM IN OTTAWA**

**H. Keller, P.Eng. and D. Stephenson, P.Eng.  
Keller Engineering Associates Inc.**

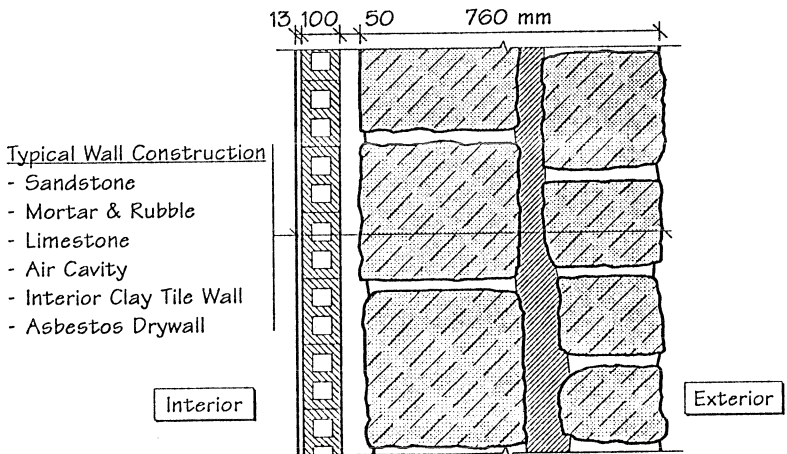
Fig. 2 Cross-section of Exterior Wall

The exterior walls are constructed with a combination of dressed and rough sandstone on the outside, backed by an equal thickness of limestone. An interior clay tile wall covered with asbestos plaster provides the air barrier. The walls are not insulated. A cross-section of the exterior walls is shown in Fig. 2.

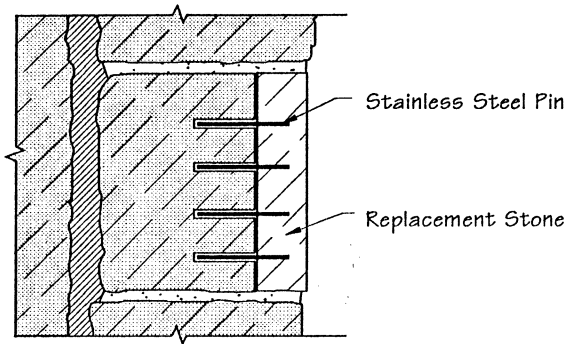
Fig. 3 Partial Flat Stone Replacement

Wallace stone replacement involved both complete replacement, where deterioration had occurred over a significant area of the stone, and partial replacement. Complete replacement typically involved smaller stones at buttresses and building corners. Partial replacement, which was more frequent, was carried out Dutchman Style, or using composite patching techniques. For the Dutchman style repairs, typically 2 to 4 stainless steel pins, set in epoxy, were used to secure the new stone segment. A gap of about 3 to 6 mm was left at the exposed joint between the new and the old stone. The gap was then filled with the Jahn M70 restoration mix to better match the finish colour of the adjacent stone. See Figs. 3 and 4.

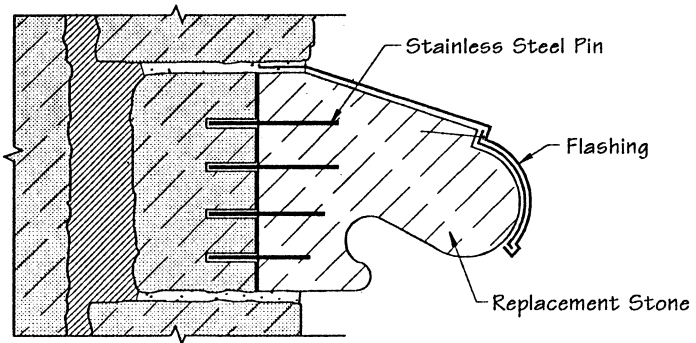
Fig. 4 Partial Stone Replacement at Band Course

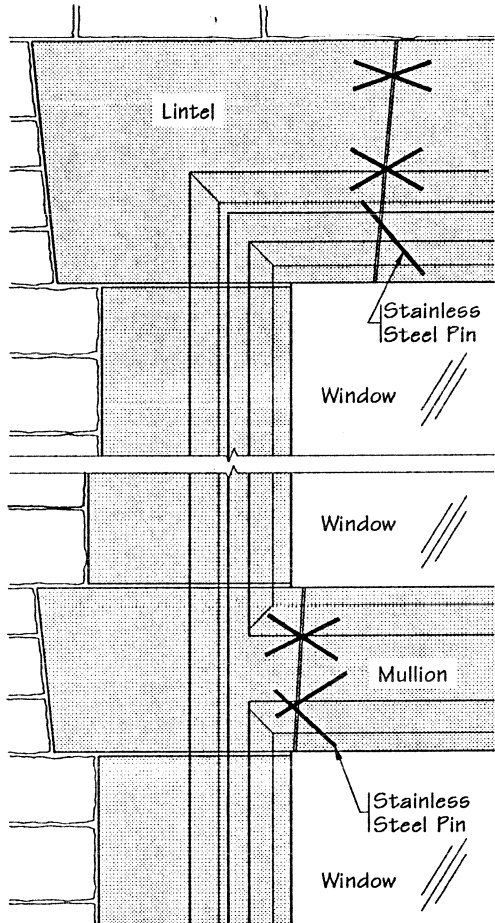
Fig. 5 Wallace Stone Repair at Window Lintel & Mullion Using Pinning and Crack Injection

Typically, cracks were first sealed with modelling clay, then filled with adhesive. Trial repairs were made using epoxy and cementitious materials. However, the use of epoxy to fill cracks was rejected due to difficulties in injecting the material and because of staining of adjacent stone surfaces. On the other hand, cementitious Jahn M30 and M40 products were successfully used for the injections and any staining could be easily cleaned. After removal of the modelling clay, the top 12 to 20 mm of the crack was filled with the Jahn M70 mix so as to better match the surface colour of the stone. Where pinning was required, stainless steel threaded rods, set in an epoxy based adhesive, were used subsequent to the crack injection work. See Fig. 5.

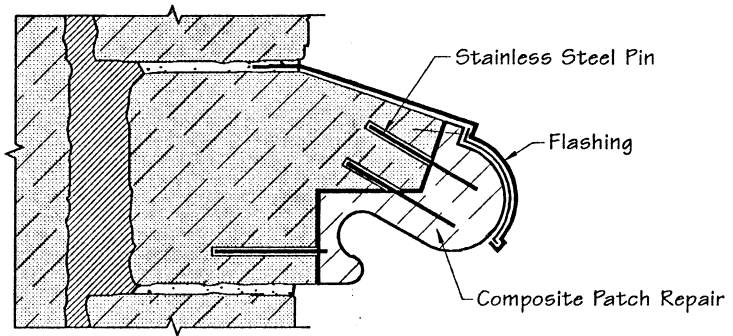
Fig. 6 Composite Patch Repair at Band Course

Composite repairs made to the underside of stones, as well as deeper vertical repairs, were typically reinforced with stainless steel pins as shown in Fig. 6.
