**Jasper, Alberta
May 31 - June 3, 1998**

**MONITORING THE HYGROTHERMAL PERFORMANCE OF A MASONRY WALL
WITH AND WITHOUT THERMAL INSULATION**

A H P Maurenbrecher, M Z Rousseau & M N A. Saïd
Institute for Research in Construction, National Research Council, Ottawa K1A 0R6

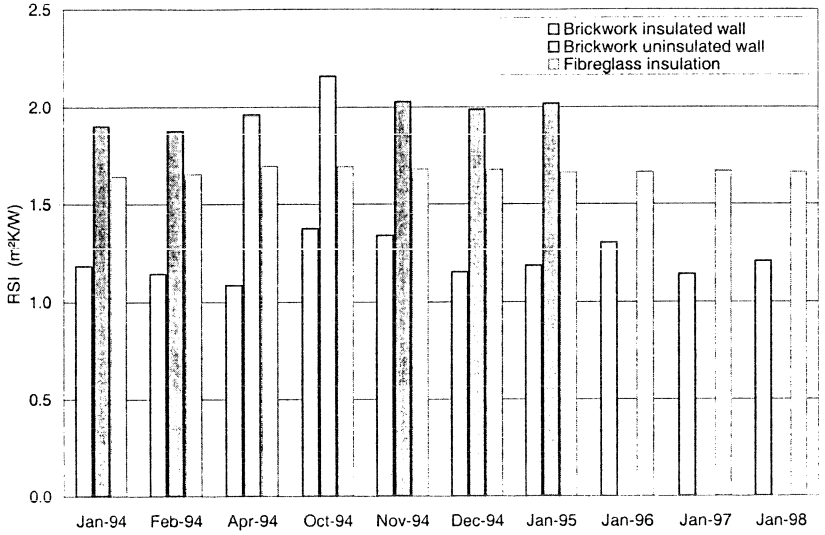
Figure 5 Variation in thermal resistance of the masonry and glass fibre insulation
Heat flux sensor removed from uninsulated wall in March 1995; $R = 5.68$ RSI

Figure 5 shows the thermal resistance of the masonry and the glass fibre insulation for the cold months in 1994 and, for comparison, January in the following years. The values do not include the interior and exterior surface air film coefficients. The mean RSI value for the masonry was 2.0 in the uninsulated wall and 1.2 in the insulated wall. The glass fibre insulation had an average value of 1.7.

The thermal resistance of the masonry in the insulated wall was on average 40% lower than the masonry in the uninsulated wall. The reason for such a large difference is not fully clear. There can be many explanations to account for the difference. Either the difference in thermal resistance is real or it is a measurement error. If the difference is real, it could be partially due to a higher moisture content or variation in the construction of the two wall sections. However the moisture sensors installed did not indicate high moisture levels and the modelling study predicted only slightly increased moisture levels (due to lower thermal gradient across the wall which in turn, reduces the drying potential). Variation in the construction of the wall sections include differences in the locations and geometry of the steel structural components in the wall and multiple air voids in the masonry assembly. These factors require further investigation before final conclusions can be drawn.

The thermal resistance of the 55-mm thick glass fibre insulation varied between RSI 1.6 and 1.7 which is close to the nominal design value of 1.58 at 24°C mean temperature (Fiberglas wall design guide; AF530 series). In Equation 1, the constant k was taken as 0.004 (based on laboratory measurement of a glass fibre sample of similar density, 48 kg/m³).

The total measured thermal resistance for the masonry and glass fibre insulation varied between RSI 2.8 and 3.1. Therefore the renovation of the wall resulted in an increase of the thermal resistance by 40 to 55% compared to the uninsulated wall. If the ASHRAE Handbook (1993) design conductivity of 0.7 W/(m.K) for clay brick had been assumed

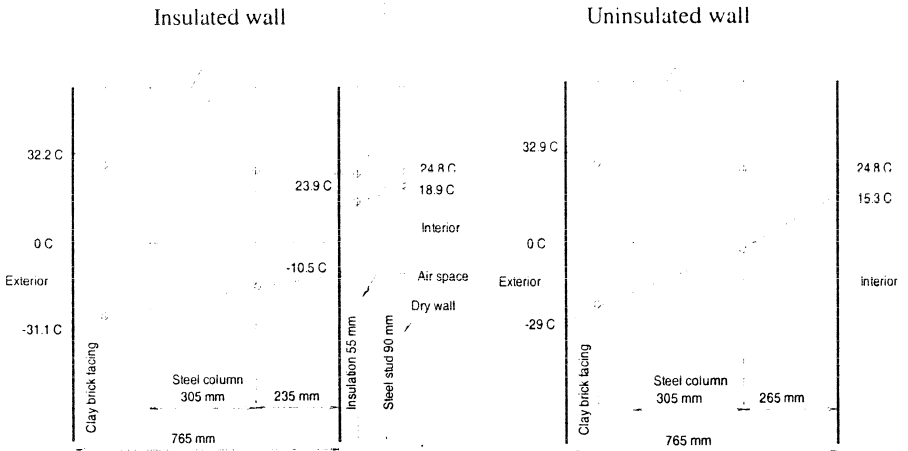
Figure 6 Maximum and minimum temperatures across the walls at mid-height in 1994
The maximum and minimum indoor air temperatures were 24.6 & 19.9°C
The maximum and minimum outdoor temperatures were 29.8 & -29.8°C

Figure 6 shows the maximum and minimum temperatures recorded over a period of a year and a half across the insulated and uninsulated walls (at mid-height). The temperature range on the exterior face of the brick wall is nearly the same for both walls (60°C). But the temperature range is much greater on the interior face of the brick in the insulated wall than in the uninsulated wall because of the added insulation (36°C compared to 9°C).

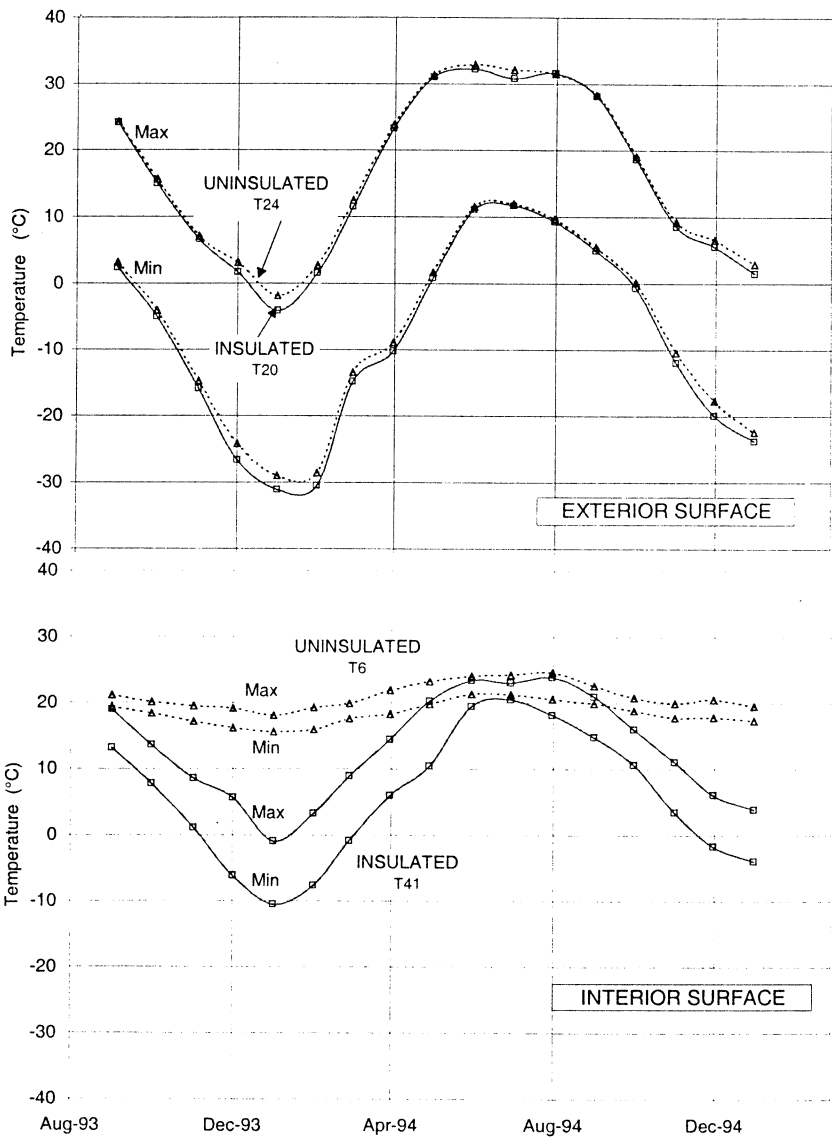
Figure 7 Monthly maximum and minimum temperatures on the exterior and interior masonry surfaces of the insulated and uninsulated walls (at mid-height)

Figure 7 shows the yearly variation of maximum and minimum monthly temperature at the exterior and interior face of the brick in both wall sections. The addition of insulation on the inside face of the masonry hardly affects the temperature on the exterior of the wall. The temperature at that location is mainly affected by the outside air temperature (solar effects are minimal because of the northerly orientation).

In the coldest part of winter, the inside face of the masonry on the insulated wall can be 25°C lower than the inside face of the uninsulated masonry. The temperature on the inside face of the uninsulated masonry hardly dropped below 15°C while the inside face of the insulated masonry dropped below freezing for several months in the winter (in January 1994 the masonry in the insulated wall did not rise above 0°C). This data indicates that adding thermal insulation on the inside face increases the risk for condensation or ice formation on the inside face of the masonry should moisture transfer occur, either by diffusion or air exfiltration.

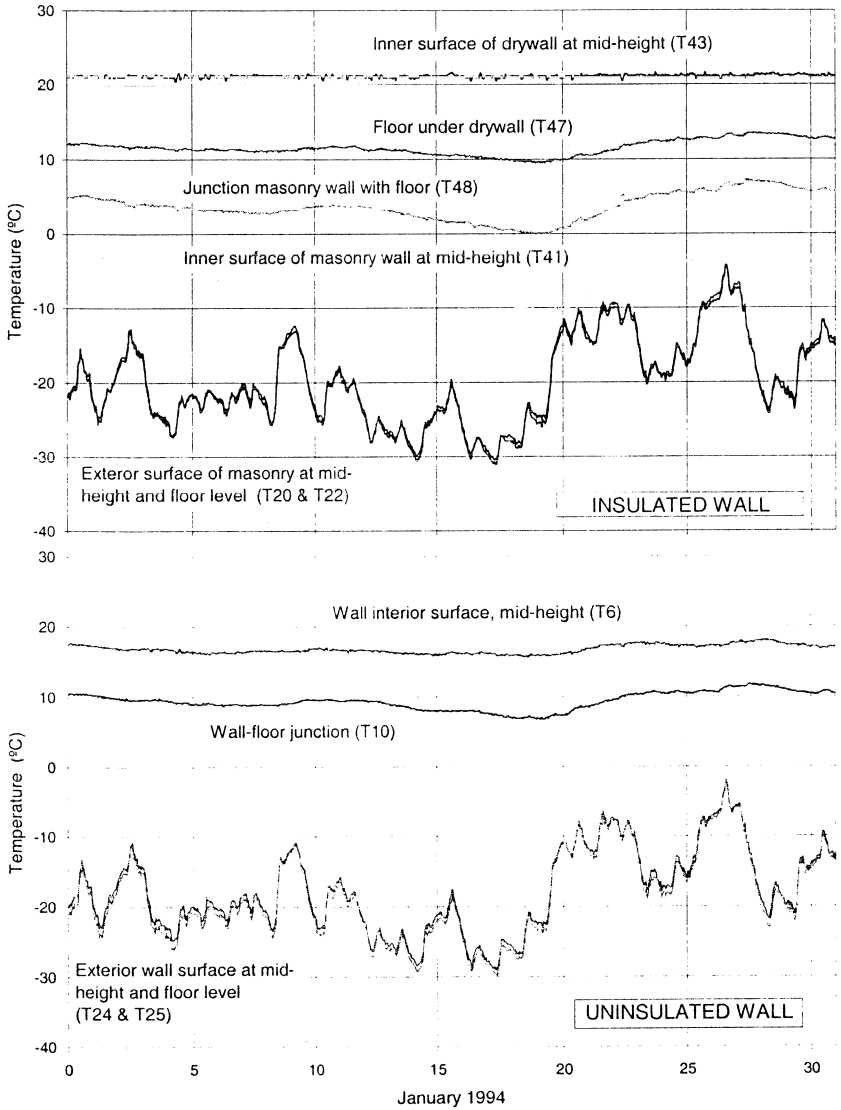
Figure 8 Temperature variation at floor and mid-height of walls in January

Figure 8 shows that the temperature in January at mid-height on the inside face of the drywall at mid-span between metal studs (T43) is quite steady at 21°C and is not affected by the fluctuations in the cold exterior surface temperature of the wall.

At the floor slab directly underneath the drywall (T47), the temperature fluctuates slightly between 10 and 12°C, that is 9 to 11°C lower than at mid-height (T43). The concrete slab is directly connected to the cold masonry and this increases the heat flow through the slab, resulting in a significant drop in temperature at the slab perimeter. The floor temperature may be low enough to cause discomfort if people were next to the wall. Standards about thermal comfort (ANSI/ASHRAE 1992) indicate that 95% of the people require a minimum temperature of 13-15°C near the floor for foot/ankle comfort.

At the junction of the floor and the masonry in the wall (T48), the temperature fluctuates between 0 and 5°C; this is an 8°C temperature drop relative to the floor/drywall junction location (T47). T48 thermocouple is located on the cold side of the insulation, and this can explain such temperature drop. However that location still benefits from some significant heat flow from the slab: it is significantly warmer (by 10°C) than the masonry at mid-height (T41). The floor slab, acting as a thermal bridge, warms up the masonry at floor level. The warming effect of the floor slab gets dispersed into the large mass of masonry as indicated by similarities between the temperature at the outside face of the masonry at floor level and the temperature at mid-height of the inside face of the masonry wall. Because that thermal bridge tends to raise the temperature of the adjoining masonry, it does not have a negative impact on the condensation potential on the wall; however it reduces its energy-efficiency.

Figure 8 shows that the temperature at mid-height on the inside face of the masonry (T6) is around 16°C to 17°C. This is about 5°C lower than the temperature of the inside face of the drywall of the insulated wall section. In terms of thermal comfort, the cooler uninsulated masonry wall surface may cause some thermal discomfort to nearby occupants because of radiative heat loss from their body towards the cooler wall surface. In terms of condensation potential, the uninsulated wall cannot sustain as high an indoor humidity level as the insulated wall section. However its surface condensation potential in the central part of the wall is low: it could sustain up to 60 % RH without condensation. Condensation would first occur at the floor/wall interface because the temperature is lower at that location.

At the wall/floor interface, the temperature (T10) ranges from 7°C to 12°C. This large difference (up to 9°C) from the mid-height location (T6) would not be expected in a completely uninsulated wall system but in this building, only a small wall section has been

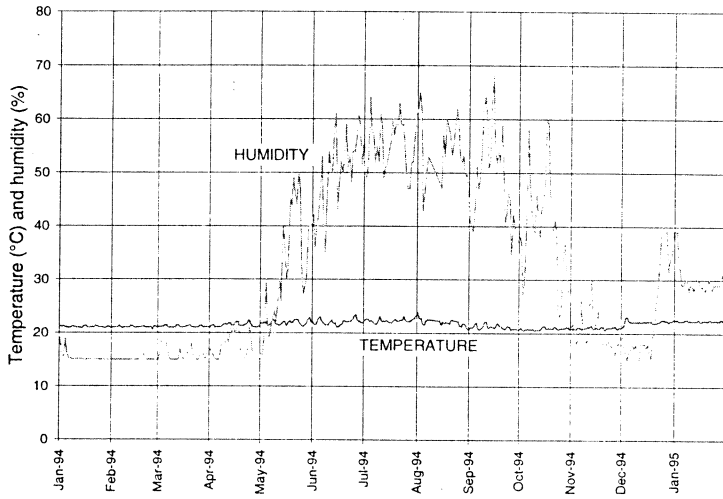
Figure 9 Average daily indoor air temperature and humidity
(Minimum reading on humidity sensor 15%)

Condensation on inside surfaces is also a possibility but generally, during the winter, indoor humidity levels were low (Fig 9). For 23°C and 30% RH the surface temperature should be above 4°C to prevent condensation. The indoor relative humidity would have to be above 40% before condensation occurred at the wall/floor interface in the winter. Relative humidities of this magnitude would be difficult to attain in winter because the large surface area of ordinary double glazing in the building would act as condensors.

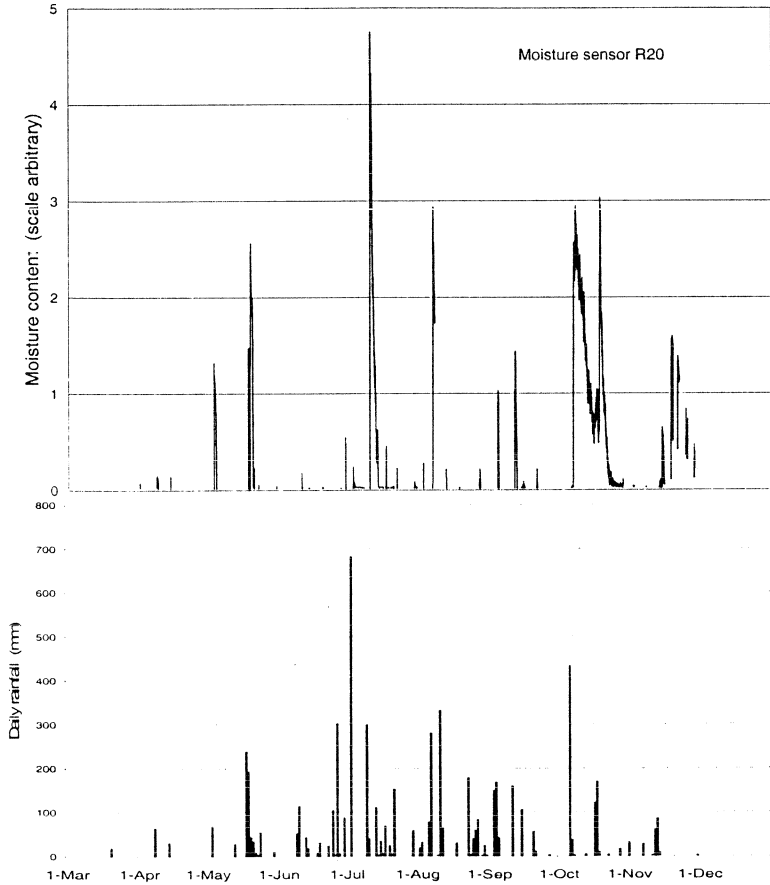
Wetting of the exterior face of the masonry often occurred during rain (Fig 10). Wetting was dependent on the wind direction. The heaviest daily rainfall recorded at the airport on July 3, 1994 hardly affected the wall sections (the wind was SSE; the rain may also have been less severe in central Winnipeg). This indicates that a small weather station installed at the monitoring site would provide a more accurate representation of the actual weather exposure of the building than the airport meteorological weather station. In 1994, the longest periods of wetting for the monitored wall sections occurred in October/November while the highest moisture level occurred during a rainstorm in July.

Figure 10 Wetting of exterior face of the masonry in the insulated wall in 1994
 Daily rainfall measured at Winnipeg airport. Moisture measured with two pins fitted in holes drilled 10 mm apart in a brick; plot shows half hour averages of one minute readings. No data recorded between 8-13 Aug when the second large daily rainfall in August occurred.

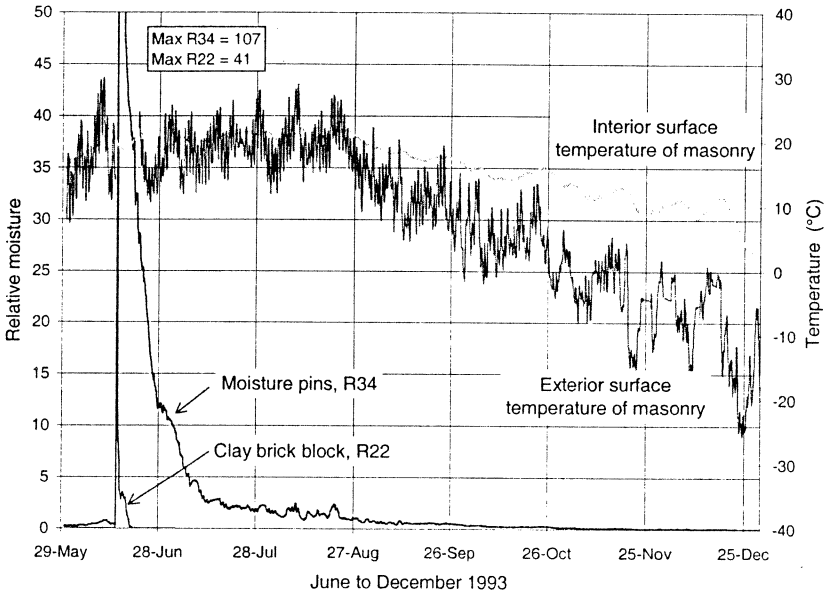
Figure 11 Moisture at the bottom of the inside face of the masonry of the insulated wall

During the installation of the instrumentation in the insulated wall section, it was observed that the base of the wall was damp. Moisture pins inserted into this part of the wall confirmed the wetness; the pins have kept measuring changes in moisture throughout the monitoring period. The temperature of this part of the wall did not drop below freezing because of the warming effect of the concrete slab. With one exception, the level of moisture measured was very low, the maximum occurring over the warmer months of the year and dropping to almost zero during the colder months. The one notable exception occurred early in the monitoring (Fig 11, R34 and R22). This area of wall became completely wet, with even a ceramic block sensor located on the floor registering water. The block and the masonry around the moisture pins probably had very high moisture levels. The source of the water is not known (it may have been caused by a leak from the floor above; the ceramic block registered the moisture increase before the sensor in the wall; it occurred around midnight of June 16/17th 1993). The moisture level in the wall took several months to return to lower levels. There may be a possibility for mould growth at that location.

Moisture levels in the monitored wall sections do not seem to be a problem. Only at one location, at the intersection of the masonry and the floor in the insulated wall, was a continuous low level of moisture measured. This moisture was present from the start of monitoring. Mould growth could be a possibility there.

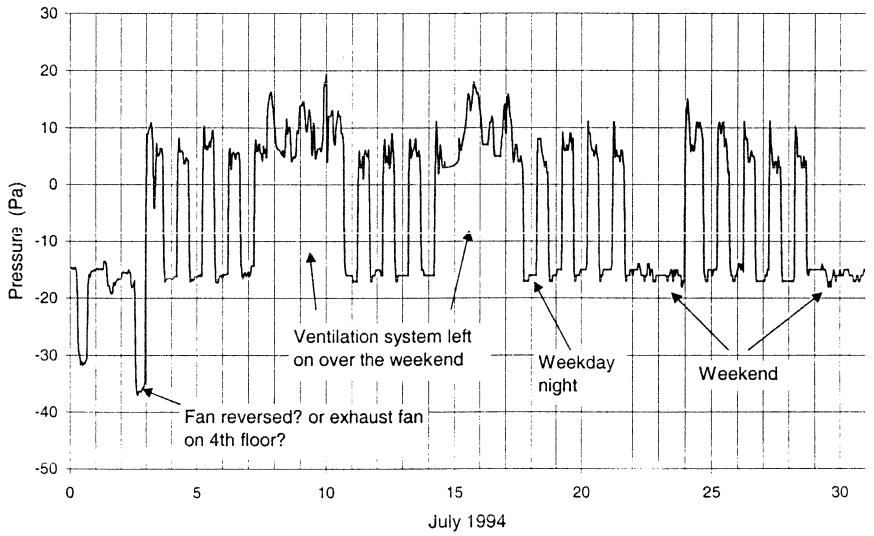
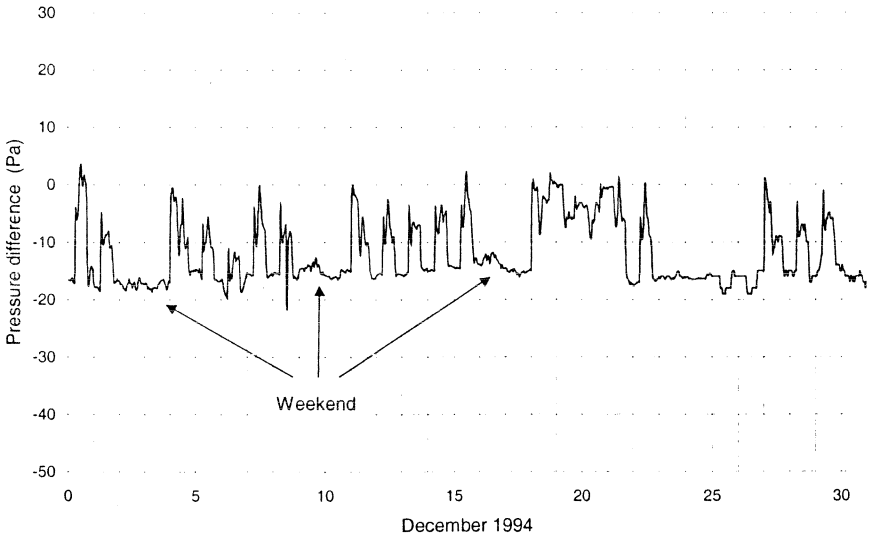
Figure 12 Air pressure difference across wall in July & December (positive pressure indicates air pressure is higher inside than outside)

During the months of January, February and December of 1994 the outdoor air pressure was almost always higher than the indoor air pressure (negative pressure differential across the wall). The higher outdoor air pressure during the winter led to air infiltration at any openings in the wall. Therefore there was little potential for condensation within the wall from indoor air in winter. The dominating negative pressure across the third storey walls was induced by the independent ventilation system on the fourth floor (there are also many exhaust fans on that floor; one operates continuously). This counteracted the positive pressure normally expected near the top of buildings due to stack effect in the winter.

During the rest of the year the indoor air pressure tended to be higher when the ventilation system was switched on during the day (Figure 12 shows July & December). The HVAC

supply fan for the first three storeys of the building normally operates during working hours only. Then there can be a positive pressure across the wall (see July).
