Jasper, Alberta  
May 31 - June 3, 1998

**FINITE ELEMENT ANALYSIS OF THE SOUTH WEST TOWER OF THE  
WEST BLOCK PARLIAMENT BUILDINGS, OTTAWA, CANADA**

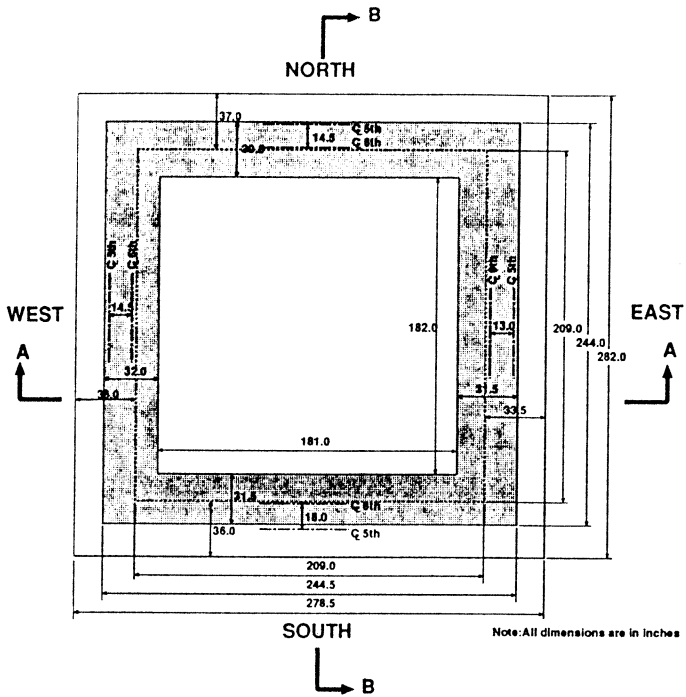
Fig. 2 Sectional Plan and Cross-Sectional Elevations for the Tower between the 5th and the 6th floor

As indicated in Figs. 1 and 2, the square loadbearing stone masonry tower exhibits an unusual wall offset at the 6.floor plinth region. The offset is large for all four tower elevations and is largest for the South wall where it amounts to 18 in. (about 450 mm) as shown on Fig. 2. The walls are composed of inner and outer wythes of roughly squared Nepean sandstone filled solidly with rubble stone and mortar. The plinth as well as the quoin chain stones, pointed arch voissiors, moldings and trim consist of dressed Ohio sandstone. The two floors of relevance to the tower analysis dealt with here act structurally very differently: while the fifth floor consists of shallow brick masonry arches spanning between the lower flanges of the four substantial steel beams indicated in Fig. 2 (and the steel beams extend to the centre of the East and West walls thus providing adequate support for potential stabilization measures), the sixth floor prior to the 1994 repairs had ten minor steel beams encased in deteriorated concrete. These steel beams extended little into the East and West walls and were additionally supported at their third points by two deteriorated brick masonry arches.

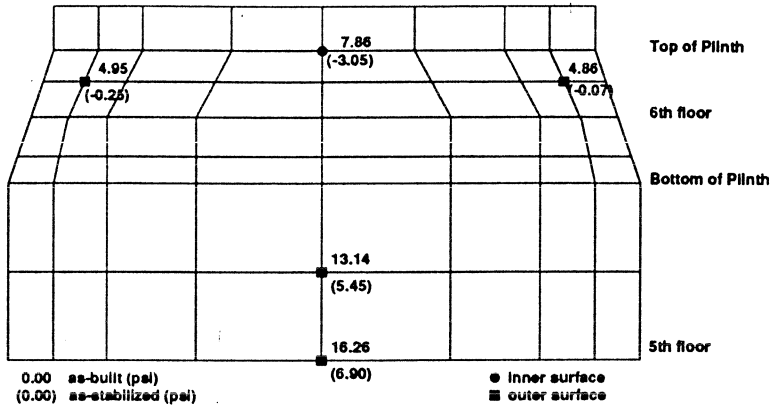
The analysis of the tower under its own weight indicated that the wall offsets cause significant spreading forces concentrated mainly at the bottom of the plinth. These forces in turn cause transverse tensile stresses in the horizontal direction in both the plinth region and the storey below. Critical horizontal tensile stresses on both the outer and inner wall surfaces are shown for the wall having the largest offset and therefore the largest stresses, i.e. the South wall, in Fig. 3(a). A critical vertical tensile stress also occurs in the plinth region as illustrated in Fig. 3(b) for the South wall. Based on the premise that massive loadbearing stone masonry walls must be kept in compression to prevent cracking and the direct tensile bond strength of stone masonry built with low strength lime mortar is very weak at all times, the 3-D analysis results indicate that the eccentric wall offsets likely initiated structural cracking soon after completion of tower construction over a century ago. The effect of wind loading was found to increase critical tensile stresses by only about 20 percent; this is as expected due to the massiveness of the walls and overall tower geometry.

(a) Horizontal Stresses at Key Points on Surface of the South Wall (positive stress is tensile)

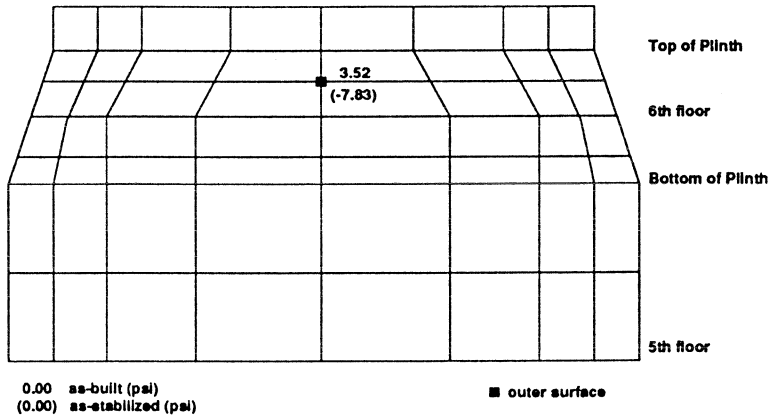
Fig. 3 Comparison of Key Stresses Before and After Applying the Stabilization Scheme

(b) Vertical Stresses at Key Point on Surface of the South Wall (positive stress is tensile)
