## POTENTIAL USES FOR POLYMER MODIFIED REPOINTING MORTARS

Fernando Pellicer<sup>1</sup>

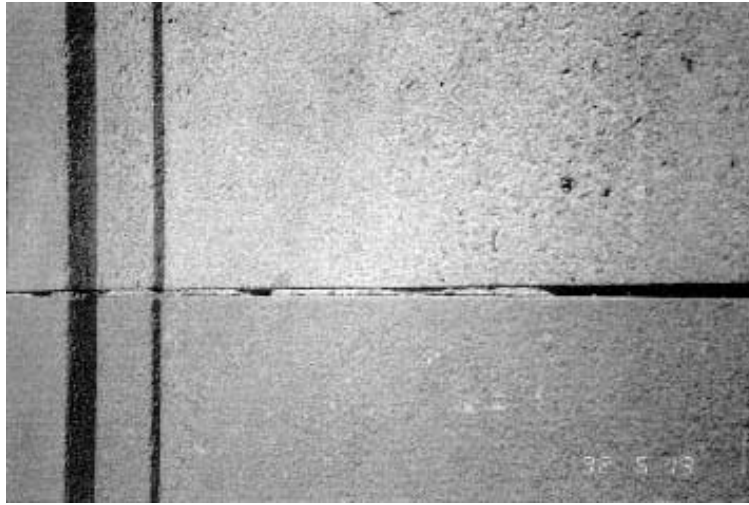
Failure of the joints typically occurred in one of two fashions. Either a hairline opening at the interface of the mortar and the stone, or sections of mortar which popped out, pieces of which a few centimeters in length were found on the lower roof levels (fig 2). The areas of least mortar deterioration were located on the north and east facades of the elevator core (which protrudes from the east façade) and parts of the east façade office block. These two facades are the least exposed to large temperature changes and wind driven precipitation, therefore less damage from freeze-thaw cycles. Another possible cause for the deterioration of the mortar, although difficult to confirm, is the structural movement of a tall building. Movement induced by wind and building creep (shrinkage) must be absorbed by the caulked horizontal compression joints located below the shelf angle of each floor. Many of these joints had failed either by excessive compression which forced the sealant out of the joints (fig 3), or by excessive tension which split the joint open. In a few instances the compressive forces were so high that the edge of the stone panels spalled off. The lack of the ability of the compression joints to absorb the stress imposed on the cladding resulted in a transfer of the forces to the mortar joints of the stone and glazed terra cotta, which in turn failed.

Fig 2 Deteriorated mortar due to excessive compression

The requirements of the repointing mortar were established as being increased flexibility, greater bond strength, and a high compressive strength in order to better resist the structural and thermal movements of the tower cladding. Our investigation lead to the suggestion to use a latex additive in the mortar mix, however there was very little field data available on its use in this context. The document which proved most useful and conclusive on the properties of latex in a cementitious mix was the Transportation Research Board (USA) Synthesis 179 Latex-Modified Concretes and Mortars<sup>1</sup>. Although

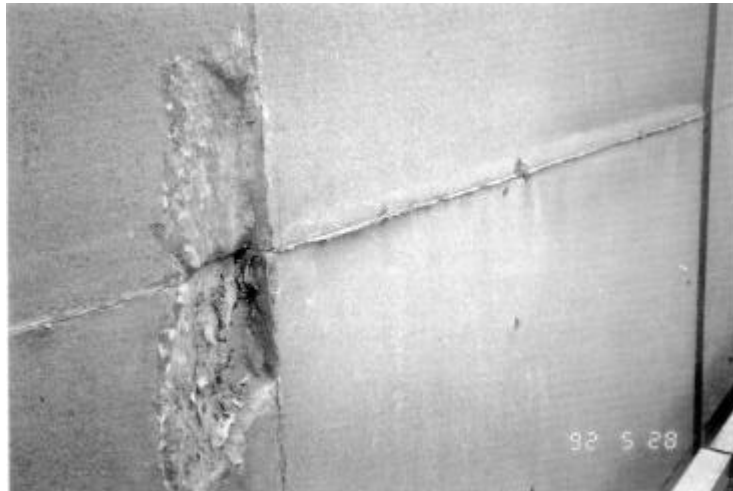
Fig 3 Stone panels spalling at compression joint due to excessive compression

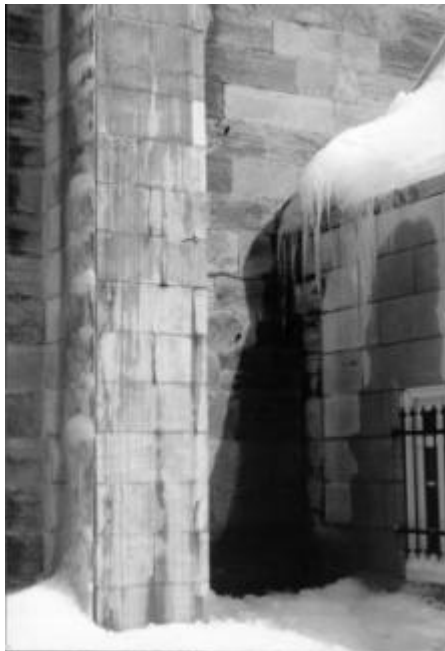
Unfortunately this restoration work did not prove successful in terms of durability. By 1997, water had again saturated the buttresses and many mortar joints had failed (fig 4). Apart from being disturbed by this failure, we established a testing program which set out as an objective to select the most performing mortar for this very demanding condition. Benefiting from the scaffolding required for the replacement of the roof (1998), all buttresses (except the apse) were fully repointed up to the second shoulder. Several mixes were established as follows:

Fig 4 Buttress in 1997  
Note ice formation at joints on left

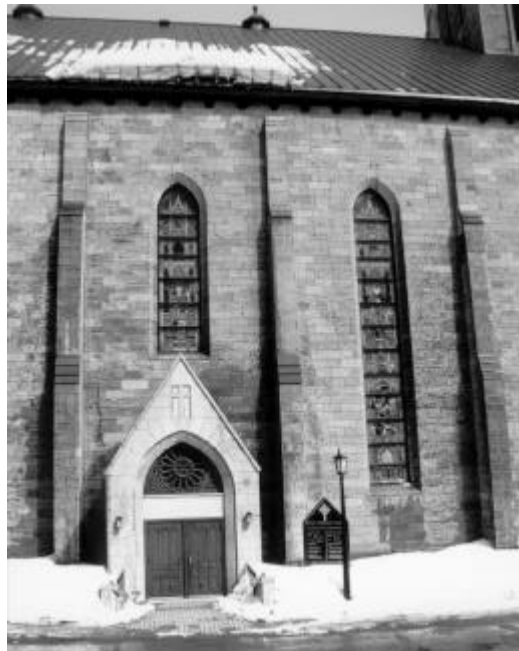
Fig 5 Buttresses 2 years after repairs

buttresses were not repointed since the roof geometry is such that they receive little roof water, hence were in satisfactory condition. All materials including water for each mix were measured and packaged in the testing laboratory of the mortar manufacturer. The joints were repointed to a depth of approximately 20mm and all cracks and surface fissures were repaired with Jahn M70 restoration mortar. No penetrating sealer was applied but lead shoulder flashings were installed to aid in the deflection of water (fig 5).
