WHY DID THIS BUILDING NOT COLLAPSE?

ABSTRACT

In 1997 a condominium building was constructed in Winnipeg, Manitoba, Canada. Some two years later, one of the tenants, a retired engineer, noticed some small concrete fragments on the floor of the underground parkade and, looking up, saw some cracked reinforced concrete beams. This was promptly reported to the building manager, who in turn commissioned an engineering evaluation of the situation. A structural investigation disclosed that some of the main transfer beams supporting load-bearing walls had only about 20% of the required reinforcement. The investigation identified an exceptionally serious problem. In fact, there was some difficulty in determining why the building was still standing! Immediate attention was required to prevent collapse and to restore the required strength and, in the process, to find out why collapse had not already taken place. This paper explains why the building did not collapse and the remedial steps taken to ensure safety.

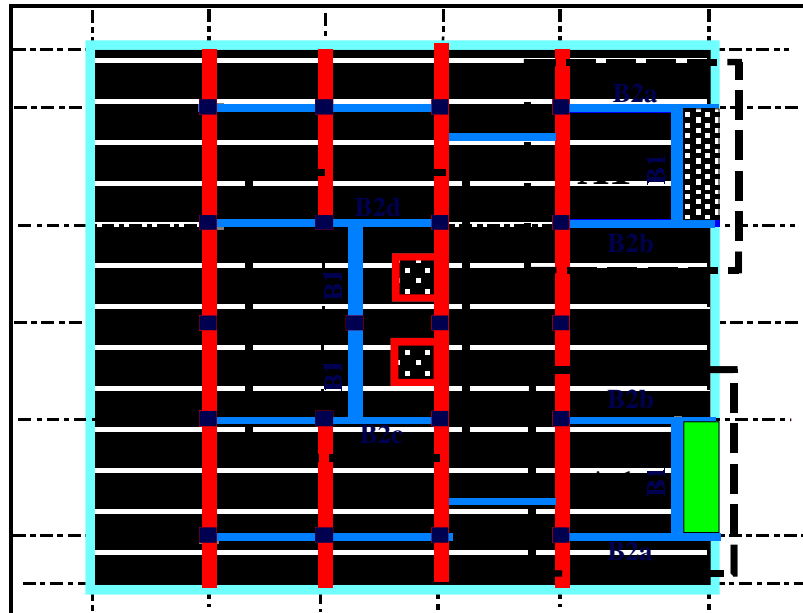
Figure 2: Locations of Concern A1 and A2.

At this point in the description of the structural layout a serious error becomes apparent: namely, that there are a few transfer beams B1 supported not on columns or transfer beams but on lesser beams B2. These lesser beams B2 in the locations A1 and A2 outlined in Figure (2) clearly should have been more substantial transfer beams of a typesimilar to B1. It is, of course, remarkable that this error was not identified during

The locations of concern are identified as A1 and A2 in Figure (2), with four types of beam B2, namely B2a and B2b in locations A1, and B2c and B2d in location A2. In all instances, B2a through B2d, the beam type B1 would have been appropriate, and this likely was the intent of the original structural design. In all four cases the beams B2 have about 20% of the resistance required for the tributary design load, and only about 50% of the reinforcement required to prevent collapse under the tributary dead load. This, of course, raises the interesting question of why they did not collapse.

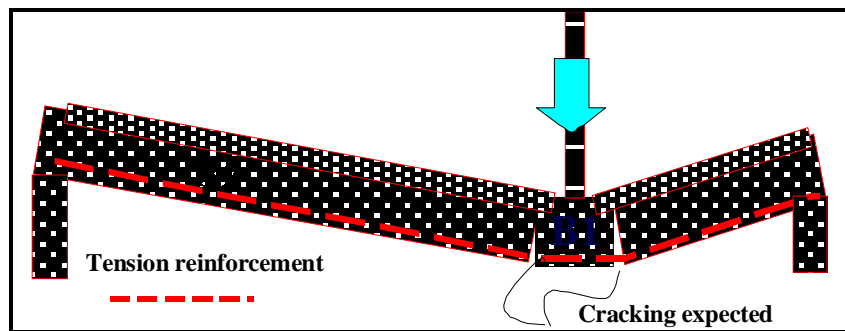
Figure 3: Configuration and Expected Behavior of Beams B2.

The general configuration of the overloaded beams B2 (B2a – B2d) is shown in Figure (3). They support the heavily loaded beams B1 at about one-quarter of the span length from one end. Their spans are, variously, in the order of 7.5m to 10.0m, and they are supported at their ends either on the exterior basement wall or on columns. When the review calculations were made, it was clear that not only were these beams seriously overloaded, they actually should have collapsed under the tributary dead load. The expected behavior was the simple collapse mode shown in Figure (3). However, collapse did not take place, and a site inspection showed cracking consistent with serious overloading, crack widths being in the order of 2-3mm, about ten times the normal crack width.

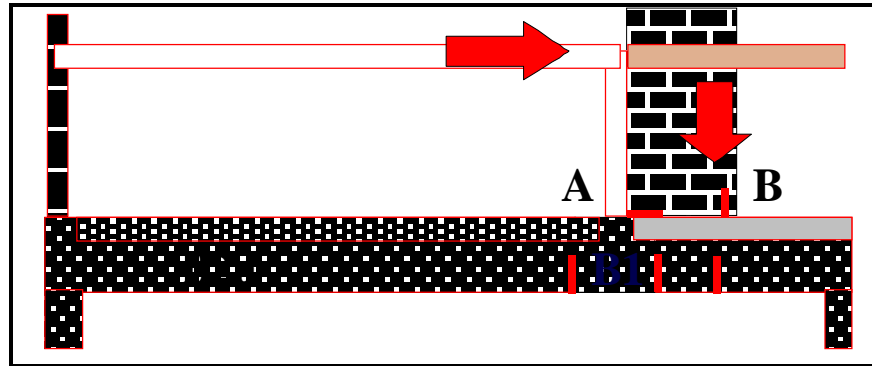
Figure 4: Redistribution of Loads on B2a.

The beams B2a and B2b in location A1 support the heavily loaded beam B1. The factored design load from B1 is in the order of 850 kN, but the factored resistance to load of B2a and B2b at this location is only about 250 kN. Beams B2a, in addition to the load from B1, support a short length of balcony bearing wall. B2a is, of course, understrength and a field inspection showed cracking consistent with serious overload and onset of collapse. The collapse mechanism requires the beam to deflect. However, as the beam deflects the balcony wall above cannot rotate because of horizontal constraint at the floor levels. This horizontal constraint is provided by the floor diaphragms transferring the required horizontal force back to the vertical service shafts. As a result of this restraint of wall rotation, the wall separated from the beam B2a at location A and was hung up on the beam at location B, as shown in Figure (4). The validity of this suspected mechanism was borne out by the presence of horizontal cracking at A in the masonry above, indicating separation, and vertical cracking at B, indicating serious overload of the masonry in compression. Fortunately, the masonry contractor, suspecting heavy loads in the short balcony walls had taken care to grout them fully. The result of this initiating collapse mechanism was to shift the load from B1 out towards the end of the balcony wall, significantly reducing the moment in B2a.

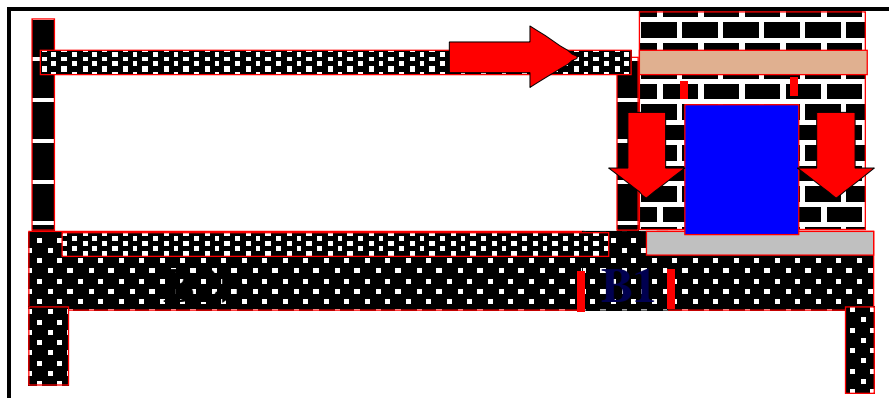
Figure 5: Redistribution of Loads on B2b.

The situation for beam B2b is rather similar in that, again, there is a balcony wall above the beam. This time the balcony wall extends further but has a large patio door opening. Once again, the balcony wall is prevented from rotation by the floor and roof diaphragms. The walls in this instance redistribute the load by a different mechanism - mainly through the masonry lintels over the door opening as shown in Figure (5). This

was borne out by the presence of cracking in B2b at B1, and lintel cracking in the balcony wall. The result is a redistribution of load from B1 toward the support, with a consequent reduction of moment in B2b. Once again, the good grouting of the masonry balcony walls prevented collapse. It is interesting to note that the masonry contractor cannot recall these balcony walls being bonded with the load-bearing masonry walls. In any case, there clearly was a transfer of load.

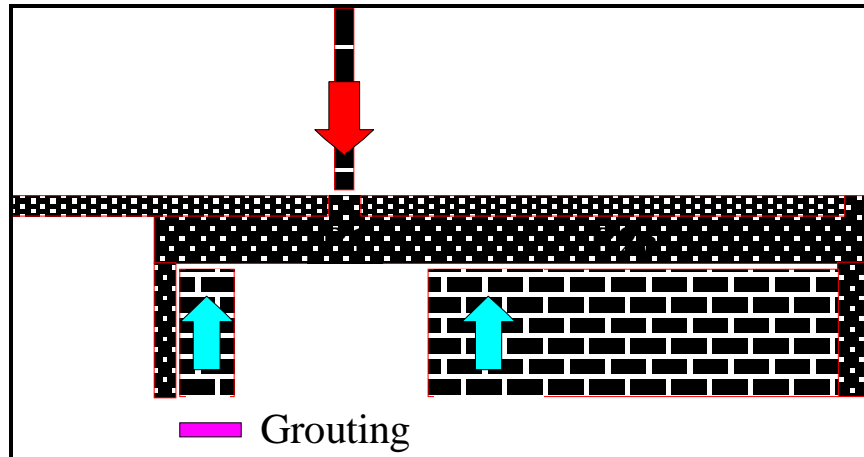
Figure 6: Redistribution of Loads on B2c.

Both beams B2c and B2d are grossly under-reinforced for the reactions from B1. Rather mercifully, there is a masonry wall beneath B2c, which exhibited normal crack widths, and sufficient foundation capacity below. In this instance, it was merely a matter of grouting the masonry wall to sustain the unexpected load safely. This is shown in Figure (6). Beam 2d, on the other hand, had some large cracks indicative of steel yield and effective structural failure, the resistance of the beam to vertical load being 350 kN,

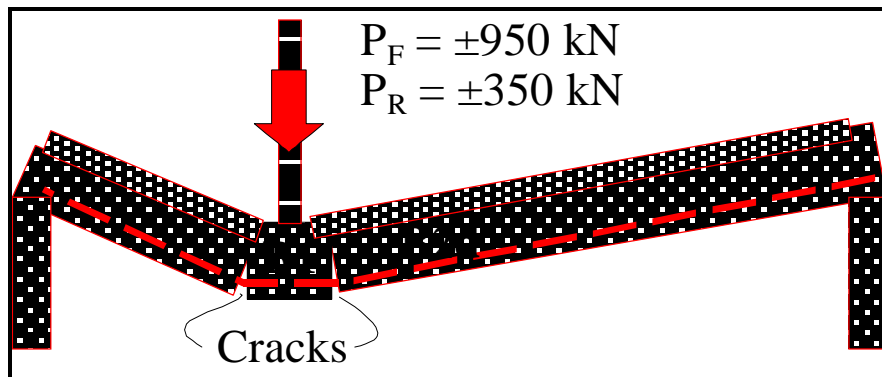
Figure 7: Loading on B2d.

compared to a factored design load of 950 kN, as shown in Figure (7). The reason B2d did not collapse can be seen from Figure (8). Once B2d started to deflect, the wall above B1 became hung up at X, reducing the load transmitted to B2d, but now overloading the beam B1 and the foundation under the column.
