## MASONRY RESTORATION OF THE OLD CIVIL ENGINEERING BUILDING, FREDERICTON CAMPUS, UNIVERSITY OF NEW BRUNSWICK

Dana E. Moxon<sup>1</sup>

### ABSTRACT

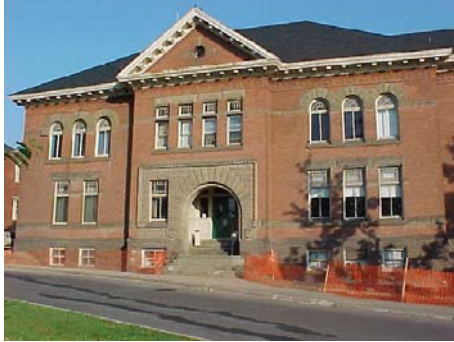
Figure 1. (a) East elevation and (b) South elevation prior to masonry restoration.

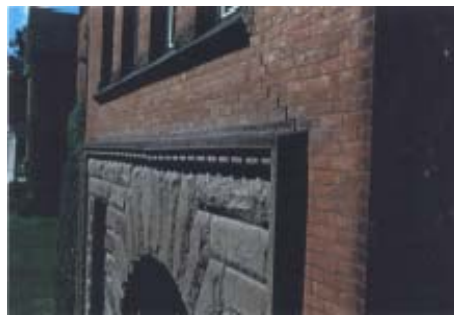
The keystone on the second floor right window arch had settled approximately 50 mm (2"), displacing the window frame below. One of the five 1.4 m (4-1/2') foot long beaded coping stones had differentially settled approximately 40 mm (1-1/2") towards the entrance arch keystone and resulted in a diagonal crack forming in the above brickwork. The eight brick courses in between the continuous second floor window sill stones and coping stones were bulged outwards by approximately 25 mm (1") in between the diagonal cracks that had formed at the two ends as illustrated in Figure 2.

Figure 2. Settled coping stone and deformed brickwork.

Repairs to the settled entrance coping stone was performed in conjunction with the sequential brick construction in the overlying 8 brick courses to the second floor window sills. The outward deformed exterior wythe bricks were removed to the center of the two end diagonal cracks with wood shoring placed 1.2 m (4') apart, and was reconstructed prior to further brick removal. While the bricks were removed, repairs to the adjacent wythe were performed in conjunction with resetting the settled coping stone with stainless steel anchors and slate shims. Resetting the keystone in the right wall arched window was accomplished once the above double wythe wall was removed. The mortar between flanking voussoirs was raked out to loosen the keystone. The keystone was carefully lifted with a hydraulic jack and slate shims were installed to secure the stone in place.

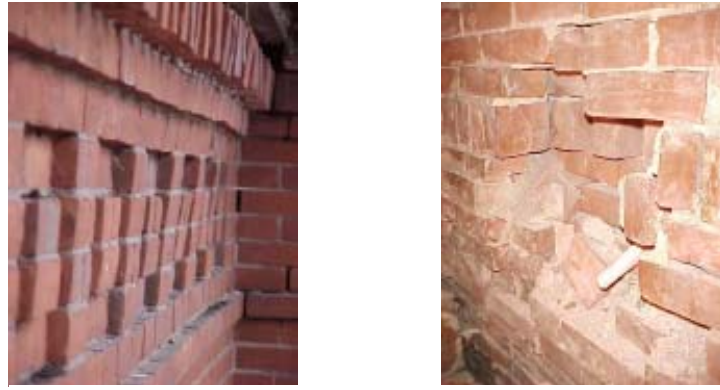
An outward deformation of approximately 50 mm (2") was observed in the double wythe brick wall above the attic floor level on the left and right walls - see Figure 3(a). The primary contributing factor associated with the wall deformations was a lack of attic ventilation, where brick closure was installed in between the wood bearing block to the underside of the roof sheathing between the roof joists, and the soffit was not vented. A history of extensive ice accumulation was observed along the roof edge, and had accumulated below the cornice and roof valleys along the frieze panel. The mortar joints along the corbelled ledger and dentil courses were extensively deteriorated with loose bricks, and the surmounted wood nailer block was also deteriorated. This is believed to be the location of prolonged water entry into the masonry that caused the progressive outward deformations to occur. Water stains were observed on roof joists and sheathing in between the brick wall and the roof edge from water backup underneath the asphalt shingles during ice formation.

At the interior location, the mortar had a powdery texture and would crumble into individual grains when removed with hand tools. Bricks were easily removed by hand in the courses adjacent to the frieze panel indicating the interior wythe was under very little compressive load, as illustrated in Figure 3(b). An inward bulging of the lower interior

wythe was observed at several locations, indicating a separation of the two wythes. The mortar joints above the frieze panel were in general sound with no cracking.

Figure 3. Typical deformations and deterioration of the double wythe walls at (a) exterior location and (b) interior location.

It was determined that full reconstruction of the double wythe walls bearing on the east elevation cavity walls above the arched windows was required. In order to provide sound salvage brick for replacement of damaged brick throughout the building, reconstruction plans included rebuilding the interior and exterior concealed wythes with new 55 MPa Lantz Tapestry Red bricks manufactured by Shaw Brick Ltd.

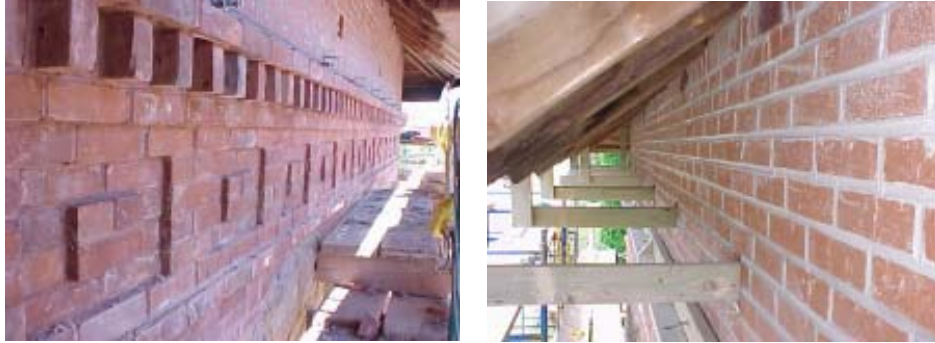
Figure 4. Reconstructed exterior wythe at (a) exposed frieze and (b) concealed area behind cornice.

The indented frieze panel, dentil and corbelled ledger courses were reconstructed with the original bricks using the prescribed lime mortar as illustrated in Figure 4(a). Bricks were pre-soaked prior to reuse. The interior wythe and concealed exterior wythe (Figure 4(b)) were constructed with new brick using Type N mortar with mix proportions as specified by CSA A179-94 (CSA 1994). To be conservative, the lime mortar was used in between courses of original and new brick. The wood nailer block for the sheet metal soffit that was previously embedded into the course above the corbelled ledger course was replaced with continuous 2x6 lumber anchored with threaded rods embedded into the masonry with toe nailed perpendicular 2x4 lumber surmounting the ledger course. The wythes were tied together using 9 gauge continuous truss type galvanized steel bed joint reinforcement, spaced vertically every 3 courses. Passages were left open in the walls for the soffit framing during reconstruction while the masonry ties from the studs were anchored to the wall. Soffit vents were installed into the sheet metal to provide

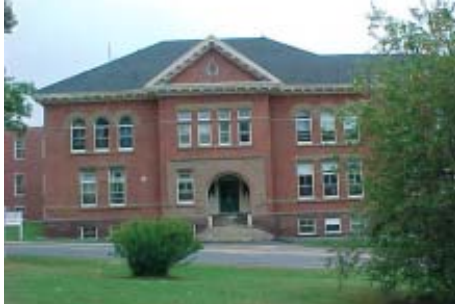
Figure 5. (a) East elevation and (b) South elevation, following restoration.
