COMPARISON OF BACKUP WALLS FOR ANCHORED BRICK VENEER

Case Studies of Building Envelope Systems with Backup Walls of Steel Studs, Concrete Masonry, and Cast-in-Place Concrete

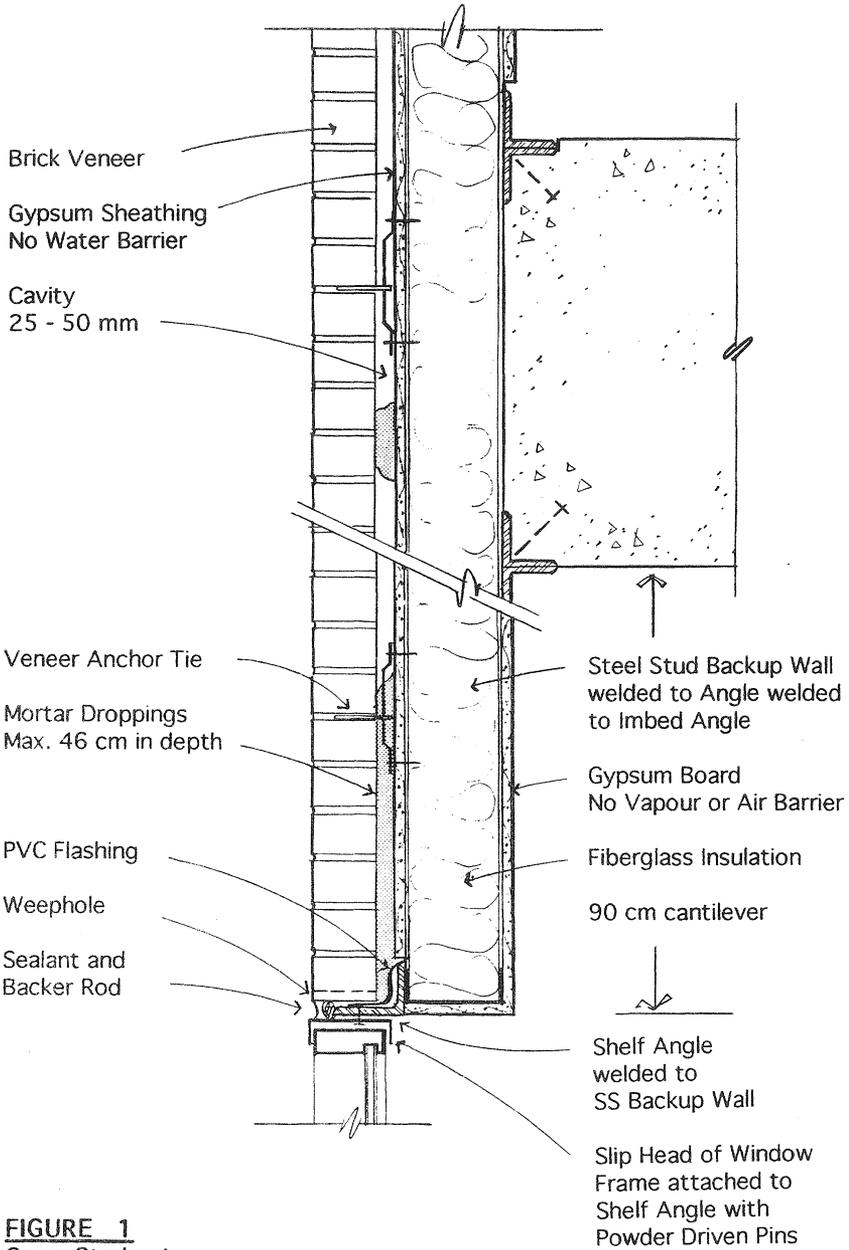
FIGURE 1
Case Study A
 Brick Veneer with Steel Stud Backup Wall

Case Study A: Anchored brick veneer with steel stud backup wall, University classroom building constructed in 1987. See Figure 1.

The backup wall consisted of 152 mm [6"], 18 gage steel studs at 406 mm [16"] on center. The steel stud wall was attached at approximately mid-height to the concrete beams creating a laterally cantilevered wall above and below the beams. Steel angles welded to embed angles in the concrete beam, were in turn, welded to each steel stud. There were poorly welded connections within the stud wall and in the attachment to the structural frame. The steel studs were faced on the exterior with gypsum sheathing and on the interior with gypsum board. The screws attaching this sheathing had no corrosion resistance and some were showing signs of rust after less than a year. The flexibility of the wall was not determined. The shelf angle that carried both the veneer and the ribbon windows was welded to the steel stud backup wall.

As constructed, there were no means of effectively sealing the top of the window at the slip head to the shelf angle. At the time of the investigation, the primary source of visible water entry was at this attachment where the unsealed gap allowed wind driven rain to easily penetrate to the interior. Water had also entered above the base of the drainage cavity due to a mass of mortar droppings that prevented the weepholes from draining. Most shelf angles exhibited some rust attributable to water leakage after construction was completed.

The brick veneer panel was tied to the backup wall with galvanized veneer anchor ties consisting of 5 mm [3/16"] triangular ties and 12 gage strap anchors spaced at 406 mm [16"] o.c. in both directions. The strap anchors, which had no backing plates to prevent crushing of the gypsum sheathing by the triangular ties, were fastened to the steel stud backup with two steel screws with no corrosion protection. Horizontal movement was accommodated with vertical expansion joints spaced at 6 m [20'] on center but none were located at or near corners. Vertical movement was accommodated by the slip head of the window frame.

Kraft paper faced, fiberglass insulation filled the steel stud cavity. There were no additional water, air, or vapour barriers. The cavity between the brick veneer panel and the backup wall was typically 25 mm to 32 mm [1" to 1-1/4"] with a maximum cavity width of 50 mm [2"]. There were extensive mortar droppings, ranging to 46 cm [18"] in depth, and mortar bridges. The mortar droppings were well consolidated and had bonded to the paper face of the gypsum sheathing. Flexible 20 mil PVC flashing meant to protect the shelf angle had been compromised in several ways. It stopped an average of 25 mm to 38 mm [1" to 1-1/2"] back from the face of the brick, and the powder-driven pins attaching the slip head of the window frame to the underside of the shelf angle had protruded through the angle often puncturing the flashing. The flashing was also melted or torn in numerous locations.

It was determined that at the time of the investigation, the SS backup wall was not part of the failure of this system. However the wall had several problems that may have created the potential for future failures given the high lateral loading and continued corrosion of welds, fasteners, and the steel studs themselves.

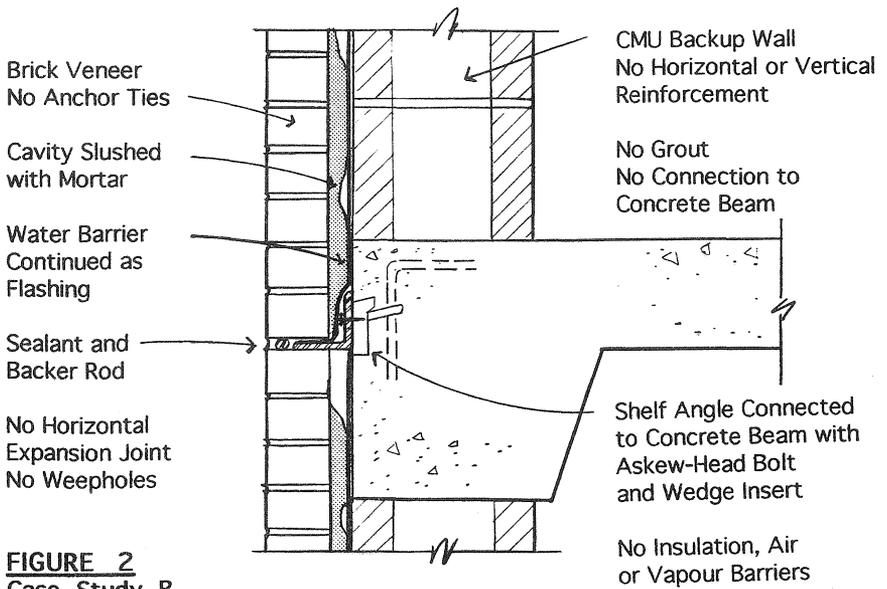
FIGURE 2
Case Study B
Brick Veneer with Concrete Masonry Backup Wall

Case Study B: Anchored brick veneer with a concrete masonry backup wall, College dormitory constructed in 1967. See Figure 2.

The 250 mm [10"] CMU backup wall had no vertical or horizontal reinforcing and the cells of the block were not grouted. There were no dowels fixing the CMU backup to the concrete frame at the top or bottom. The only connection to the frame was at the columns with dovetail anchors randomly spaced, laid in the concrete block, and inserted in a cast-in-

place slot in the column. Because of the depression cast into the end of each concrete block there were gaps up to 50 mm [2"] in width between the column and the CMU at the point where the anchors were installed. Shelf angles were attached to the concrete frame at each floor with askew-head bolts in wedge inserts.

The brick veneer was tied randomly and with inadequate spacing to the concrete columns using dovetail anchors. There was little attachment to the CMU backup wall. In many areas the cavity was partially full of slushed mortar in what may have been an attempt to create a collar joint. The CMU wall was not acting as a backup for lateral loads, except in these fully parged areas and then only for positive wind pressure. No horizontal expansion joints were included so as the veneer expanded vertically, the askew-head bolts were lifted in the wedge inserts allowing the angles to move freely in the vertical direction. This movement was such that near the top of the building many of the bolt heads had raised to the extent that they were no longer properly engaged in the wedge pockets. This vertical expansion had badly distorted many of the aluminum window sills, some of which now sloped towards the interior. It also lifted the parapet which forced the brick veneer to span the 1.83 m [6'] width of every window opening at the top floor creating gaps up to 25 mm [1"] between the veneer and the window head. This caused stresses the veneer was incapable of supporting with the result that many of these "arches" had cracked at the center of the span and often at the ends as well. Some of the brick had loosened and ended up resting on the window head. A combination of horizontal and vertical movement had damaged some of the dovetail anchors between the brick veneer and the concrete columns. This movement had twisted the dovetail section of one anchor, almost completely disengaging it from the dovetail slot in the column. This occurred in an upper story near a corner where differential movement was greatest. The dovetail section of the anchor had been deformed about 25 mm [1"] vertically and 6.4 mm [1/4"] horizontally. Also a crack had developed at the narrow area where the dovetail section meets the corrugated section.

A water barrier of asphalt impregnated felts was adhered with mastic to the exterior of the CMU wall. It extended to provide cavity flashing at the shelf angle but did not extend beyond the toe of the angle. The interior face of the CMU backup wall was painted creating the interior finish. There was no insulation in the system and no other air or vapour barriers.

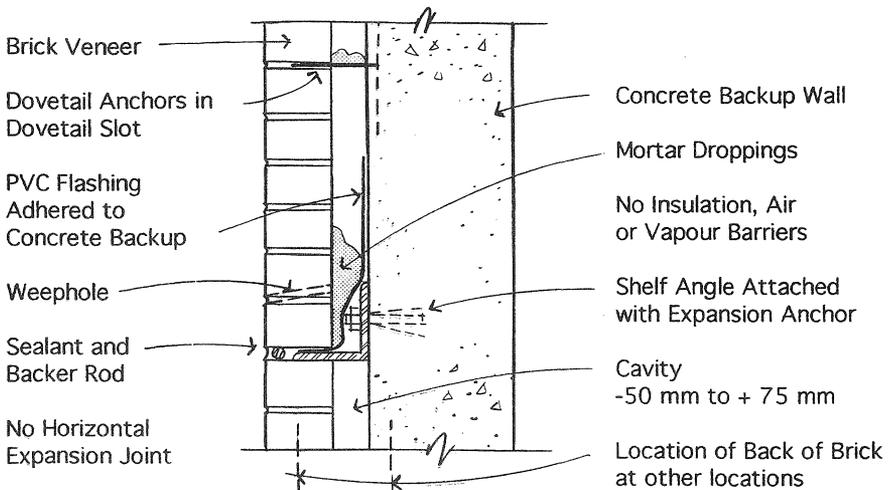
FIGURE 3
Case Study B
Brick Veneer with Concrete Backup Wall

Case Study C: Anchored brick veneer with a reinforced, cast in place concrete backup wall, Performing Arts Hall constructed in 1974. See Figure 3.

The backup wall was integral with the 203-356 mm [8-14"], reinforced, CIP concrete structure. Hot-dipped, galvanized shelf angles were bolted to the concrete backup 6 m [20'] above the foundation and then at 3.66 m [12'] intervals. The anchor bolts were sometimes poorly installed, often inadequately spaced, usually with no shimming at gaps. As there were no horizontal expansion joints, the shelf angles served to partially constrain

vertical movement of the brick veneer. This resulted in buckling loads that also contributed to some lateral movement. Furthermore almost no vertical expansion joints were installed and none that protected corners.

The brick veneer panels were tied to the concrete backup wall with 16 gage, corrugated or crimped, 25 mm [1"] mill galvanized, dovetail anchors. The dovetail slot was cast-in-place with anchors spaced 38-61 cm [15-24"] vertically and 71-96 cm [28-38"] horizontally. The slots had been deformed during placement of the concrete to the degree that many of the original anchors must have been ineffective as lateral play was often 9.5 mm [3/8"]. In investigating whether the slots could be reused it was found that in order to limit movement of the dovetail anchor in the lateral direction to 1.59 mm [1/16"] it would be necessary to use several different anchor configurations, some of which were not commercially available.

The cavity between the brick veneer and the backup wall averaged 25 mm [1"] in depth but ranged at the extremes from plus 75 mm [3"] to minus 50 mm [2"] (the brick was trimmed to half its depth and parged to the backup wall). There were frequent mortar droppings and bridges. Weepholes, when installed, were located a course above the shelf angle and flashing. PVC flashing, protecting the shelf angle, terminated before reaching the outer edge of the horizontal leg. The exterior of the concrete was coated with an asphaltic water barrier and there was no insulation in the system. The interior finishes consisted of painted gypsum board, brick veneer, and paint applied directly to the concrete backup wall.
