DESIGN, DURABILITY, AND THE POLITICS OF SUSTAINABILITY (WHAT DO THE THREE LITTLE PIGS TEACH US?)

Eric K. Olson¹ and Werner H. Gumpertz²

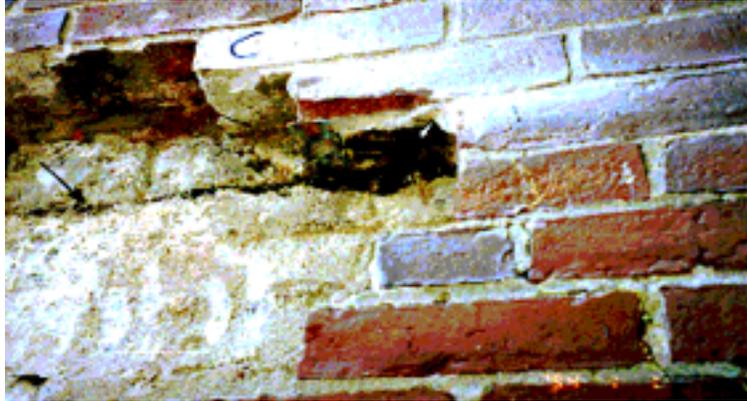
Figure 1. Asphalt-impregnated fabric through-wall flashing has decayed; all that remains is black residue in the bed joint.

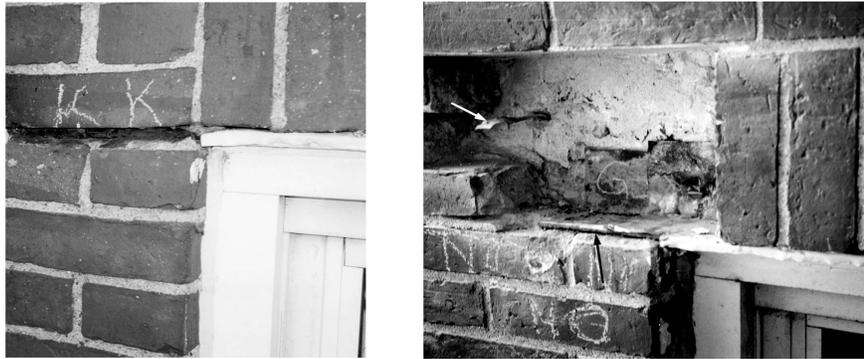
Figure 2. Copper lintel flashing lacks end dams to protect embedded steel, which has rusted and expanded, spalling mortar from the brick joint.

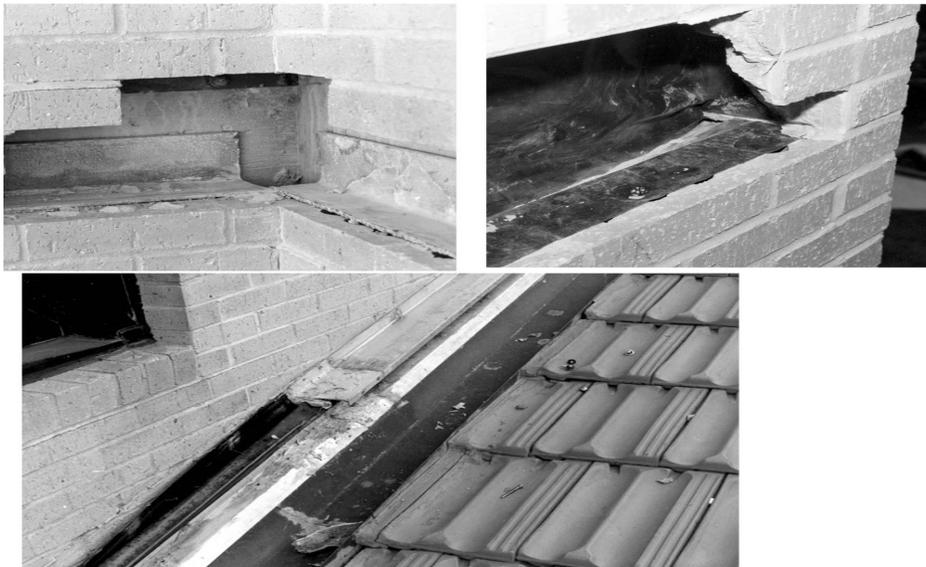
Figure 3. Thru-wall flashing is missing at shaft angles (top left) and roof to rising wall intersections (bottom). Where flashing is present, it is unsupported and unsealed at joints.

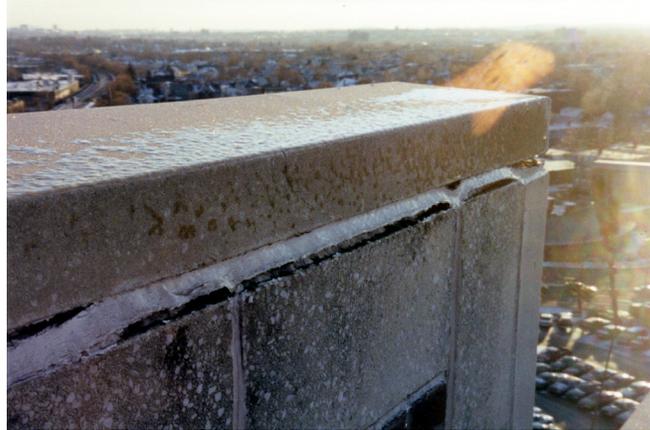
Fig. 4. Flashing beneath these coping blocks terminated behind sealant. The resulting water ingress rusted reinforcing steel beneath the blocks and heaved them upward.

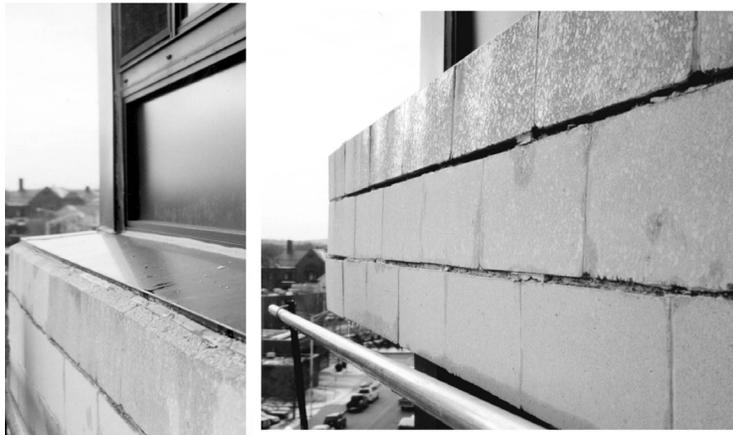
Fig. 5. Significant damage has been caused by the termination of sill flashing above the concrete block, and by failure to extend flashing over the face of the block. These defects directed water into the masonry.
