INTERNAL STRENGTHENING OF HISTORIC CLAY BRICK MASONRY PUMP HOUSES IN NEW ORLEANS

ABSTRACT

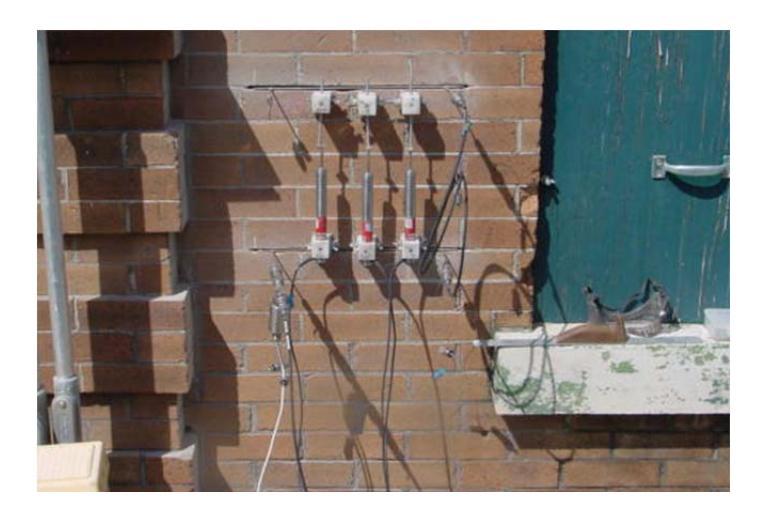
Figure 4: Flatjack testing at Pump Station 7 to determine existing masonry compressive strength and stiffness.

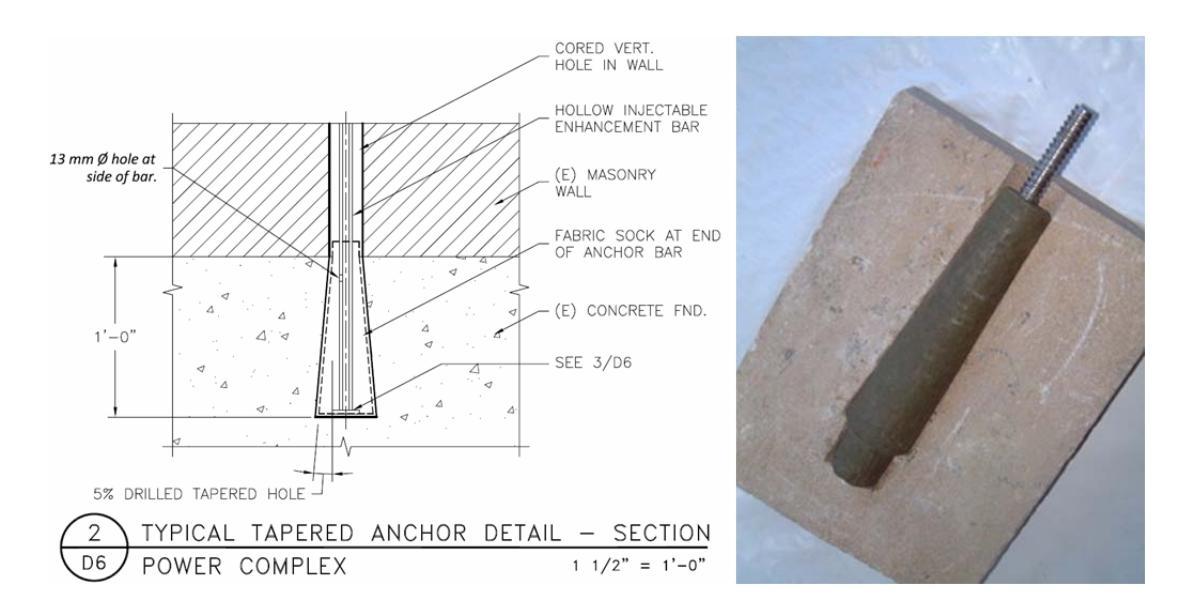
Figure 6: Left, design detail showing the reverse tapered vertical reinforcing termination. Right, installed taper.

The final retrofit stre ngthening design included several components. As mentioned previously, the existing masonry wythes were tied together using stainless st eel helical rods and injected solid with CIF. The masonry walls were also strengthened internally using vertical and horizontal stainless steel reinforcing bars (Figure 5). Vertical bars were installed into holes that were cored from the top of the wall into the foundation using specialty coring equipment. Since development of the vertical reinforcing at the base of the wall was som etimes critical to the strengthening design, a special end detail was used to engage the reinforcing into the foundations. The bottoms of core holes were reverse tapered, and the bars were installed with a washer and sock at the base (Figure 6). This connection norvided a positive, mechanical attachment to the found ations that can be significantly more effective than adhesive bonding of the reinforcing alone. The stain less steel reinforcing was comprised of bars with a hollow core that permitted relatively simple filling of the taper with CIF material.

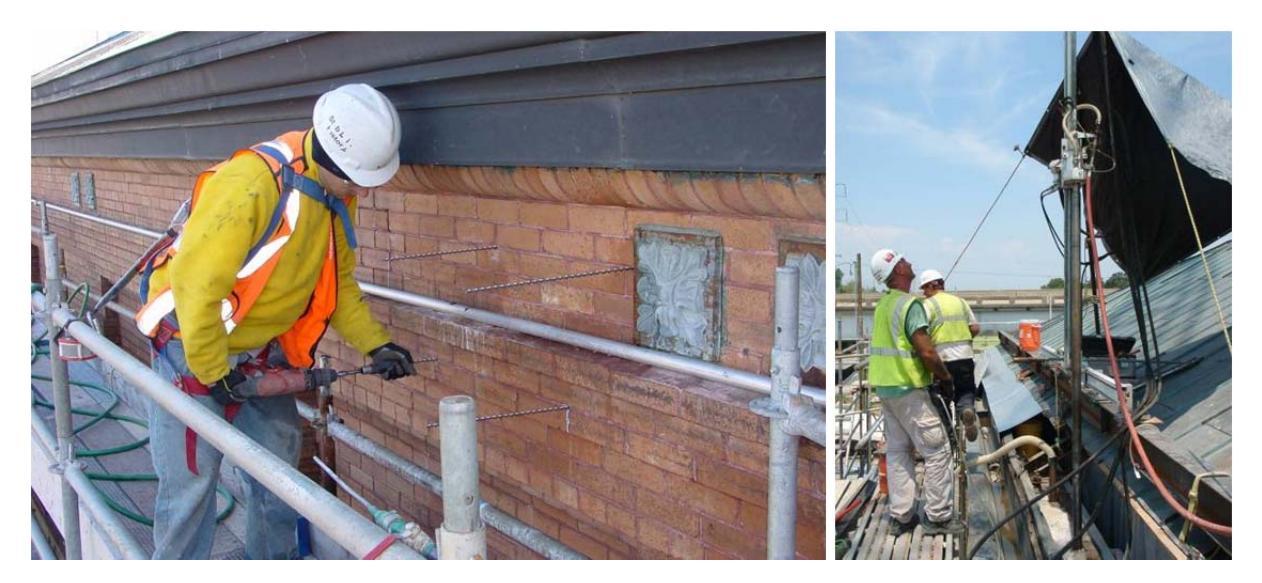
Figure 7: At left, installation of helical wall ties into existing clay brick masonry walls. At right, coring at the top of the exterior walls in order to insert vertical reinforcing.

Portions of the installation of helical ties between wythes and vertical reinforcing is shown i n Figure 7. Generally, holes were cored for vert ical reinforcing placement prior to injection grouting, although coring both before and after injection has been performed. Each approach has a unique set of challenges.

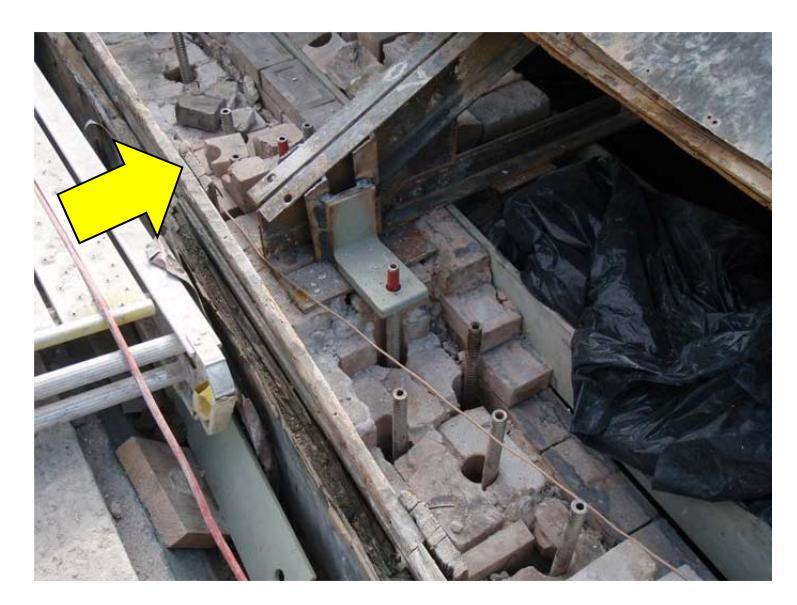
Like most construction projects and virtually all remediation projects, there were several challenges with implementing the structural retrofit design concepts . In some ar eas, the existing masonry wall mortar joints were in poor condition, occasionall y even resulting in loose or disl odged units (Figure 8). Therefore, prior to coring and CIF injection, signifi cant repointing of the mortar joints was required in some areas. This initial repair work allowed for the coring to take place with less risk of localized damage due to loose units and CIF injection to proceed without excessive leakage at the interior and exterior wall surfaces.

Figure 8: Top of masonry wall condition during vertical reinforcing installation. Dislodged bricks are indicated with an arrow.

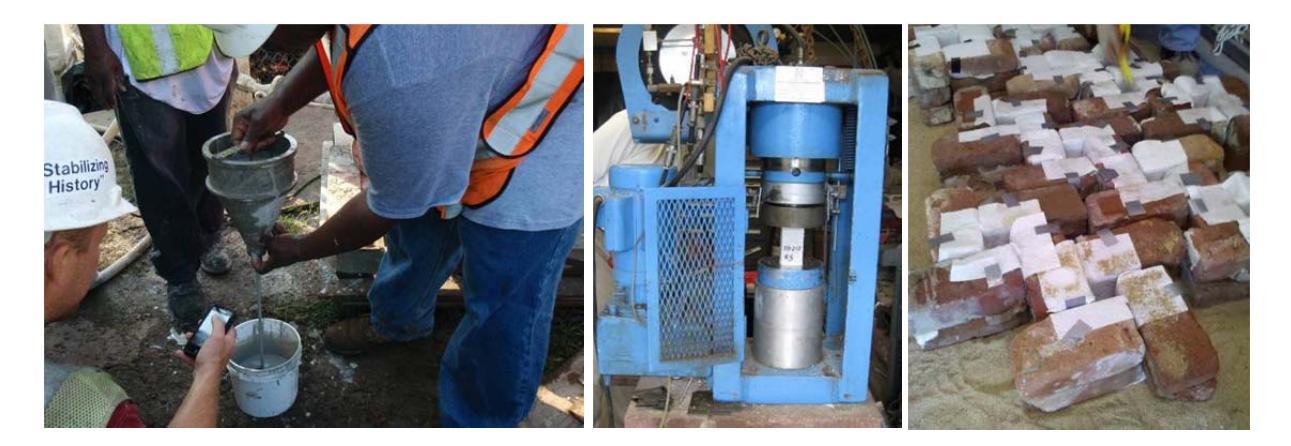
Figure 9: Left, flow cone testing to verify viscosity of CIF material. Center, compression testing of a hardened CIF sample. Right, brick forms used to cast CIF compression samples.

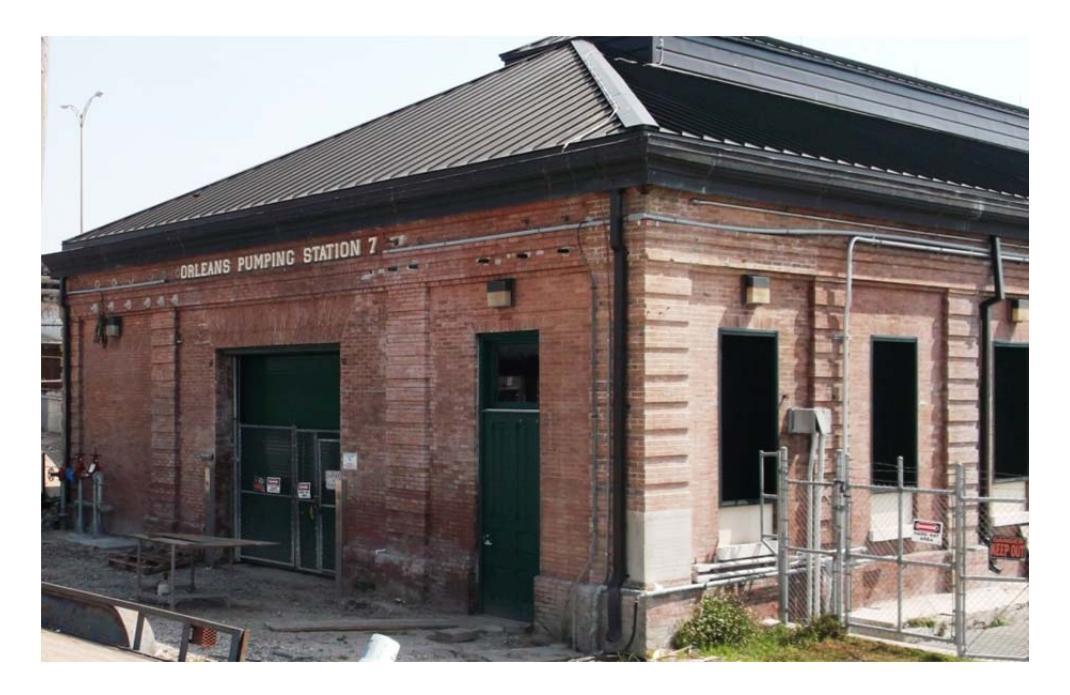
Figure 10: Overall view of southwest corner of Drainage Pump Station Number 7 showing the clay brick masonry exterior walls after completion of the strengthening project.

Although retrofit work is on-going at several stru ctures, the work at three pump stations has been completed, including Pump Station 7 (Figure 1 0). Pump Station 7 i ncludes approximately 1050 sq. m (11,000 sq. ft.) of wall area, ty pically approximately 460 mm (18 inches) thick. Int o these walls, approximately 32 cu m (42 cu. yd.) of CIF grout was injected (approximately 7% of the wall volum e) to fill voids. A total of approximately 2700 m (9000 linear feet) of vertical stainless steel reinforcing bars were installed.

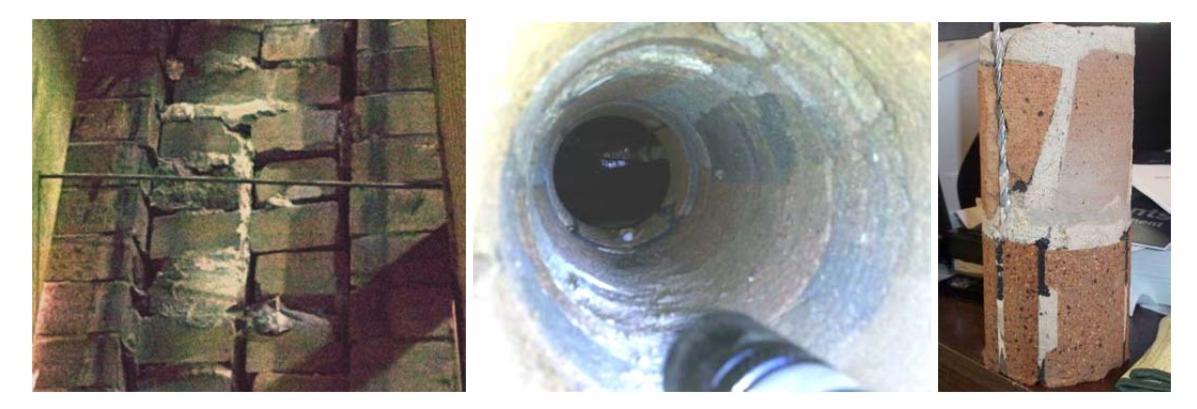
After completion at Pump Station 7, the structural enhancement appears to be successful. The walls have been grouted solid, and this has been confirmed using ground penetrating radar (GPR), borescope observations, and even (unintentionally) by subsequent coring through walls by electricians (Figure 11). The vertical reinforcing was installed successfully using the reverse tapered end connections, and helical wall ties were installed throughout the masonry exterior.

Figure 11: Left, view of voids in brick masonry prior to injection at window jamb. Middle, view looking into a core hole made after completion of CIF injection showing the lighter colored CIF material has filled the voids in the wall. Right, core extracted from the exterior wall by the electrician after completion of CIF injection showing a helical wall tie and filled voids.
